# CONSTRUCTION EQUIPMENT

## VOLVO L150H 4375 - REAR AXLE

**Sample No:** VCP409004  
**Oil Type:** MOBIL MOBILFLUID 424  
**Job No:**

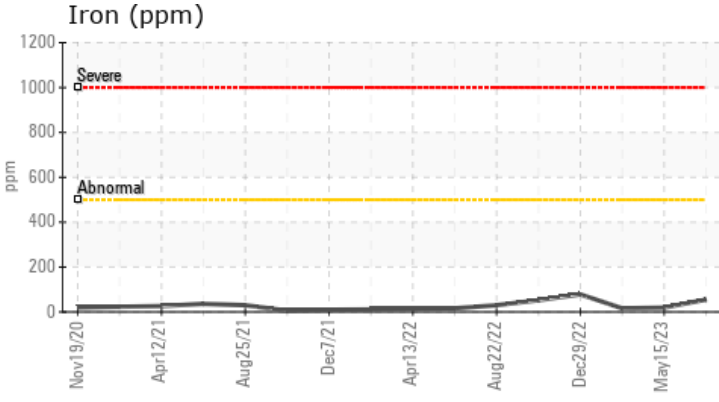
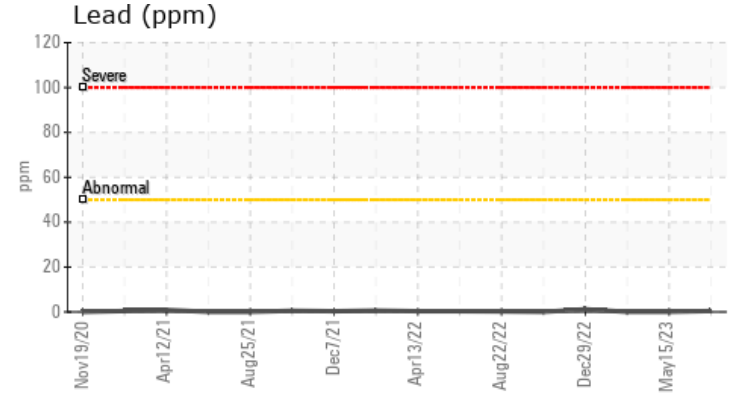
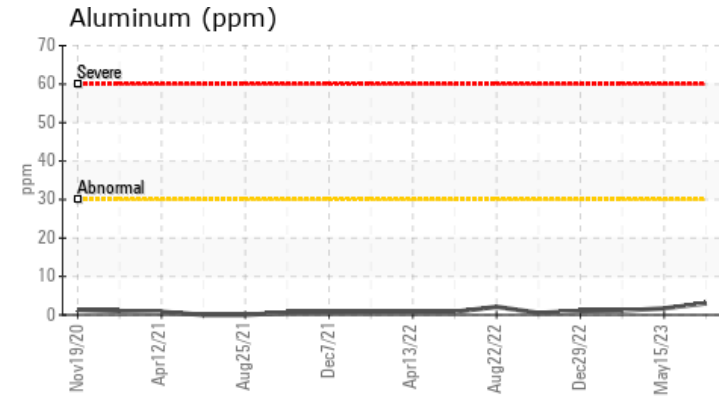
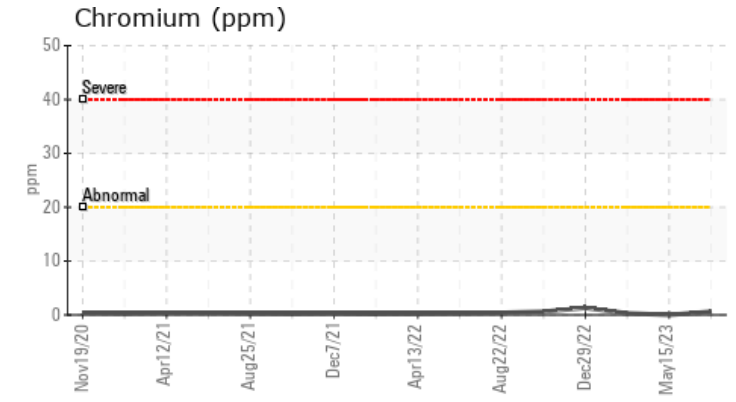
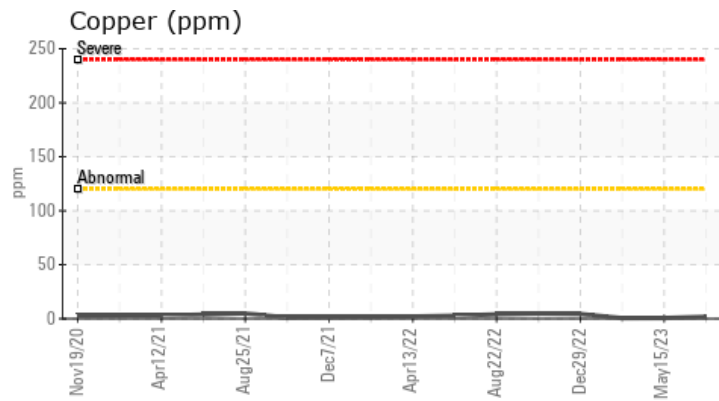
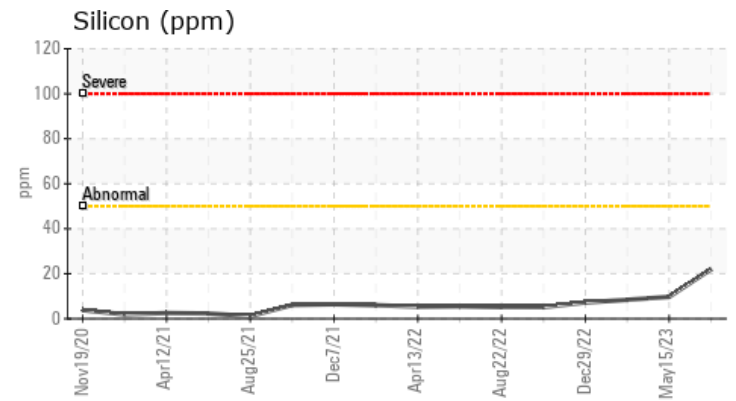
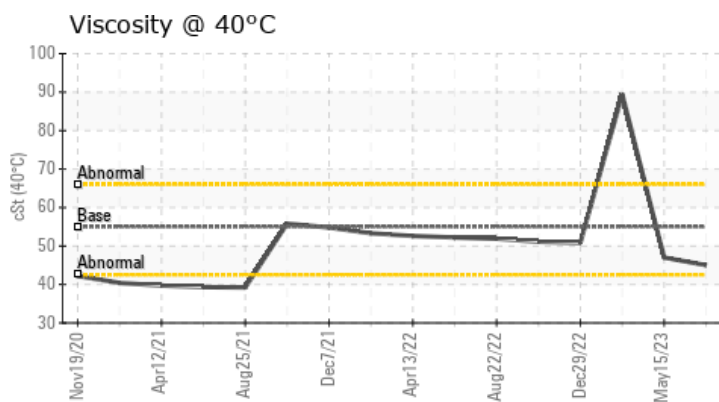
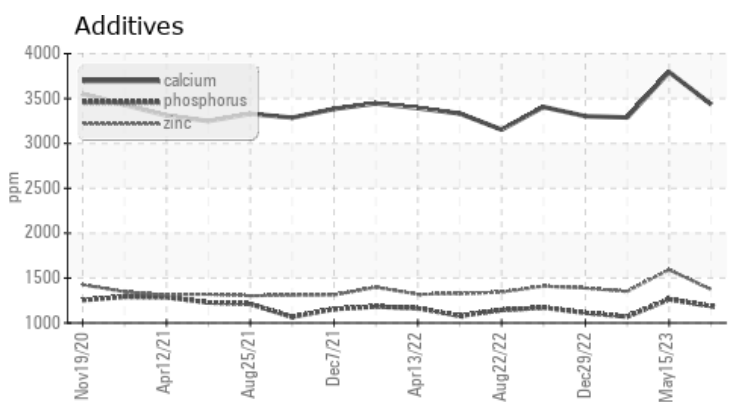
## VOLVO GRAPHS

Resample at the next service interval to monitor. All component wear rates are normal. There is no indication of any contamination in the oil. The condition of the oil is acceptable for the time in service.
