D12587 VOLVO L70H 624717 - FRONT AXLE

Sample No: VCP418685
Oil Type: VOLVO AUTOMATIC TRANSMISSION FLUID AT102
Job No: D12587

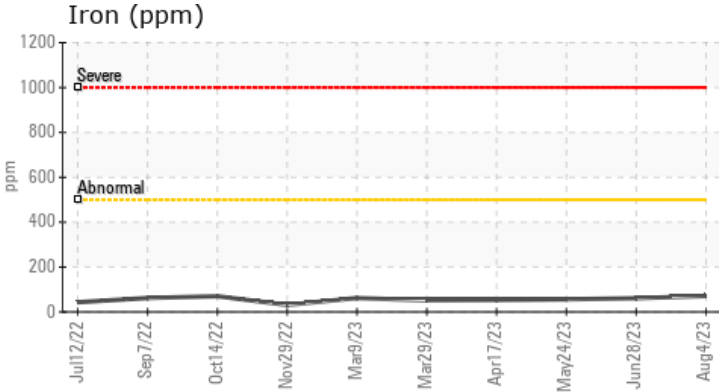
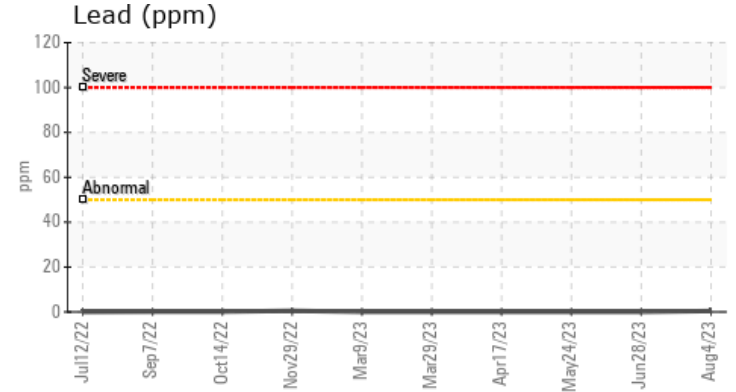
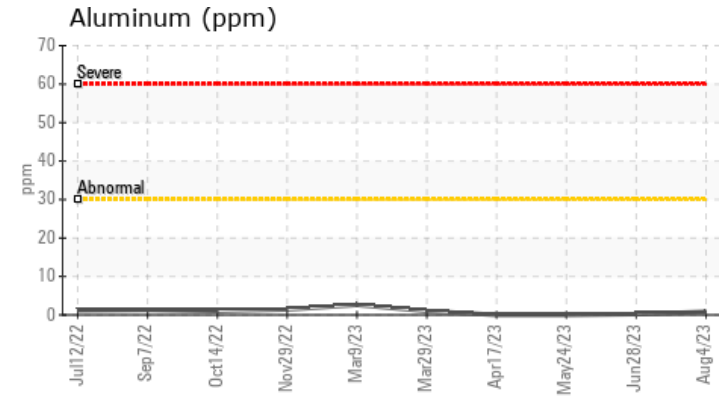
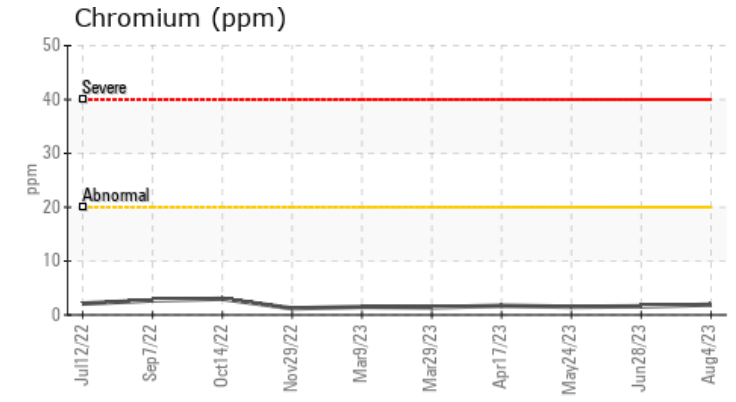
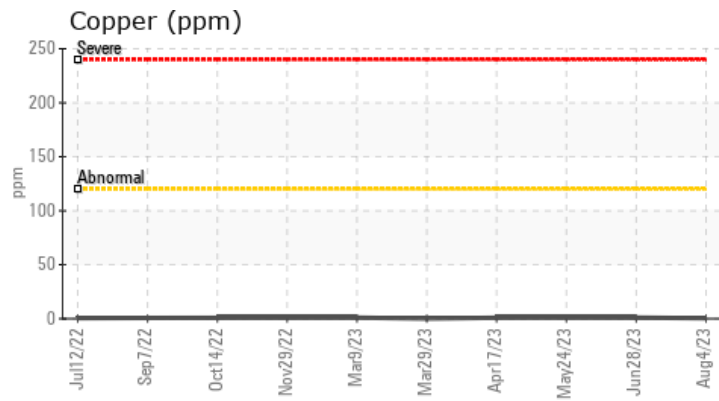
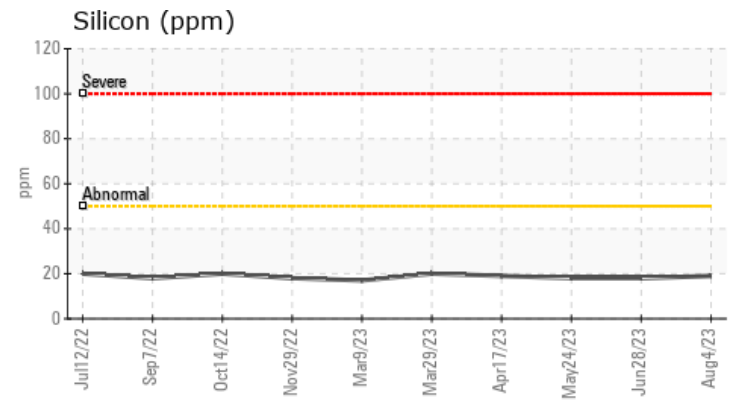
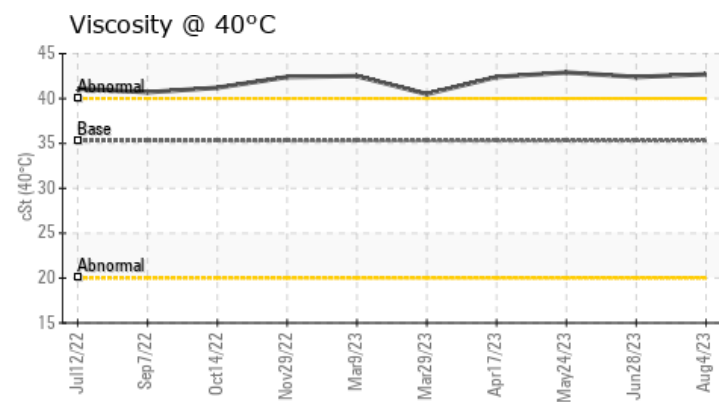
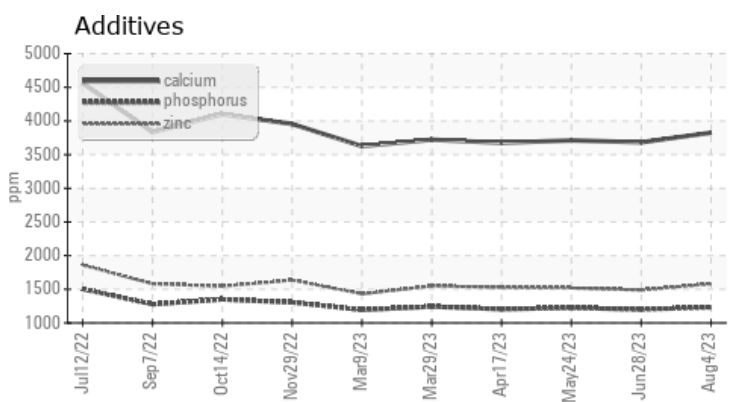
VOLVO GRAPHS

Resample at the next service interval to monitor. All component wear rates are normal. There is no indication of any contamination in the oil. The condition of the oil is acceptable for the time in service.
