# CONSTRUCTION EQUIPMENT

## VOLVO A30G 742111 - TRANSMISSION (AUTO)

**Sample No:** VCP422699  
**Oil Type:** VOLVO AT 102  
**Job No:**

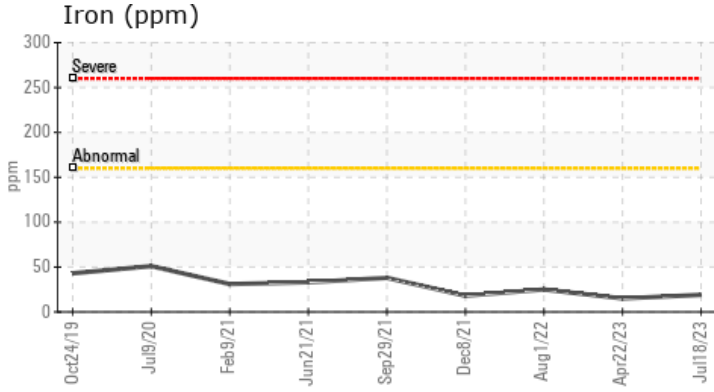
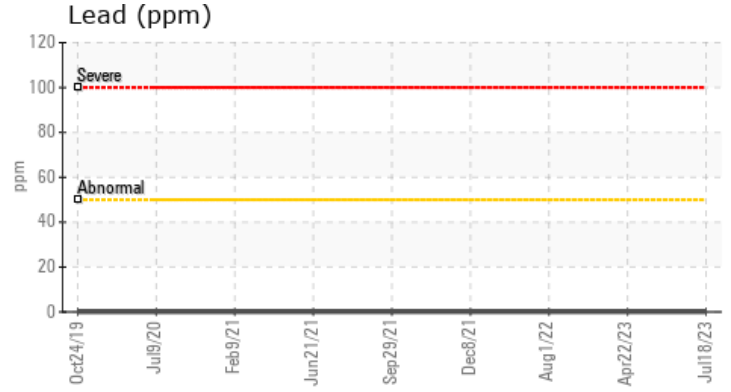
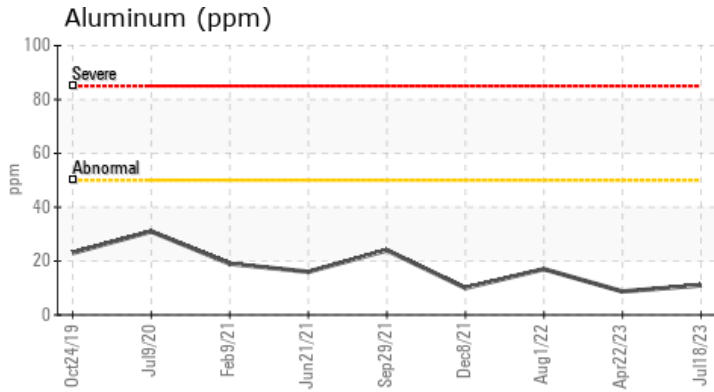
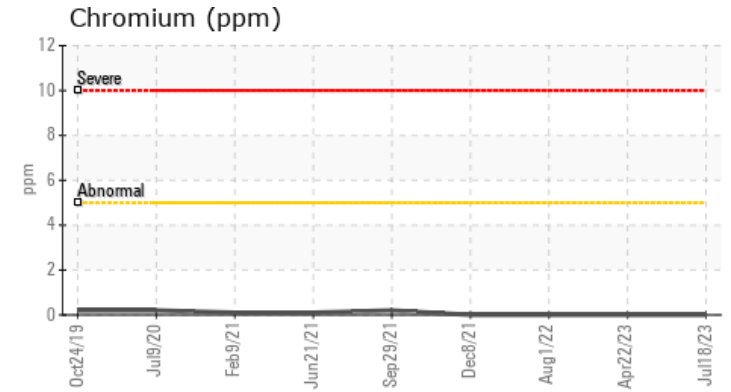
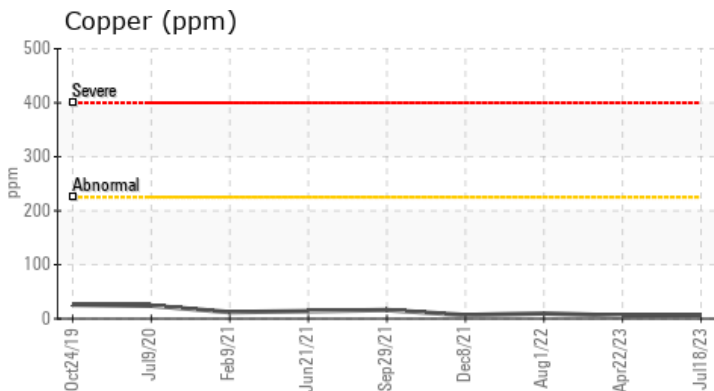
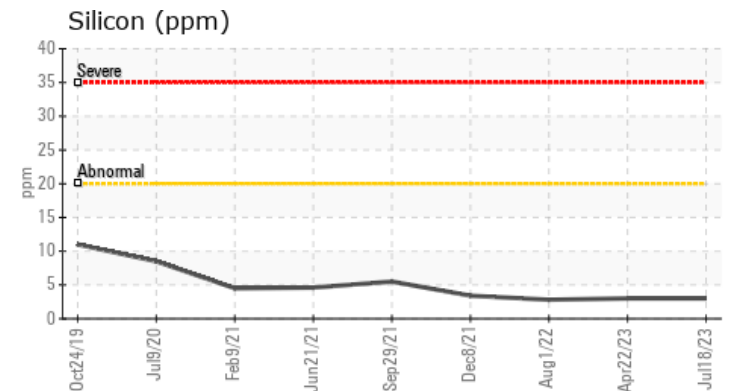
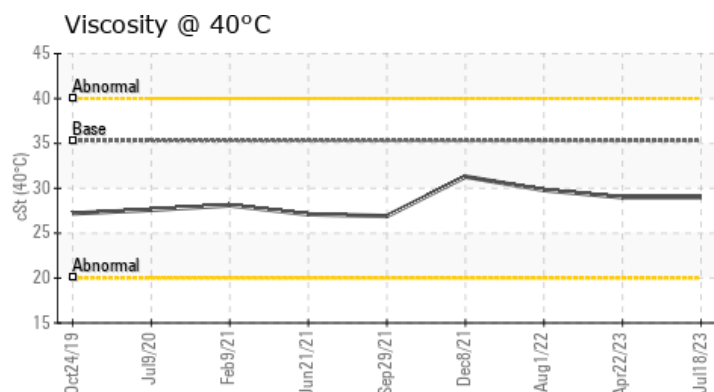
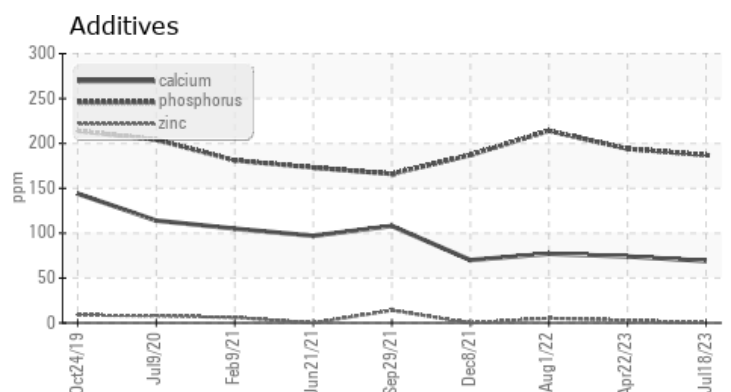
## VOLVO GRAPHS

Resample at the next service interval to monitor. All component wear rates are normal. There is no indication of any contamination in the fluid. The condition of the fluid is acceptable for the time in service.
