CONSTRUCTION EQUIPMENT

A10901 VOLVO A30D 70020 - FRONT AXLE

Sample No: VCP413669
Oil Type: MOBIL MOBILUBE HD 80W90
Job No: A10901

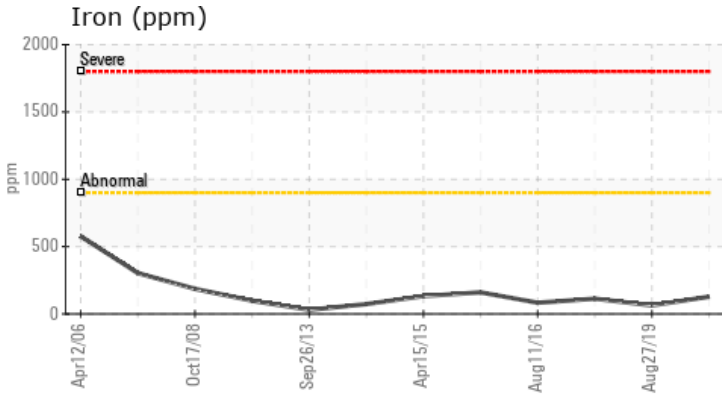
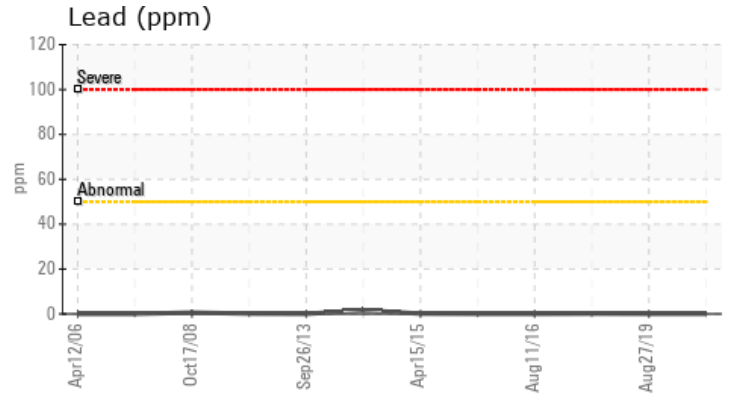
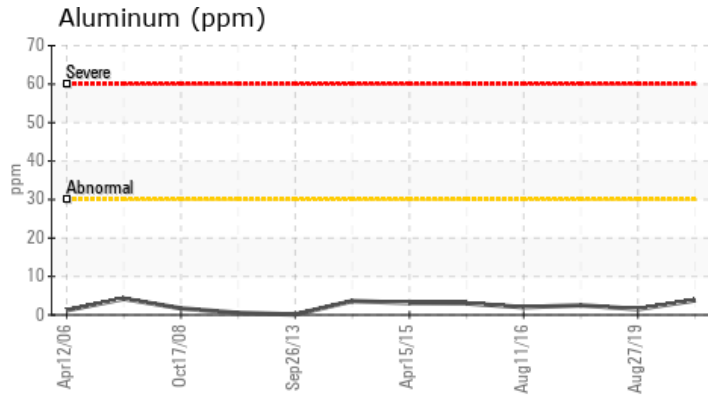
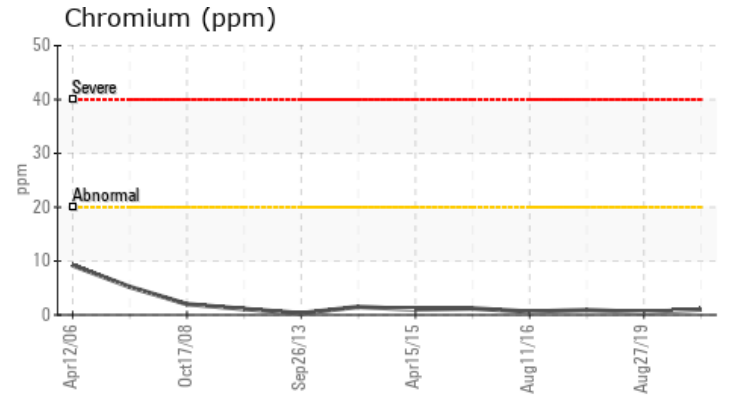
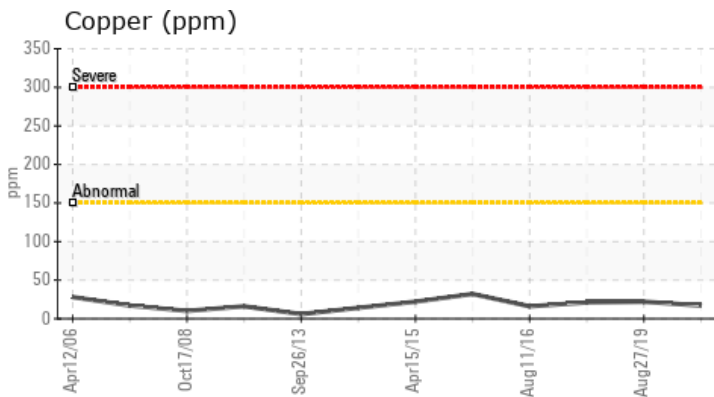
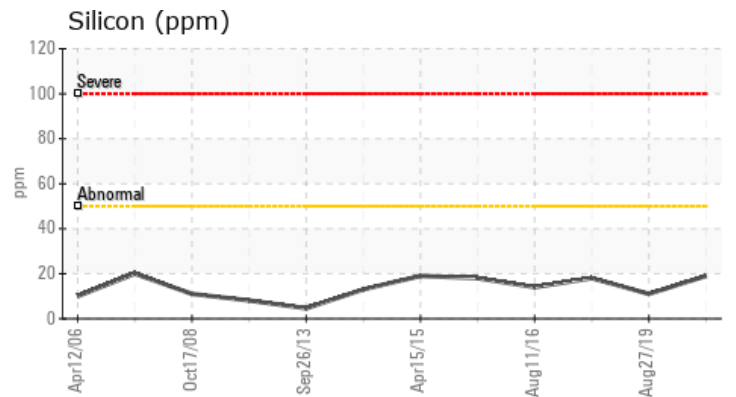
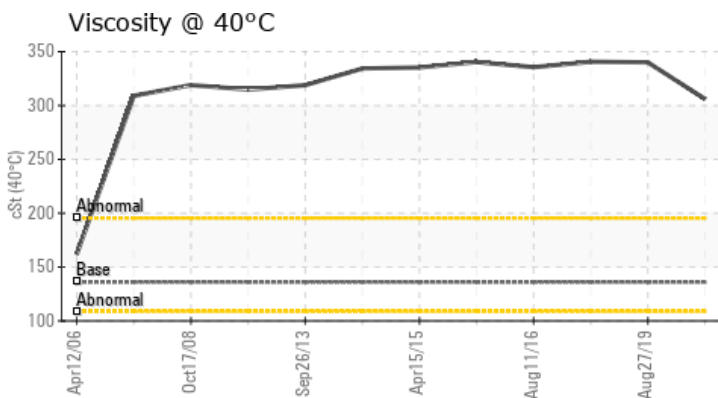
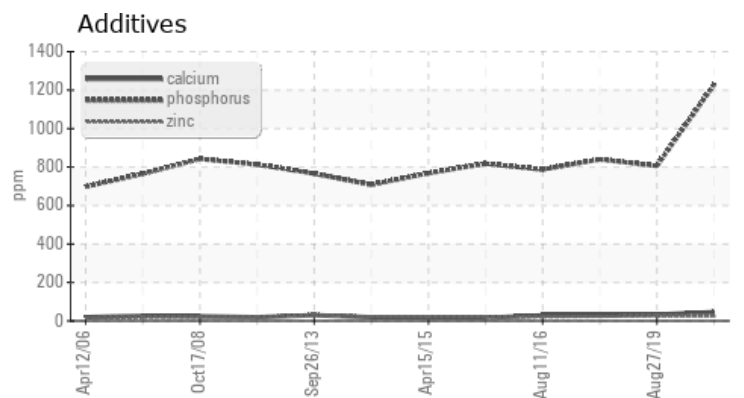
VOLVO GRAPHS

Resample at the next service interval to monitor. All component wear rates are normal. There is no indication of any contamination in the oil. The condition of the oil is acceptable for the time in service.
