# CONSTRUCTION EQUIPMENT

SWA292727 SENNEBOGEN 860 860.O.1095 - REAR LEFT FINAL DRIVE

**Sample No:** VCP410317  
**Oil Type:** GEAR OIL SAE 80W90  
**Job No:** SWA292727

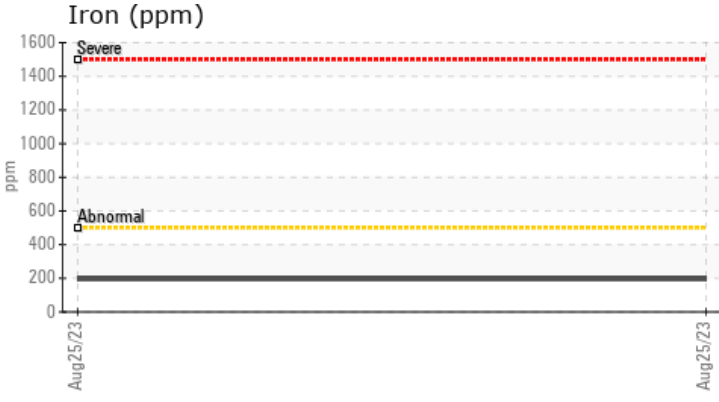
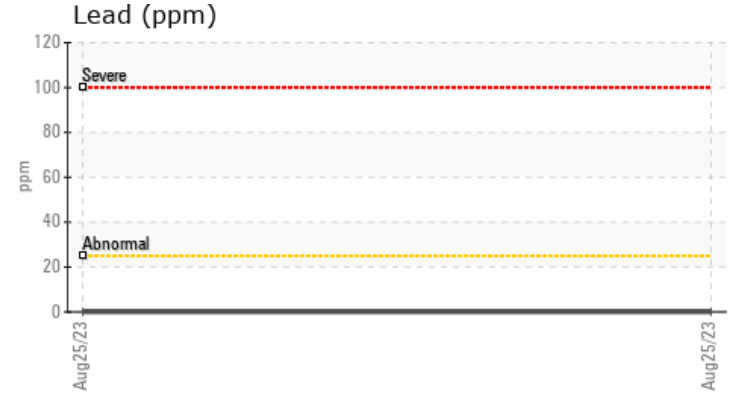
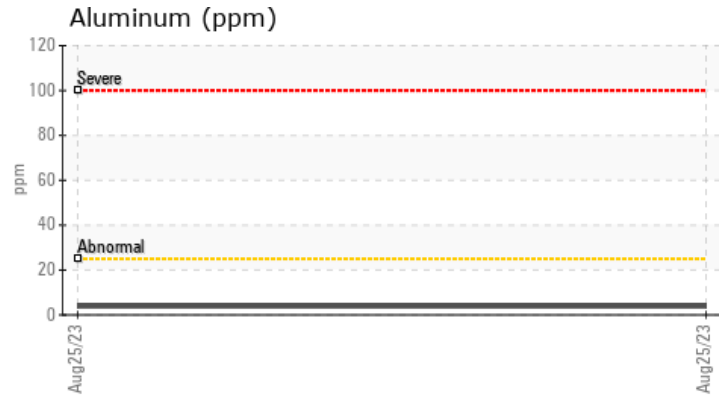
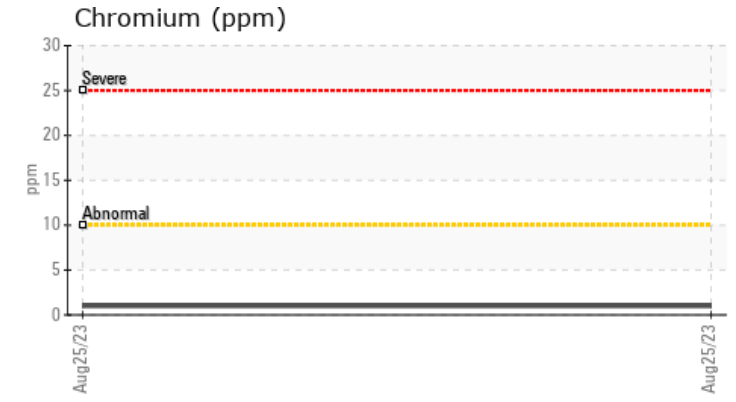
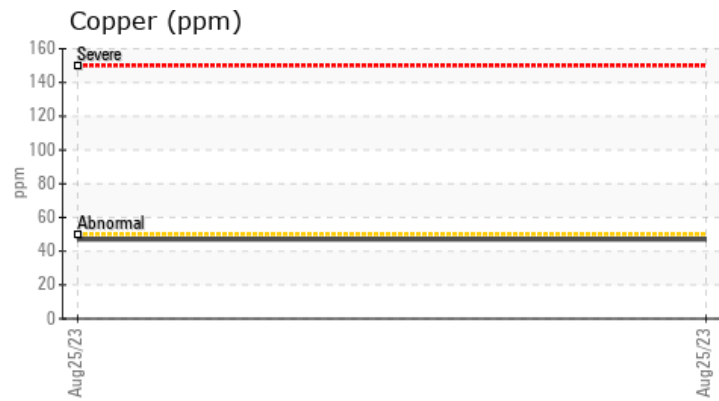
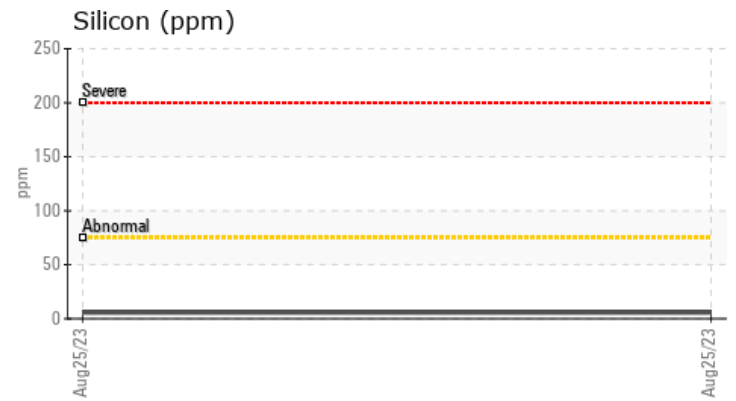
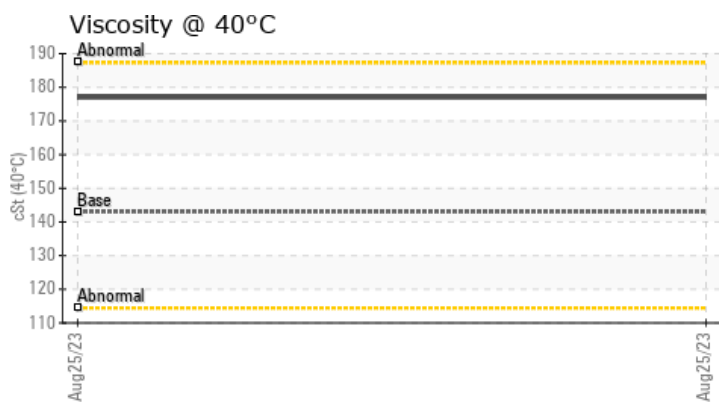
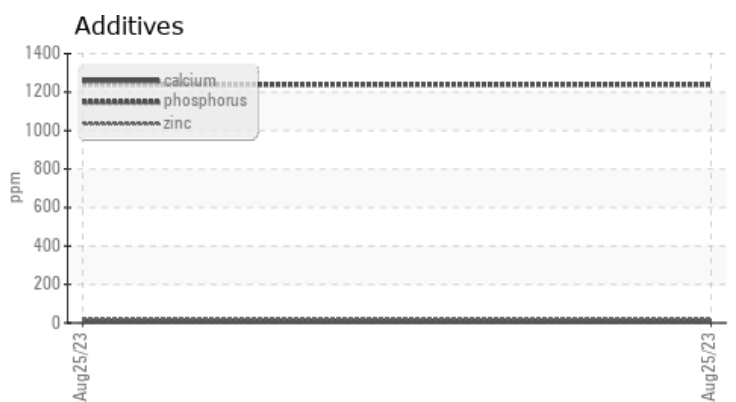
## VOLVO GRAPHS

Resample at the next service interval to monitor. All component wear rates are normal. There is no indication of any contamination in the oil. The condition of the oil is acceptable for the time in service.
