# CONSTRUCTION EQUIPMENT

SPM595106 VOLVO L90H 624199 - DIESEL ENGINE

**Sample No:** VCP354490  
**Oil Type:** DIESEL ENGINE OIL SAE 15W40  
**Job No:** SPM595106

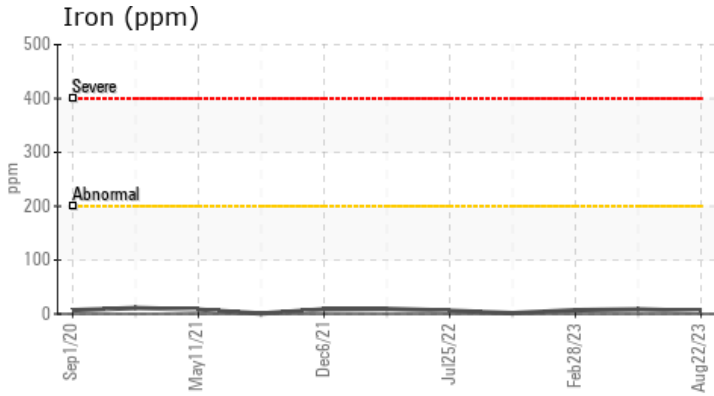
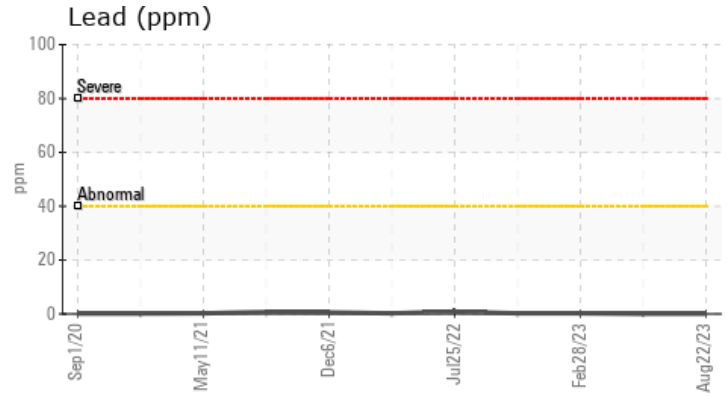
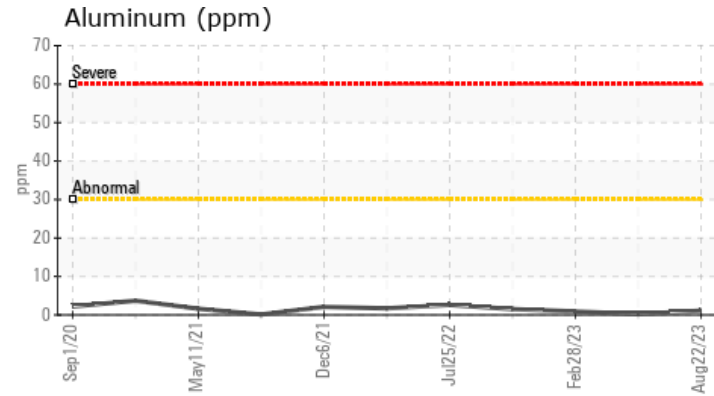
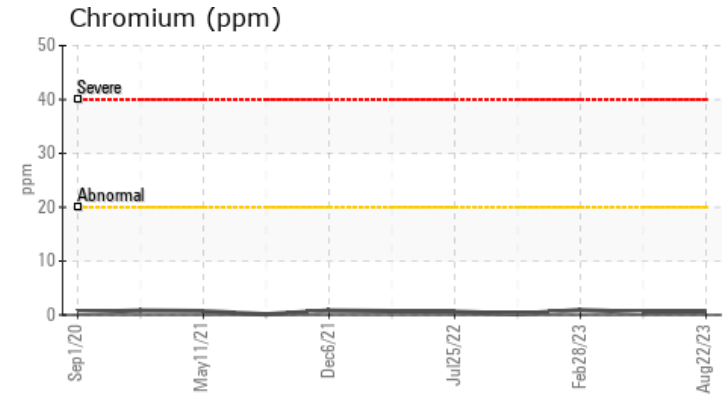
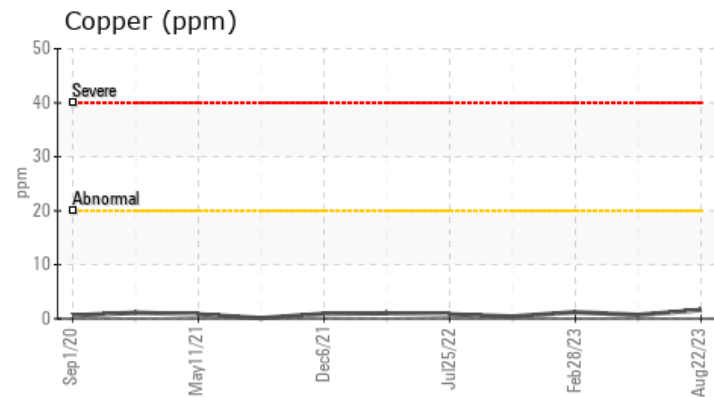
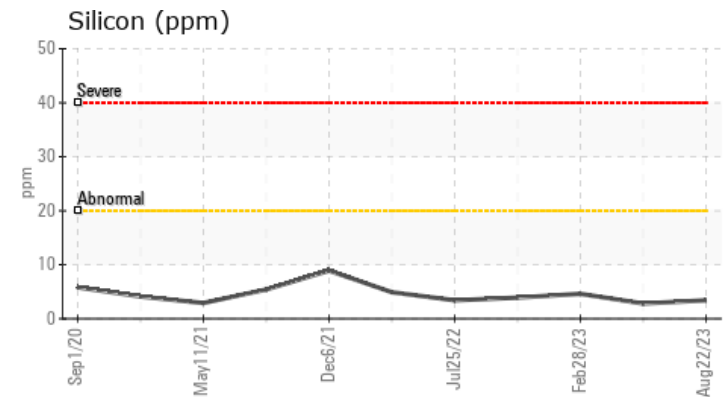
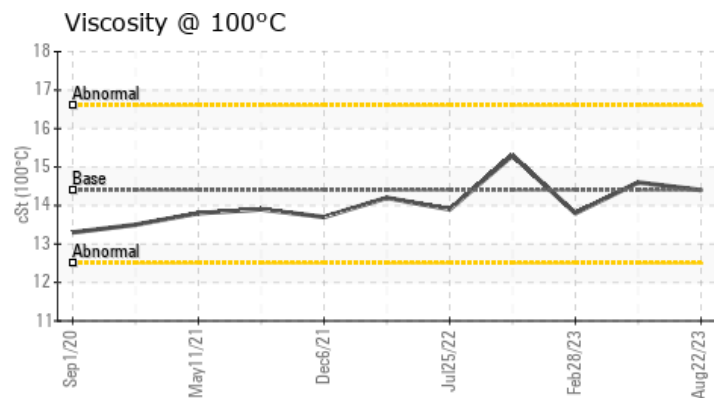
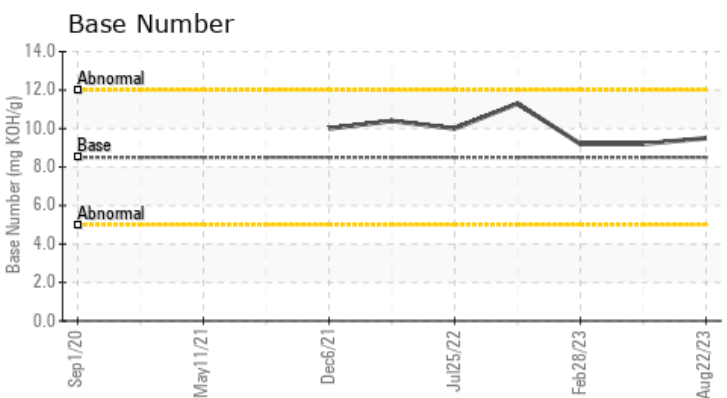
## GRAPHS

Resample at the next service interval to monitor. All component wear rates are normal. There is no indication of any contamination in the oil. The BN result indicates that there is suitable alkalinity remaining in the oil. The condition of the oil is suitable for further service.
