CONSTRUCTION EQUIPMENT

SPM595387 VOLVO L150H 6952 - TRANSMISSION (AUTO)

Sample No: VCP415446
Oil Type: VOLVO AUTOMATIC TRANSMISSION FLUID AT102
Job No: SPM595387

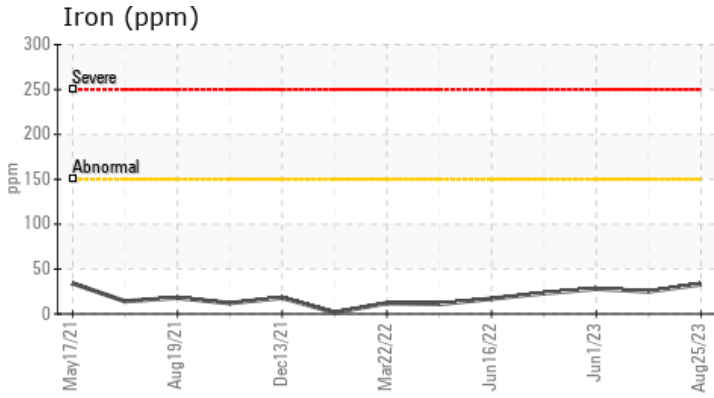
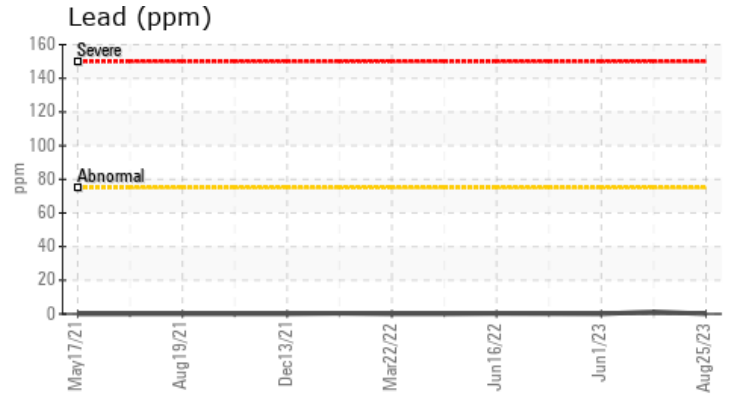
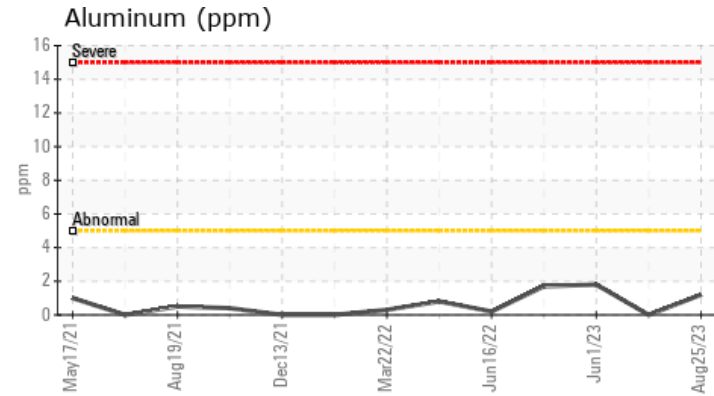
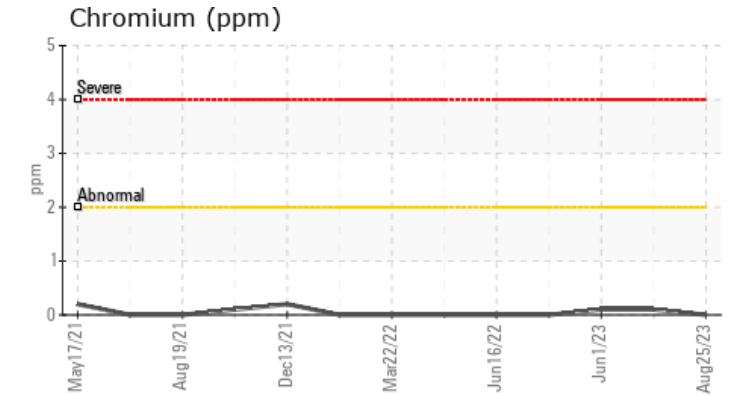
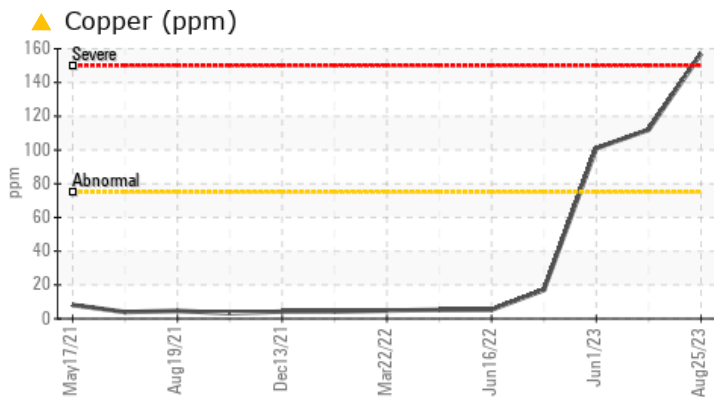
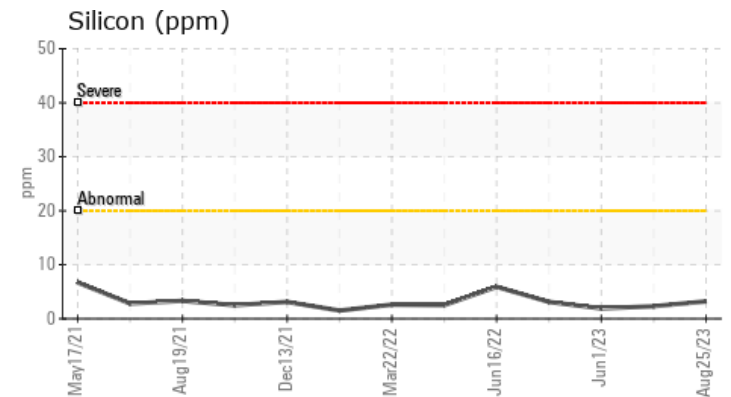
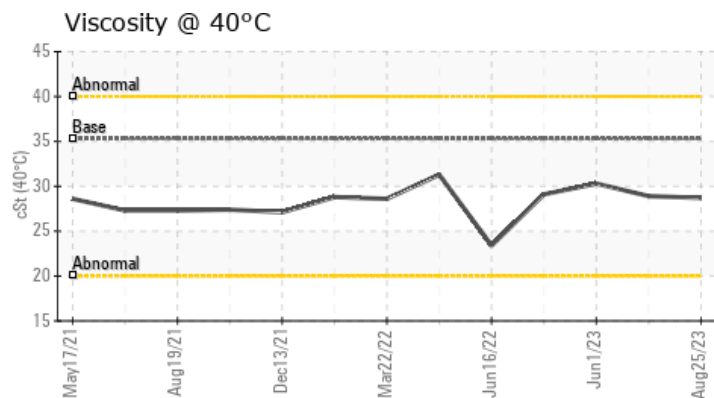
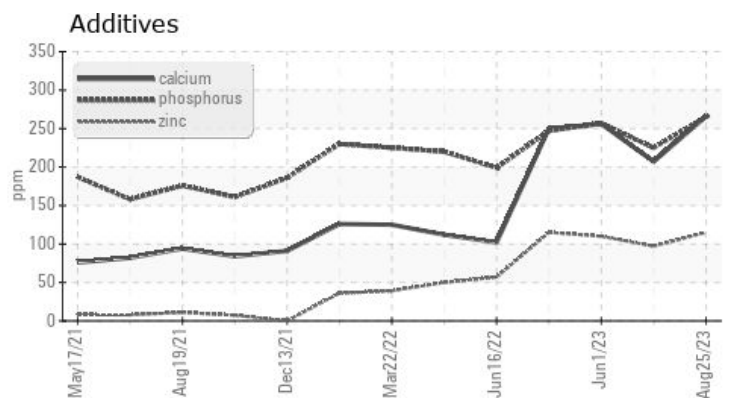
GRAPHS

No corrective action is recommended at this time. Resample at the next service interval to monitor. Clutch and/or bushing/bearing wear is indicated. All other component wear rates are normal. There is no indication of any contamination in the fluid. The condition of the fluid is acceptable for the time in service.
