606160 FL CON & LAND VOLVO ECR235E 315257 - HYDRAULIC SYSTEM

Sample No: VCP421849
Oil Type: VOLVO SUPER HYDRAULIC OIL 46
Job No: 606160 FL CON & LAND

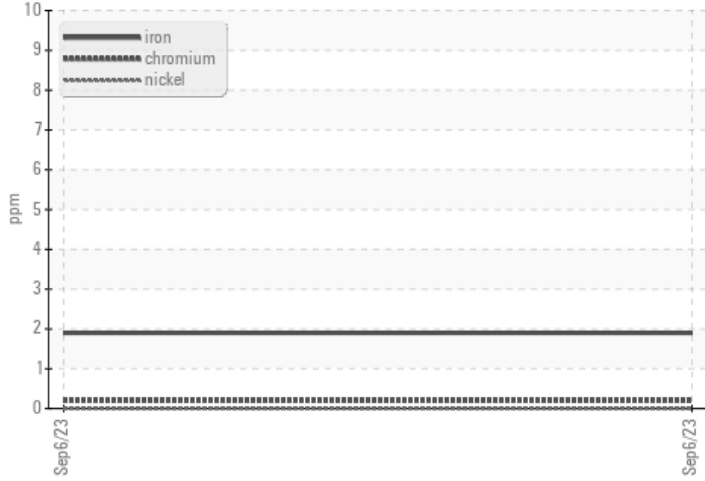
Ferrous Alloys

Iron	ppm	█ 2	---	---	---
Copper	ppm	█ 27	---	---	---
Lead	ppm	█ <1	---	---	---
Tin	ppm	█ <1	---	---	---
Aluminum	ppm	█ 0	---	---	---
Chromium	ppm	█ <1	---	---	---
Molybdenum	ppm	█ 0	---	---	---
Nickel	ppm	█ 0	---	---	---
Titanium	ppm	0	---	---	---
Silver	ppm	0	---	---	---
Manganese	ppm	█ <1	---	---	---
Vanadium	ppm	0	---	---	---

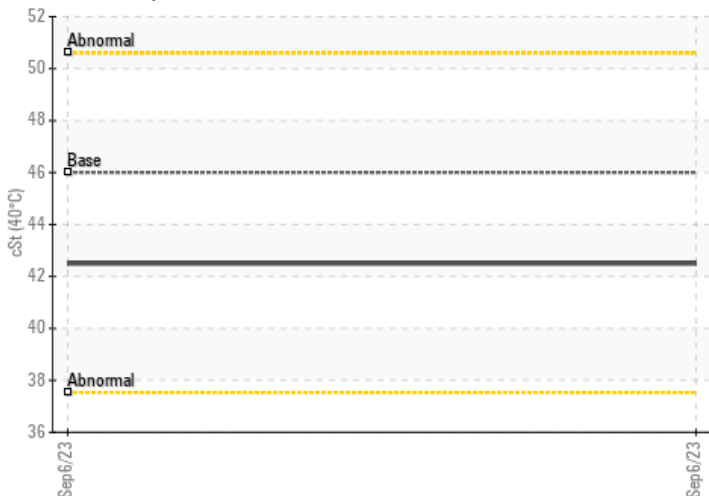
Viscosity @ 40°C

Visc @ 40°C	cSt	█ 42.5	---	---	---
Acid Number (AN)	mg KOH/g	█ 0.54	---	---	---

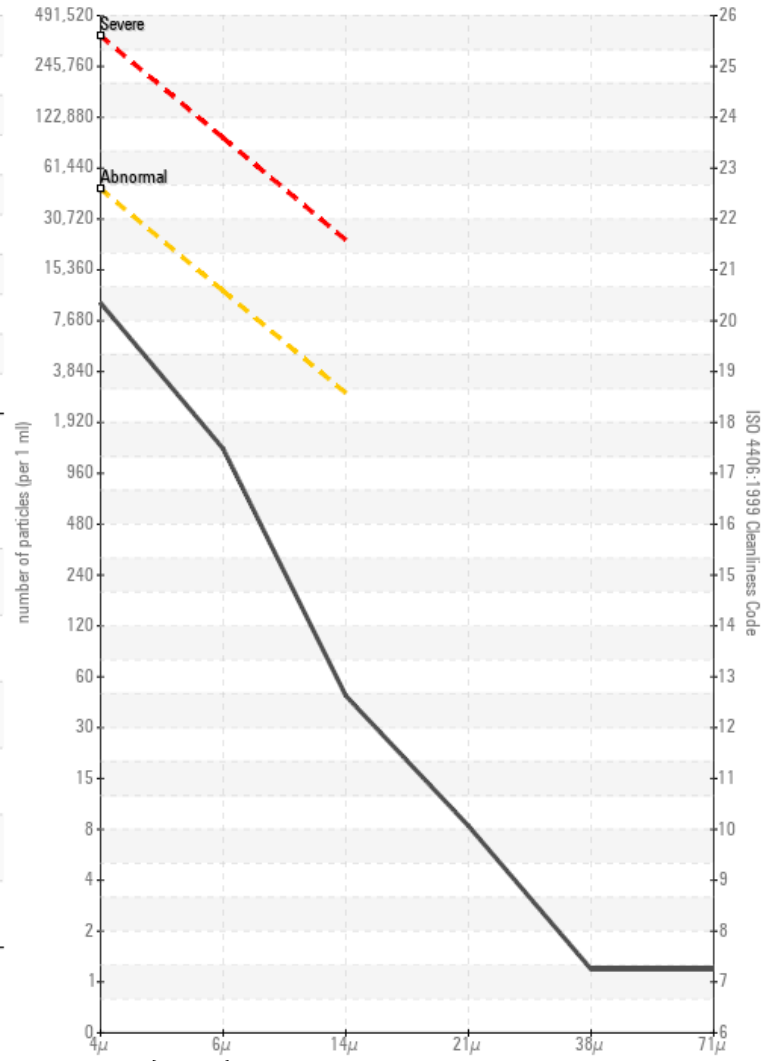
Particle Count

Particles >4µm		█ 8509	---	---	---
Particles >6µm		█ 1175	---	---	---
Particles >14µm		█ 41	---	---	---
ISO 4406:1999 (c)		20/17/13	---	---	---
Silicon	ppm	█ 6	---	---	---
Sodium	ppm	█ 3	---	---	---
Potassium	ppm	█ 1	---	---	---

Resample at the next service interval to monitor. All component wear rates are normal. The system cleanliness is acceptable for your target ISO 4406 cleanliness code. The system and fluid cleanliness is acceptable. The AN level is acceptable for this fluid. The condition of the oil is suitable for further service.
