CONSTRUCTION EQUIPMENT

A10936 VOLVO A30G 742440 - DIESEL ENGINE

Sample No: VCP424766
Oil Type: MOBIL 15W40
Job No: A10936

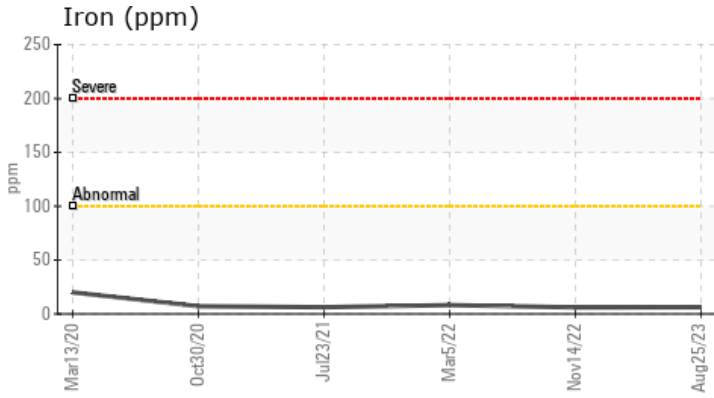
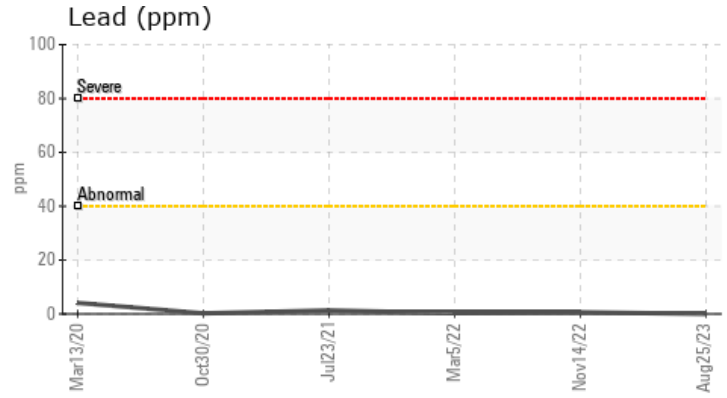
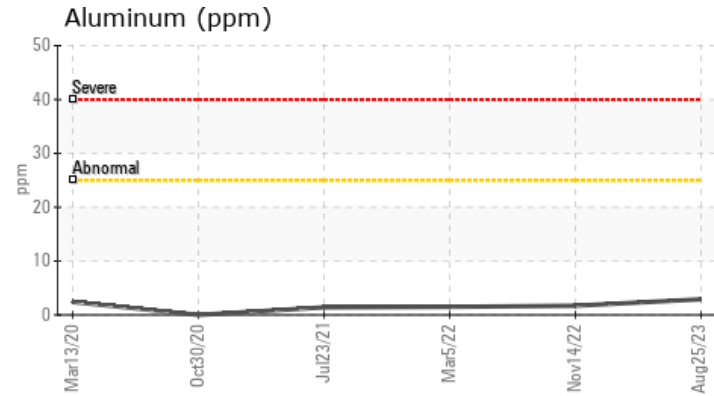
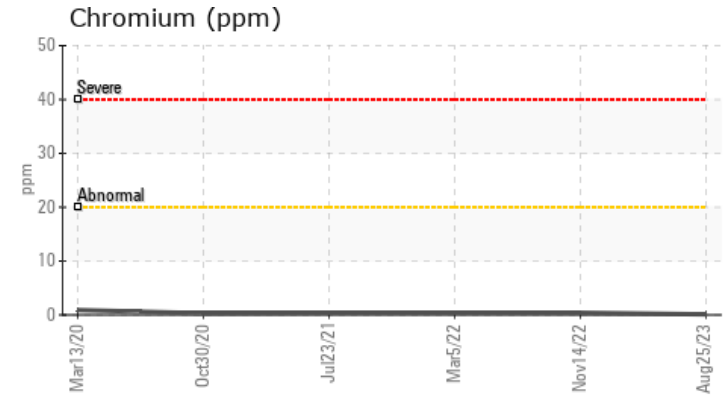
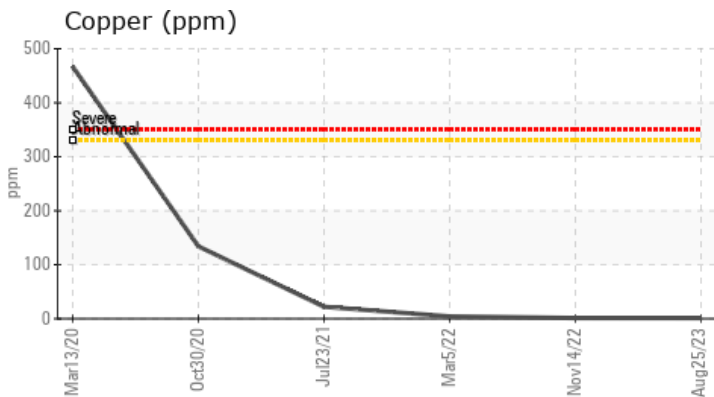
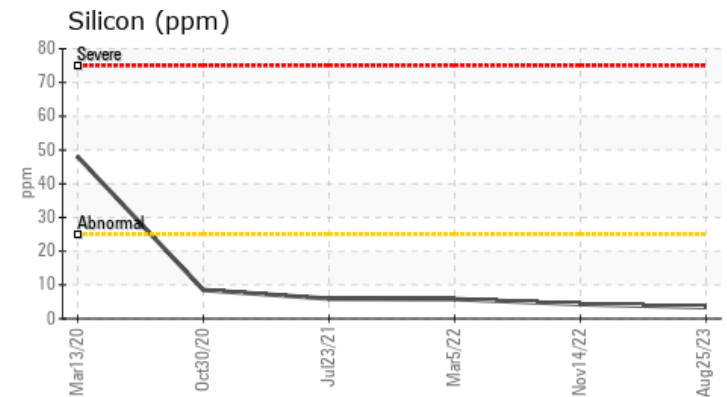
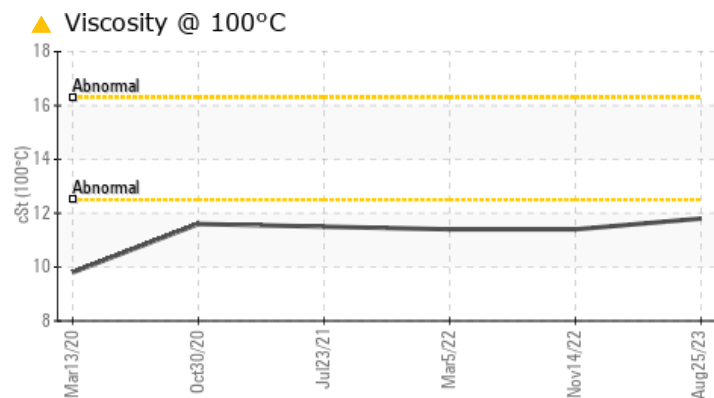
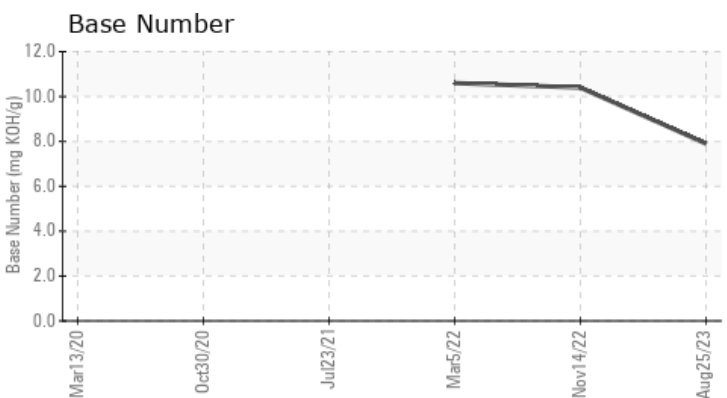
GRAPHS

Oil and filter change at the time of sampling has been noted. Resample at the next service interval to monitor. All component wear rates are normal. There is no indication of any contamination in the oil. The oil viscosity is lower than normal. The BN result indicates that there is suitable alkalinity remaining in the oil. Confirm oil type.
