225208 CRC WM VOLVO L120H 632191 - TRANSMISSION (AUTO)

Sample No: VCP424196
Oil Type: VOLVO AUTOMATIC TRANSMISSION FLUID AT102
Job No: 225208 CRC WM

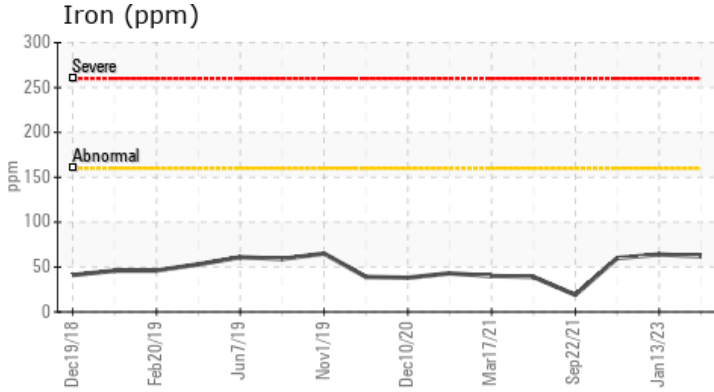
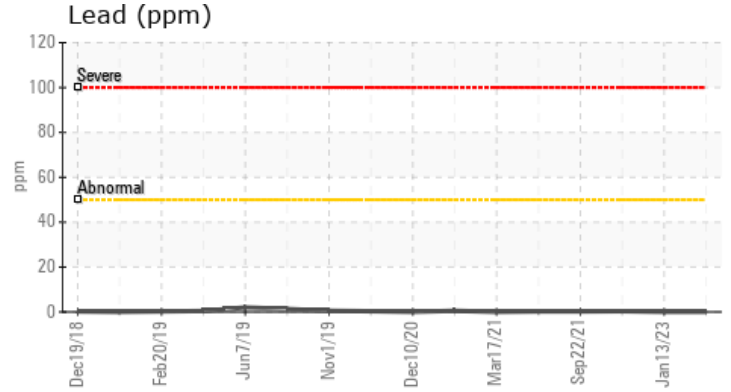
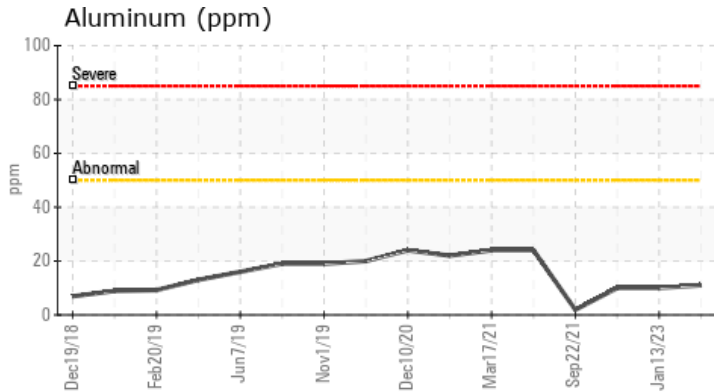
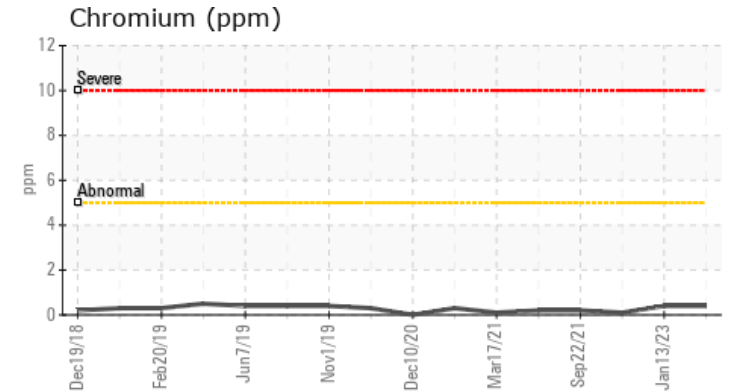
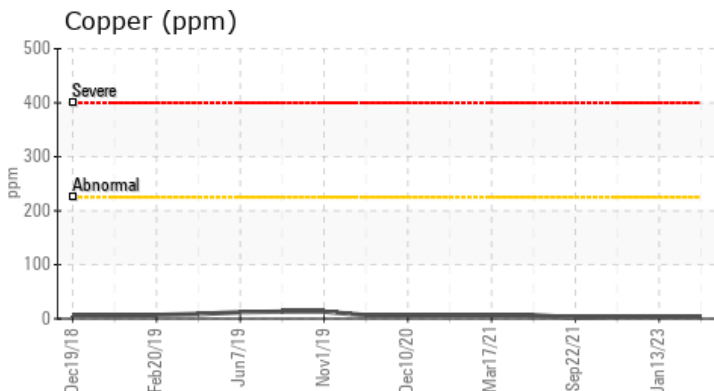
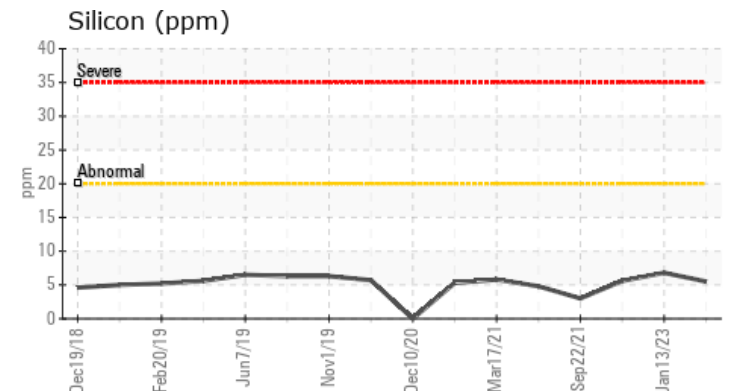
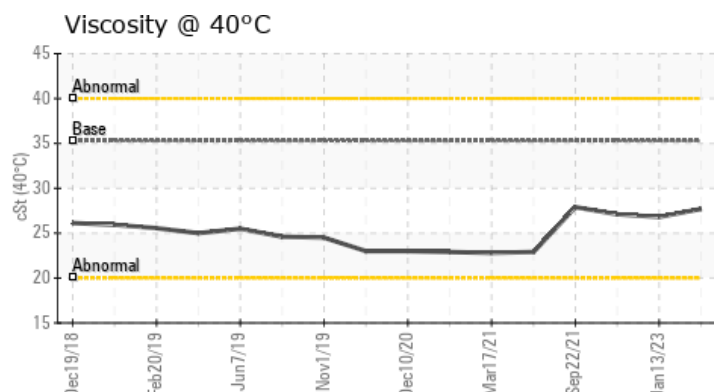
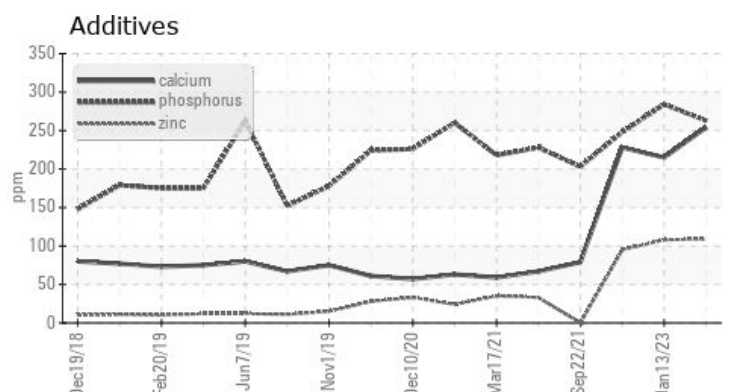
VOLVO GRAPHS

Resample at the next service interval to monitor. All component wear rates are normal. There is no indication of any contamination in the oil. The condition of the oil is acceptable for the time in service.
