CONSTRUCTION EQUIPMENT

VOLVO A40G 353142 - TRANSMISSION (AUTO)

Sample No: VCP416305
Oil Type: VOLVO AUTOMATIC TRANSMISSION FLUID AT102
Job No:

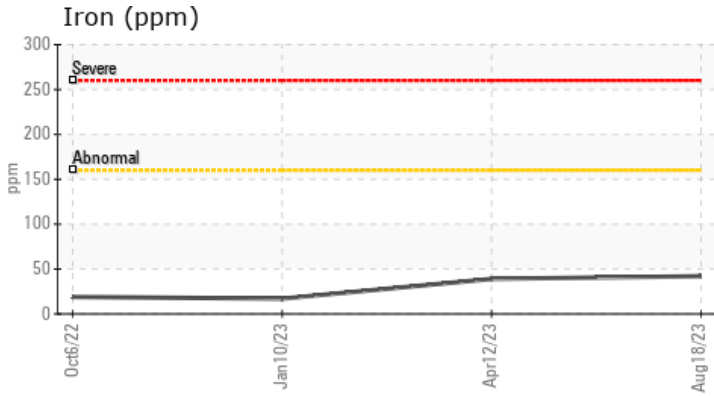
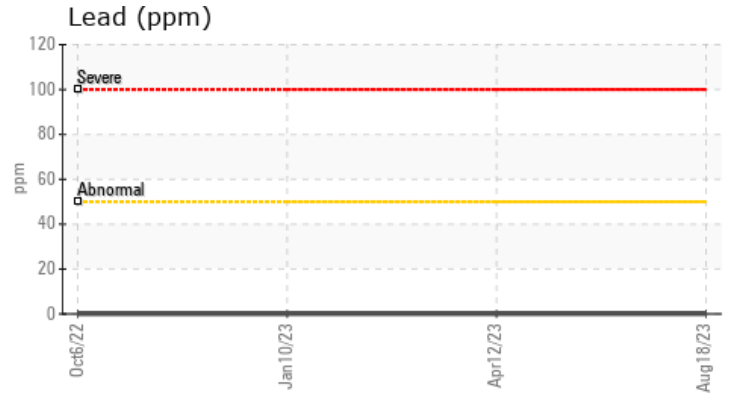
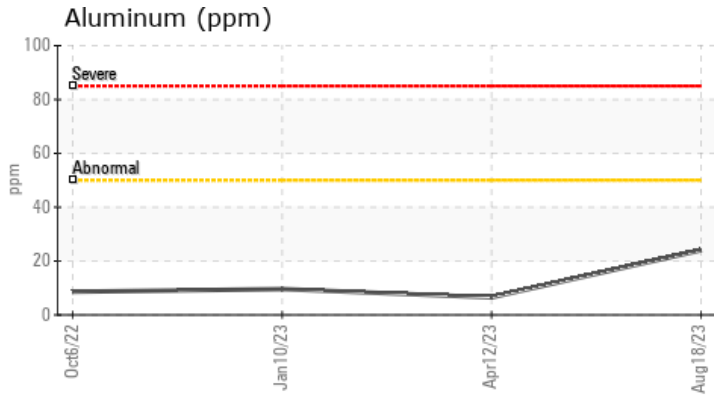
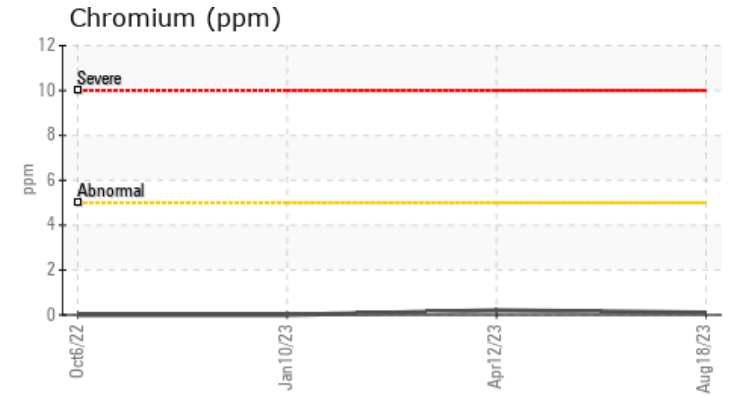
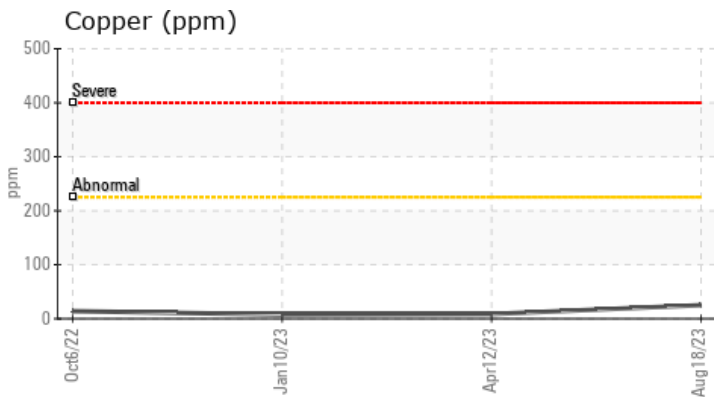
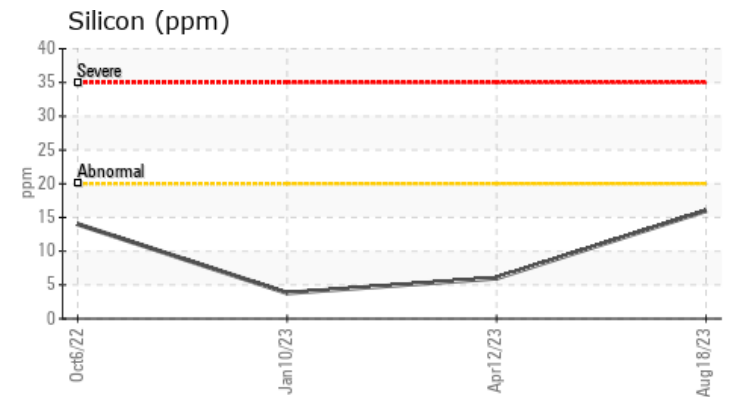
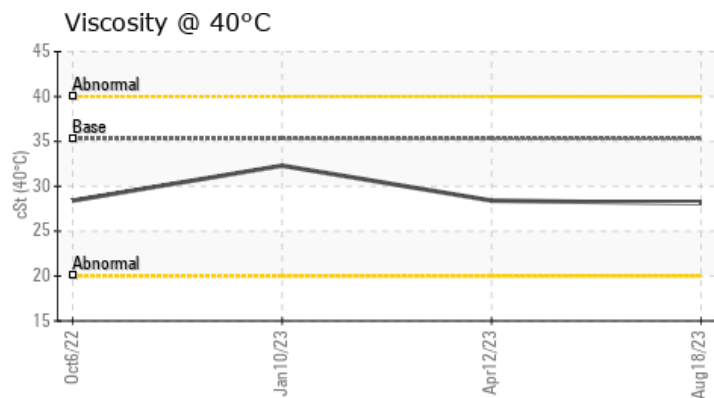
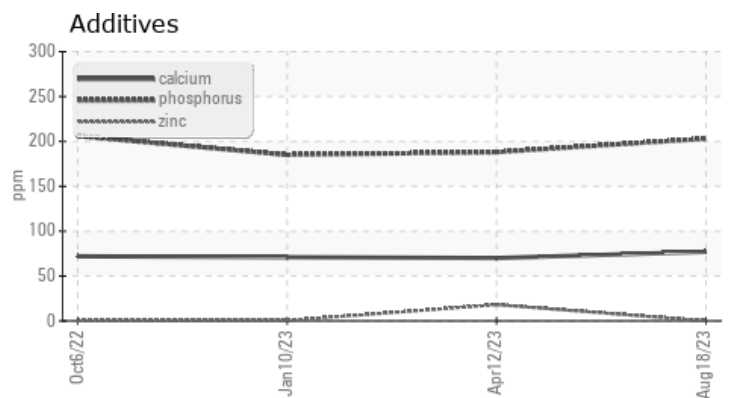
GRAPHS

No corrective action is recommended at this time. The filter change at the time of sampling has been noted. Resample at the next service interval to monitor. Moderate concentration of visible metal present. All component wear rates are normal. There is no indication of any contamination in the fluid. The condition of the fluid is acceptable for the time in service.
