SW0065921 VOLVO EC300ELR 311843 - REAR LEFT FINAL DRIVE

**Sample No:** VCP421721  
**Oil Type:** COWIN 80W90  
**Job No:** SW0065921

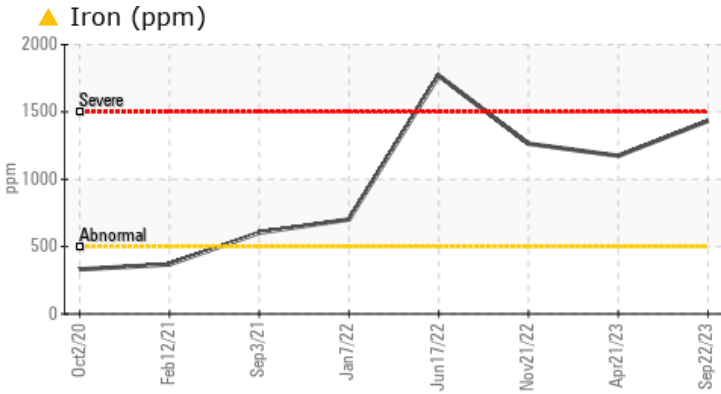
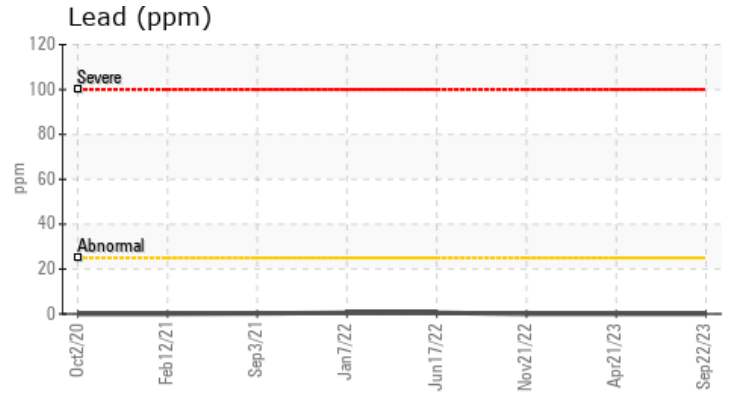
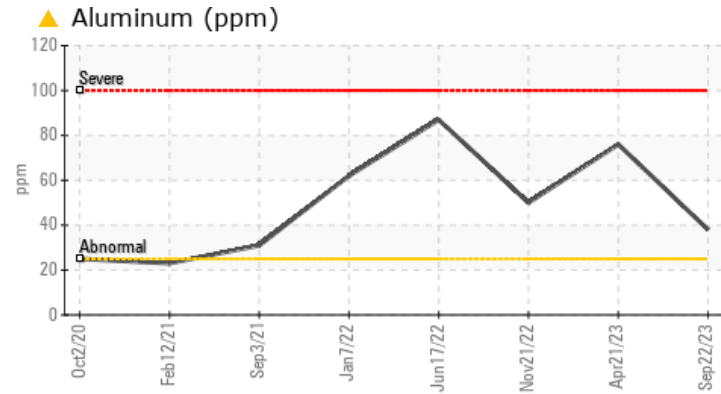
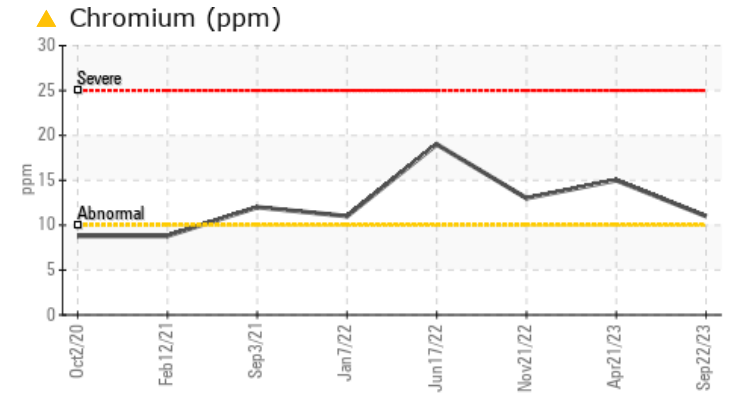
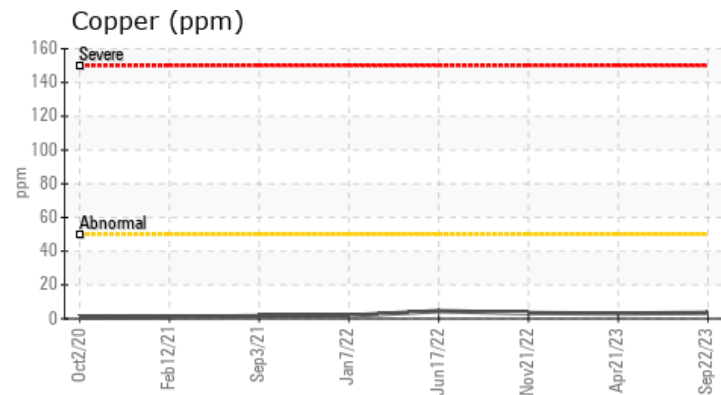
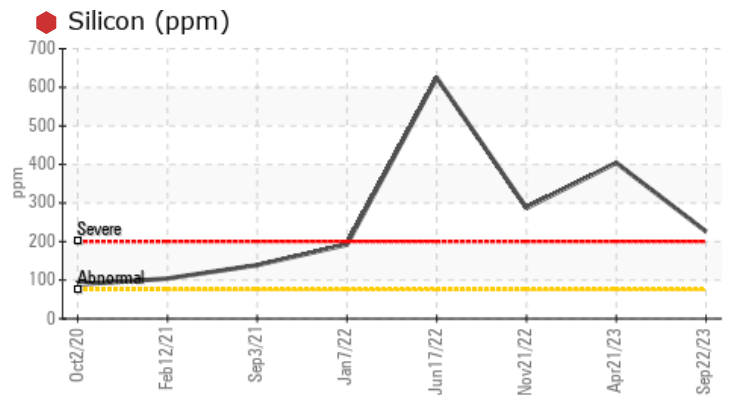
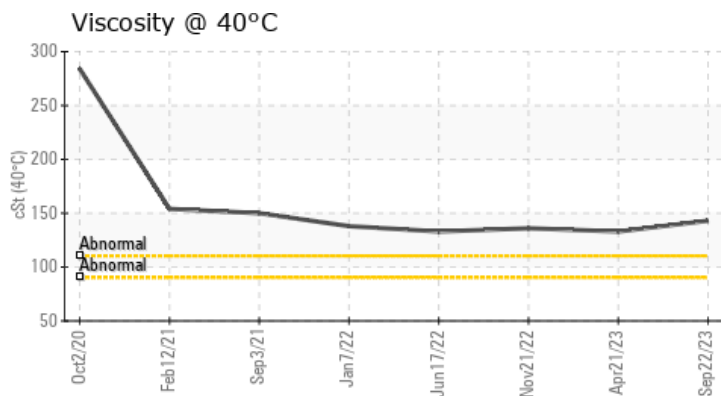
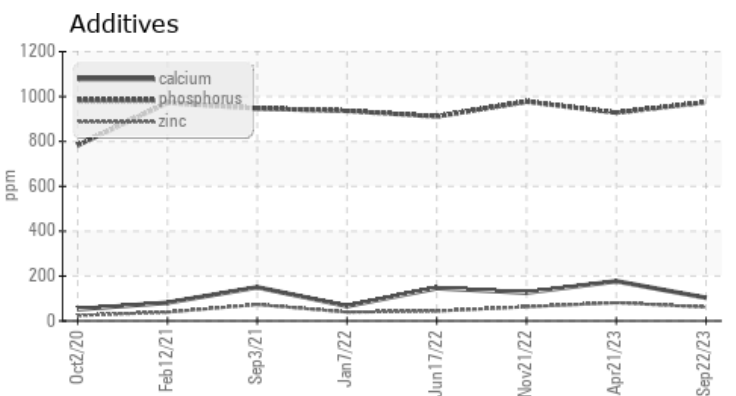
## GRAPHS

We advise that you check all areas where dirt can enter the system. The oil change at the time of sampling has been noted. We recommend an early resample to monitor this condition. Gear wear is indicated. Elemental levels of silicon (Si) and aluminum (Al) indicate alumina-silicate (coarse dirt) ingress. The oil is no longer serviceable due to the presence of contaminants.
