CONSTRUCTION EQUIPMENT

POWERSCREEN POWERSCREEN - COOLANT

Sample No: VCP408916
Oil Type: SHELL ROTELLA ELC EXTENDED LIFE COOLANT
Job No:

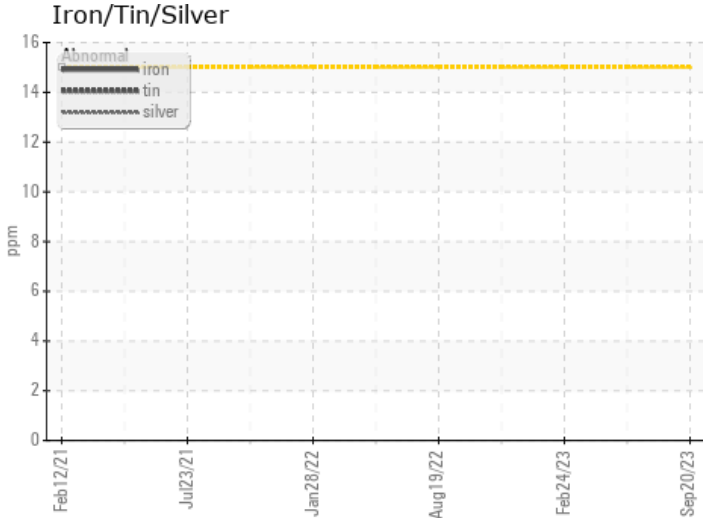
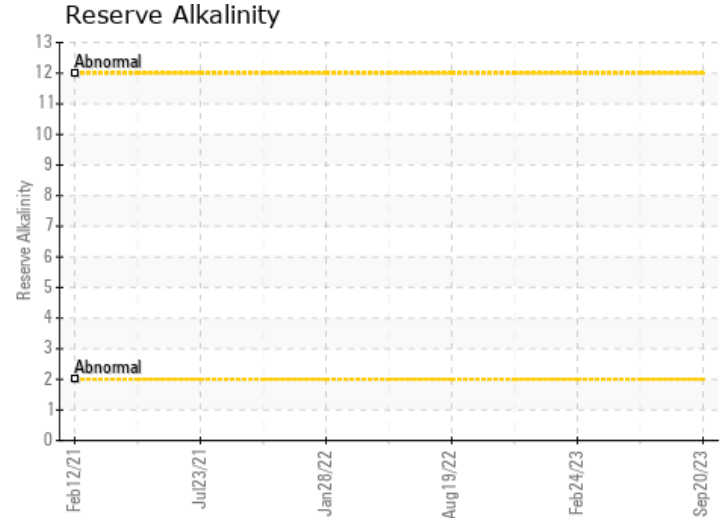
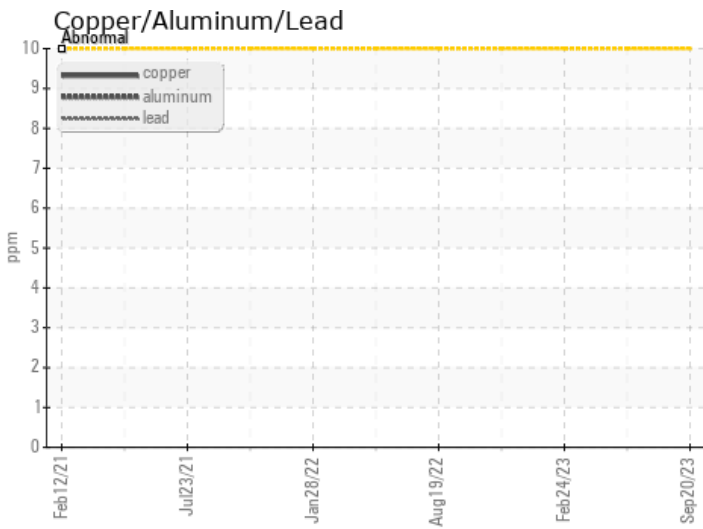
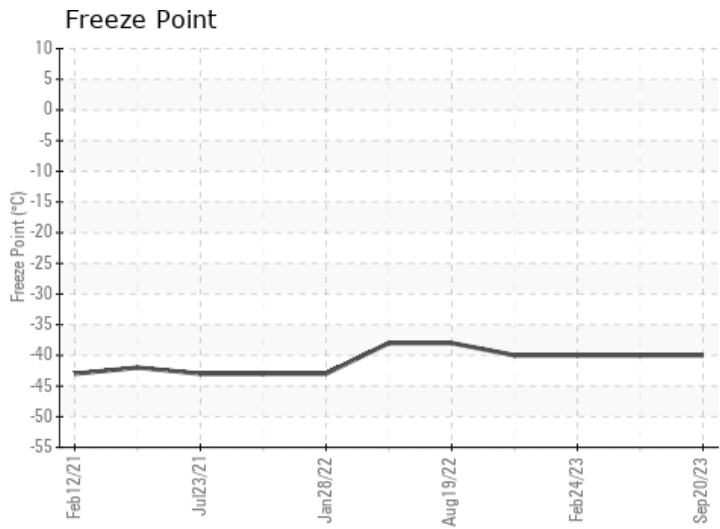
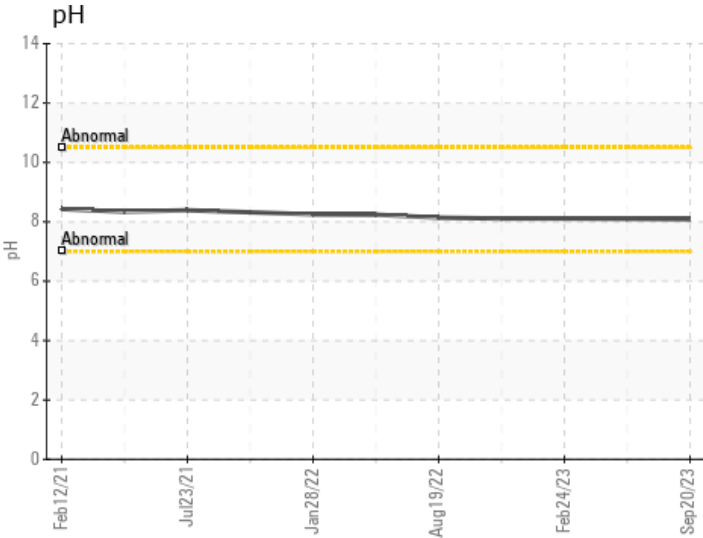
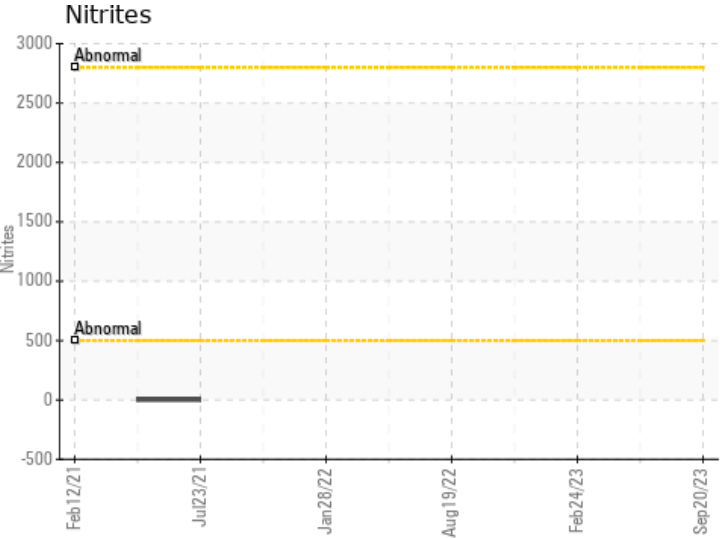
VOLVO GRAPHS

pH	Scale 0-14	8.08	8.10	8.11	8.11
Reserve Alkalinity	Scale 0-20	---	---	---	---
Nitrites	ppm	NT	NT	NT	NT
Percentage Glycol	%	52.1	52.1	52.0	52.1
Freezing Point	°C	-40	-40	-40	-40

The fluid is suitable for further service. There is no indication of any contamination in the coolant. The carboxylate level of this fluid is acceptable. The glycol level is acceptable. The pH level of this fluid is within the acceptable limits.
