# CONSTRUCTION EQUIPMENT

## VOLVO L110H 63272 - DIESEL ENGINE

**Sample No:** VCP414668  
**Oil Type:** VOLVO ULTRA DIESEL ENGINE OIL 15W40 VDS-3  
**Job No:**

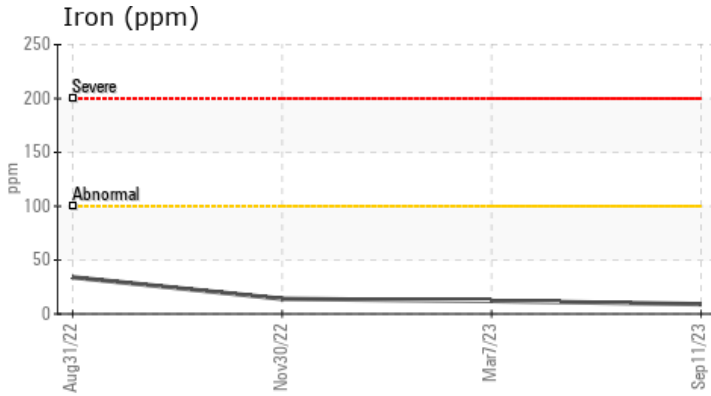
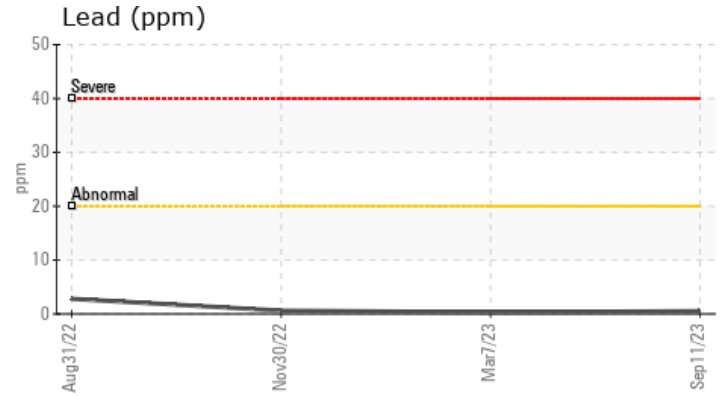
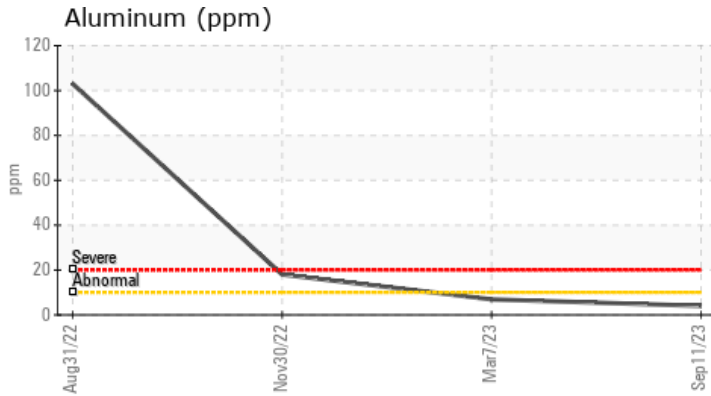
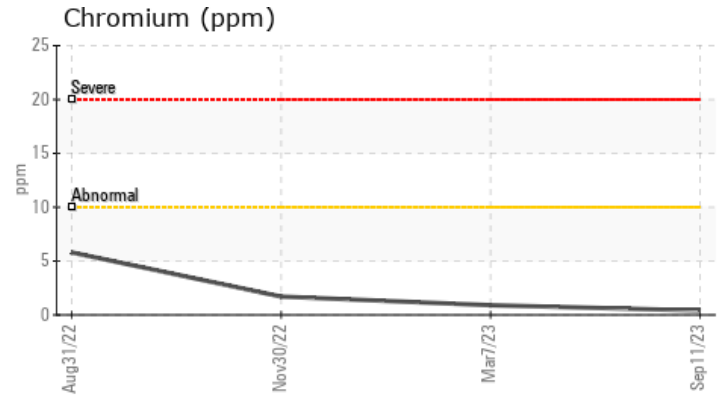
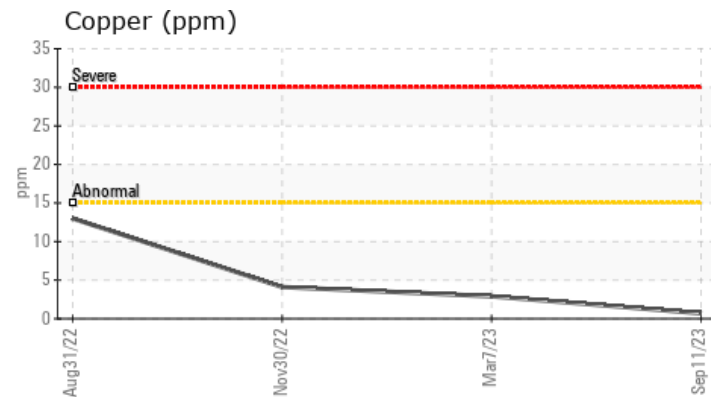
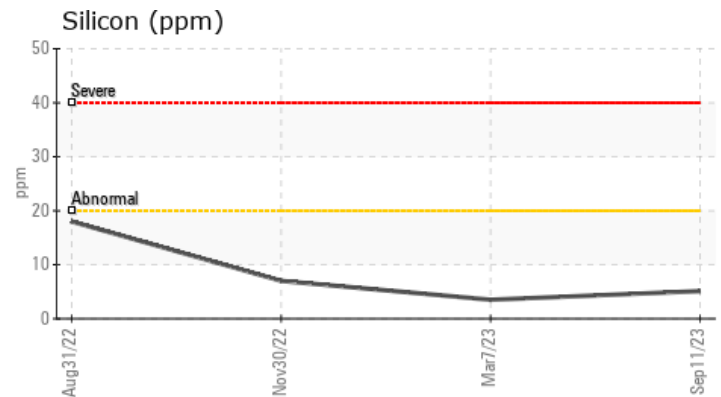
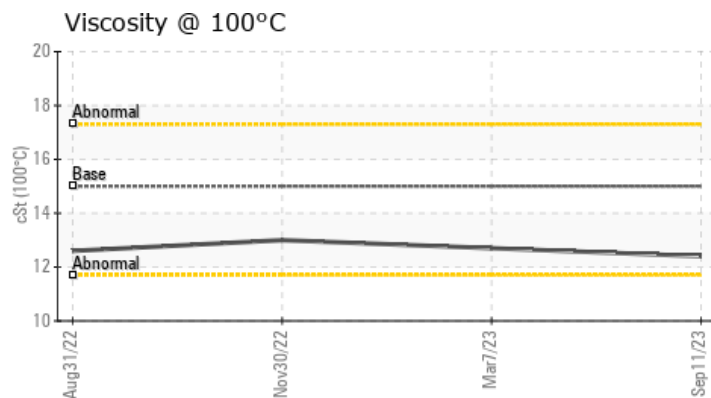
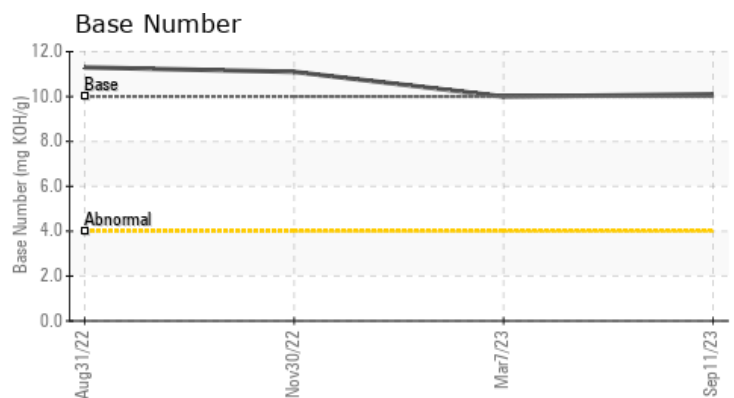
## GRAPHS

Resample at the next service interval to monitor. All component wear rates are normal. There is no indication of any contamination in the oil. The BN result indicates that there is suitable alkalinity remaining in the oil. The condition of the oil is suitable for further service.
