# CONSTRUCTION EQUIPMENT

367252-1 SENNEBOGEN 835 835.0.2949 - FRONT RIGHT FINAL DRIVE

**Sample No:** VCP396393  
**Oil Type:** VOLVO PREMIUM GEAR OIL 80W-90 GL-5  
**Job No:** 367252-1

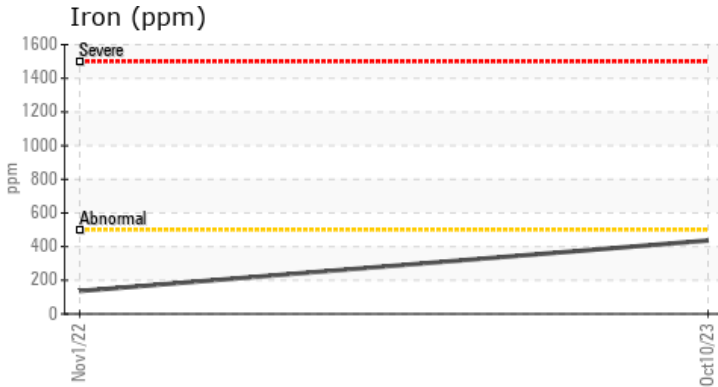
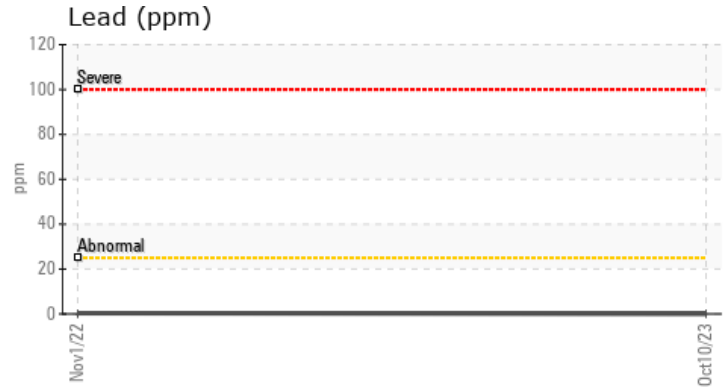
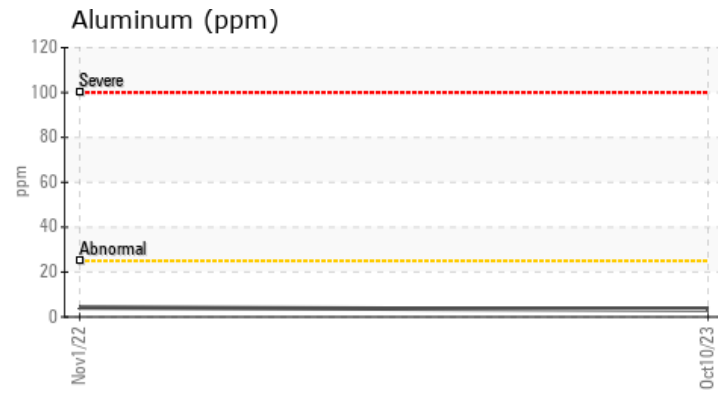
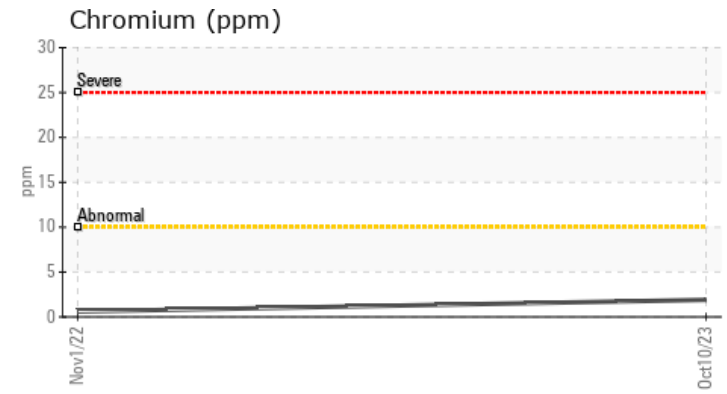
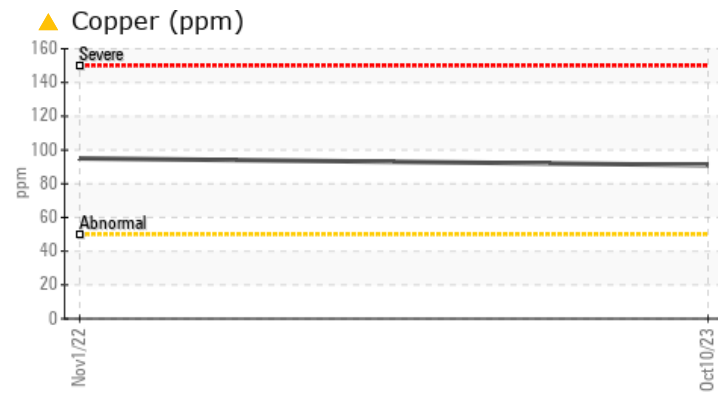
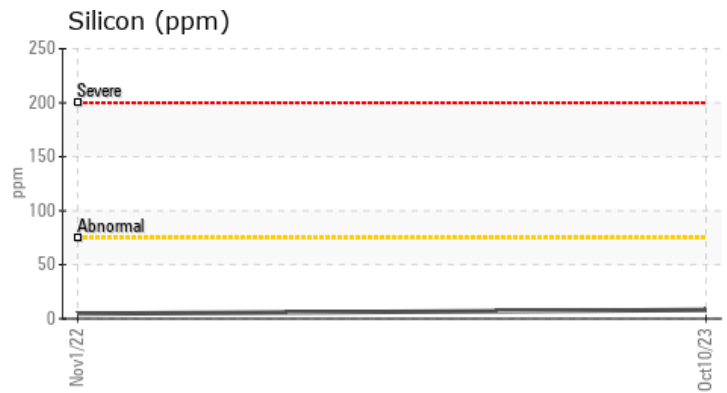
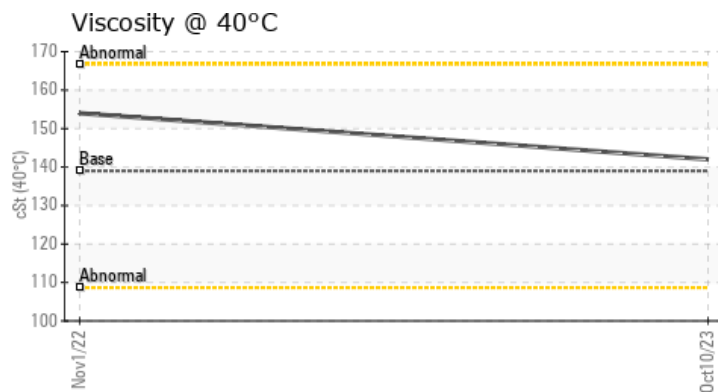
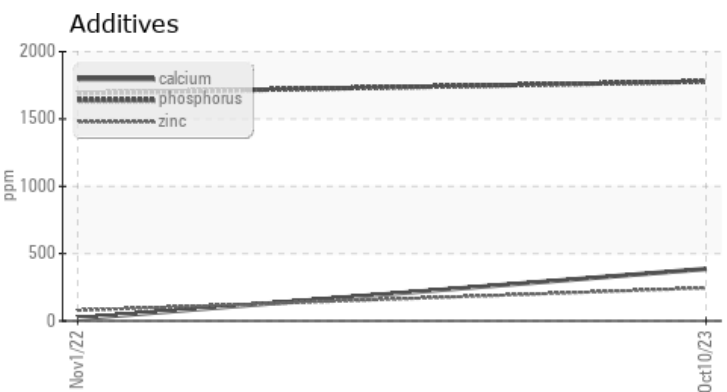
## GRAPHS

No corrective action is recommended at this time. Resample at the next service interval to monitor. The copper level is abnormal. All other component wear rates are normal. There is no indication of any contamination in the oil. The condition of the oil is acceptable for the time in service.
