Sample No: VCP430682

Oil Type: VOLVO AUTOMATIC TRANSMISSION FLUID AT102

Job No: SW-25206-2 SWIFT

## **CONSTRUCTION EQUIPMENT**

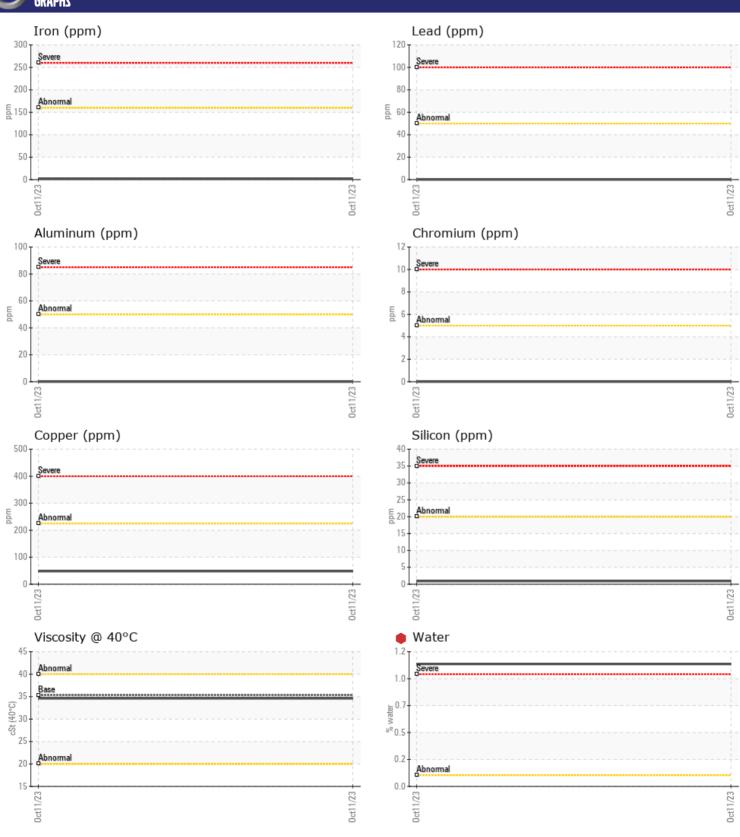
## GRAPHS

VOLVO	INFORMATION			
	INFORMATION			_
Sample Number		VCP430682	 	
Sample Date		11 Oct 2023	 	
Machine Hours		9716	 	
Oil Hours		10	 	
Oil Changed		Changed	 	
Sample Status		SEVERE	 	
OIL COND	ITION			
Visc @ 40°C	cSt	<b>■34.6</b>	 	
VOLVO	INATION			
CONTAM				
Water	%	1.09	 	
Silicon	ppm	<b>■&lt;1</b>	 	
Sodium	ppm	<b>48</b>	 	
Potassium	ppm	<b>■</b> 0	 	
VOLVO				
WEAR M	ETALS			
Iron	ppm	<b>2</b>	 	
Copper	ppm	<b>48</b>	 	
Lead	ppm	<b>0</b>	 	
Tin	ppm	<b>■&lt;1</b>	 	
Aluminum	ppm	<b>■</b> 0	 	
Chromium	ppm	■0	 	
Molybdenum	ppm	<b>■</b> 0	 	
Nickel	ppm	<b>■&lt;1</b>	 	
Titanium	ppm	0	 	
Silver	ppm	■0	 	
Manganese	ppm	<b>■&lt;1</b>	 	
Vanadium	ppm	0	 	
ADDITIV	ES			
Calcium	ppm	<b>45</b>	 	
Magnesium	ppm	■3	 	
Zinc	ppm	<b>407</b>	 	
Phosphorus	ppm	■325	 	
Barium	ppm	■<1	 	
Boron	ppm	■36	 	
DOTOIT	ррпп

We advise that you check for the source of water entry. Oil and filter change at the time of sampling has been noted. We recommend an early resample to monitor this condition. All component wear rates are normal. Appearance is unacceptable There is a high concentration of water present in the fluid. The fluid is no longer serviceable due to the presence of contaminants.
