CONSTRUCTION EQUIPMENT

381789 ALTA RENTS VOLVO A25G 752731 - TRANSMISSION (AUTO)

Sample No: VCP440396
Oil Type: VOLVO AUTOMATIC TRANSMISSION FLUID AT102
Job No: 381789 ALTA RENTS

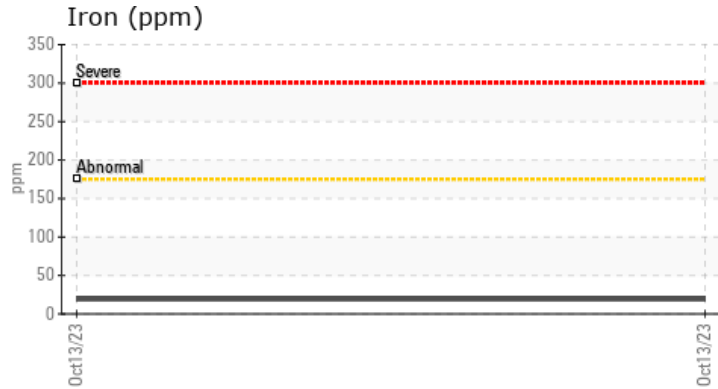
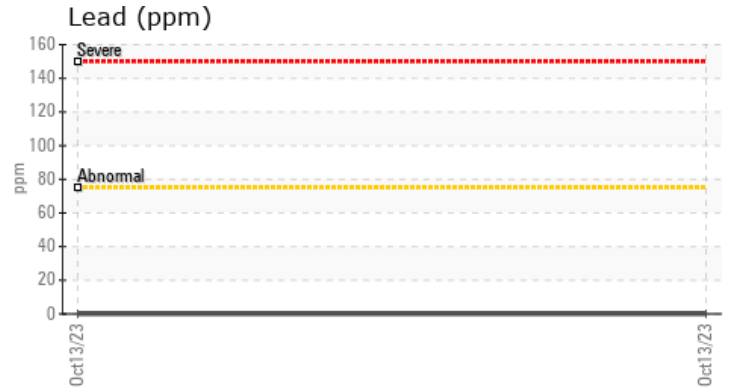
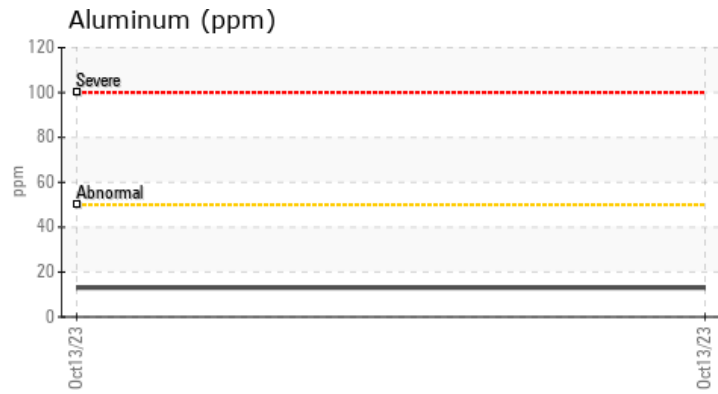
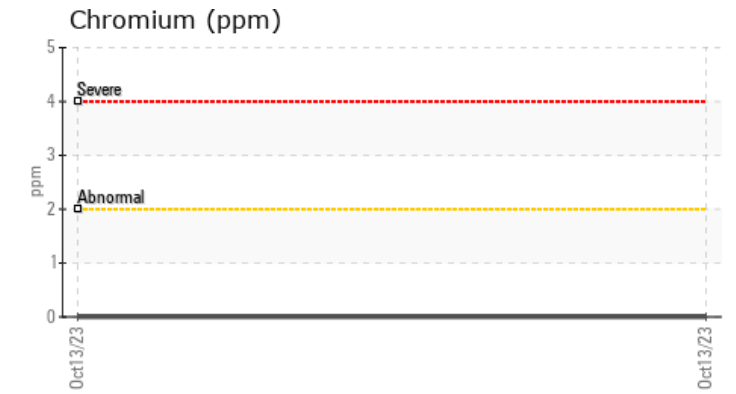
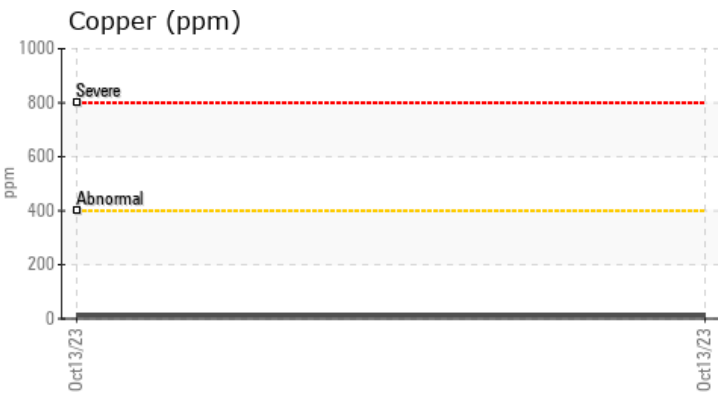
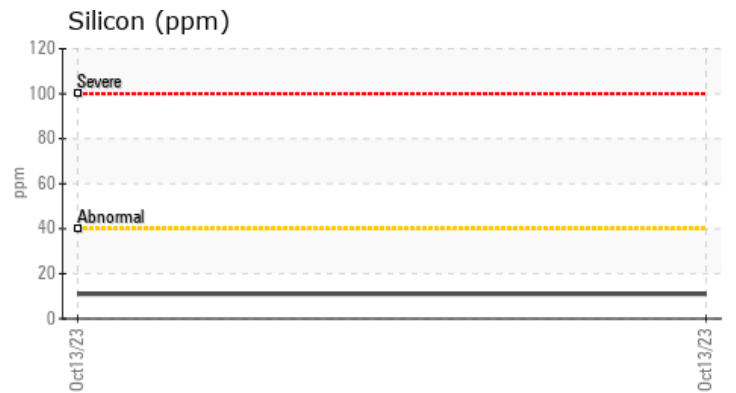
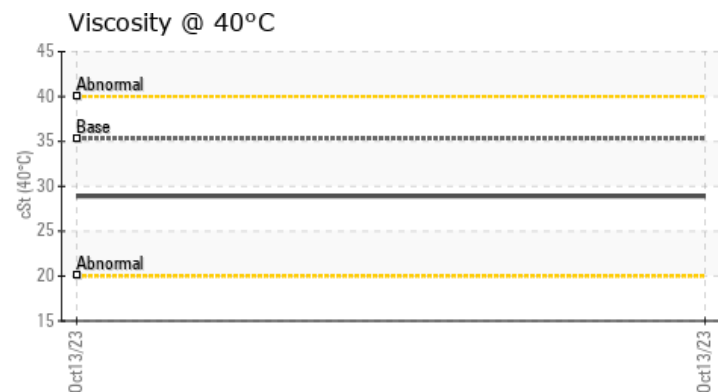
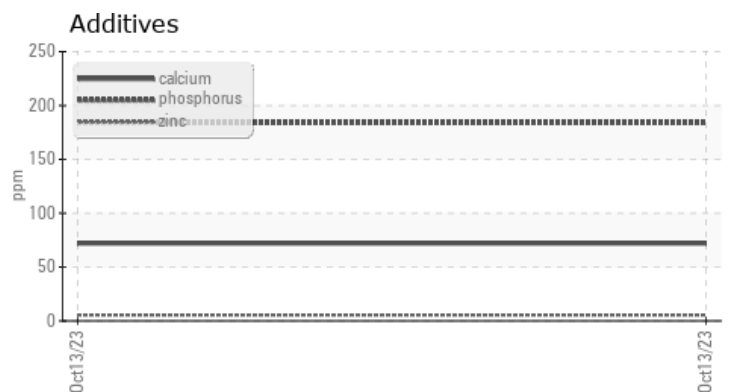
VOLVO GRAPHS

Resample at the next service interval to monitor. All component wear rates are normal. There is no indication of any contamination in the fluid. The condition of the fluid is acceptable for the time in service.
