W14836 VOLVO A40G 353426 - DIESEL ENGINE

Sample No: VCP442625
Oil Type: VOLVO ULTRA DIESEL ENGINE OIL 15W40 VDS-3
Job No: W14836

SAMPLE INFORMATION

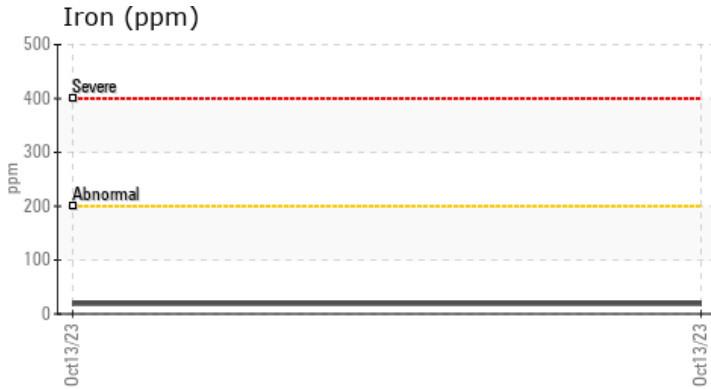
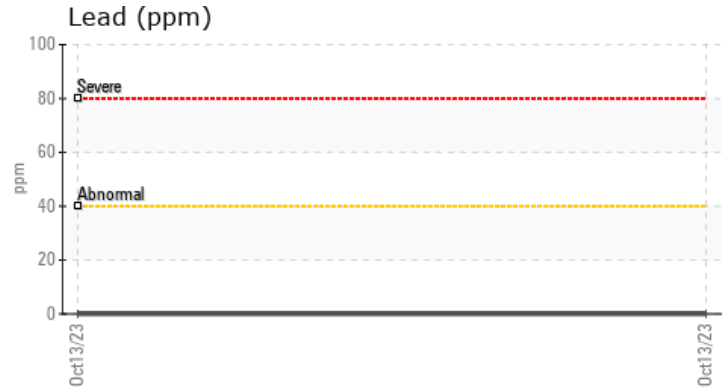
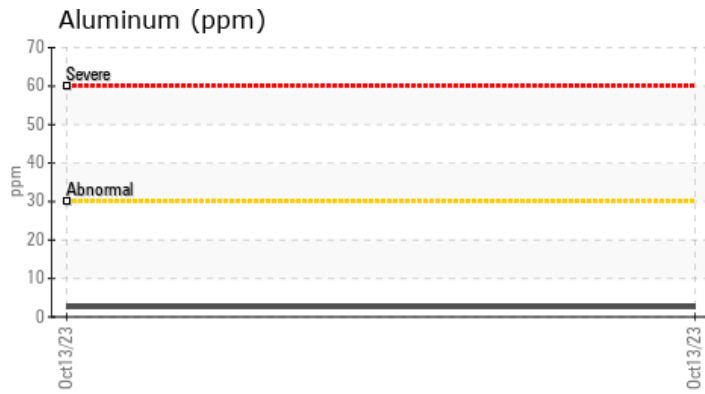
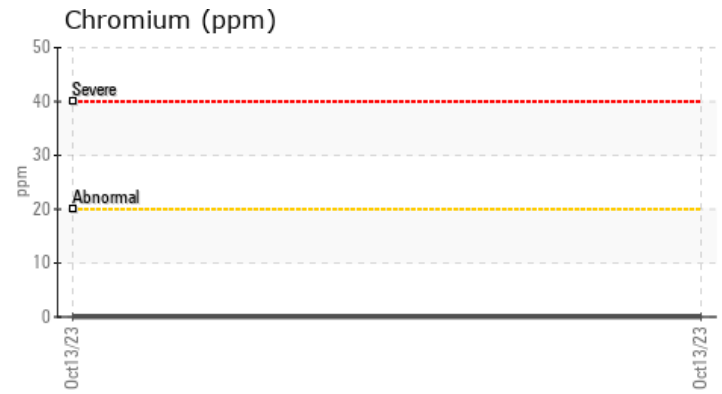
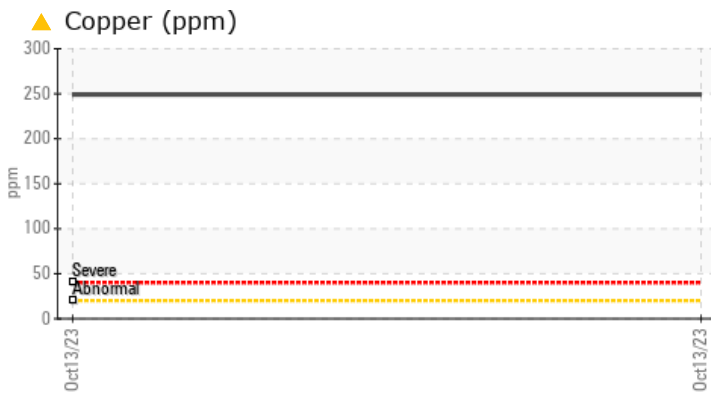
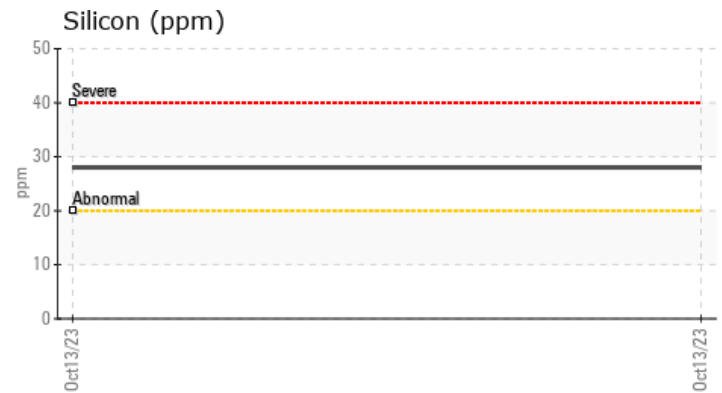
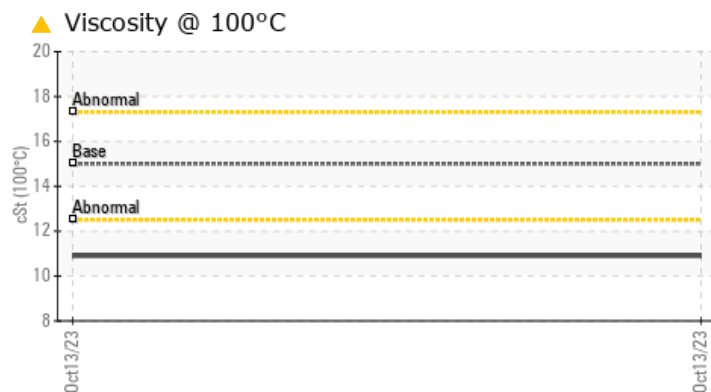
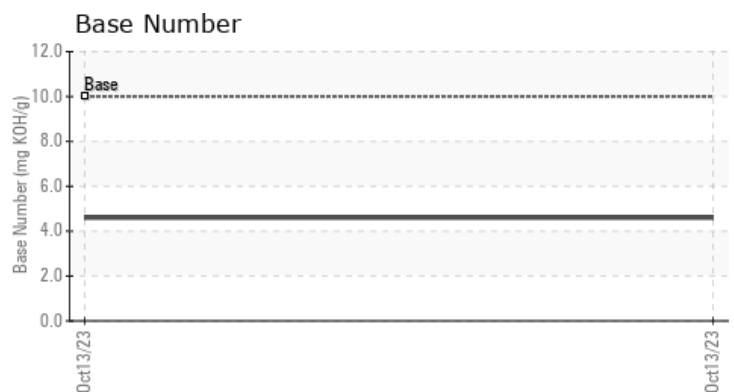
GRAPHS

Oil and filter change at the time of sampling has been noted. Resample at the next service interval to monitor. The copper level is abnormal. In the absence of other significant wear metals, suspect copper due to sources other than wear (i.e. cooling core). All other metal levels are typical for a new component breaking in. Fuel content negligible. There is no indication of any contamination in the oil. The oil viscosity is lower than normal. The BN result indicates that there is suitable alkalinity remaining in the oil. Confirm oil type.
