# CONSTRUCTION EQUIPMENT

W07013549 VOLVO A35G 342021 - DIESEL ENGINE

**Sample No:** VCP414579  
**Oil Type:** MOBIL 15W40  
**Job No:** W07013549

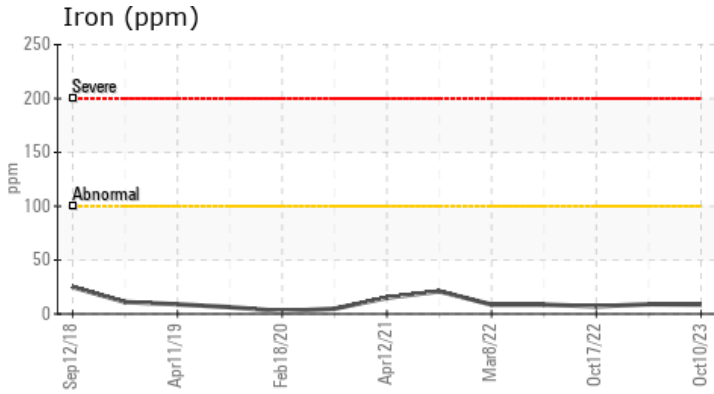
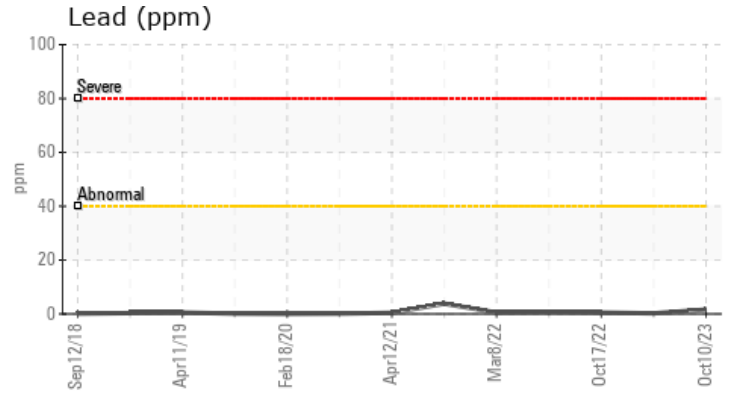
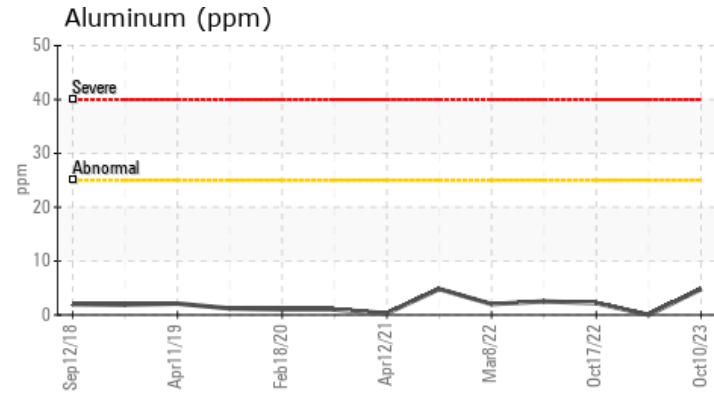
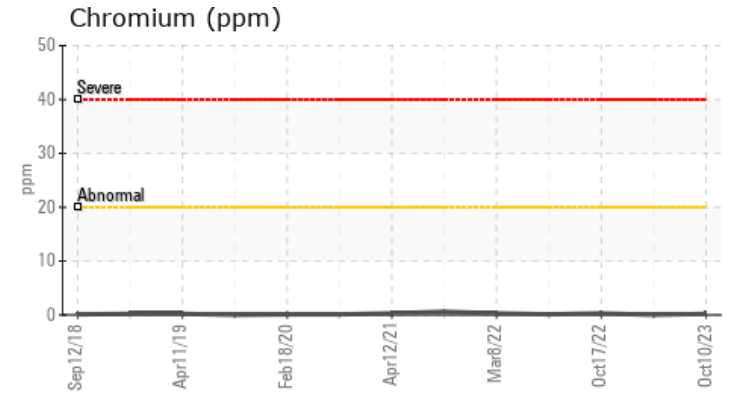
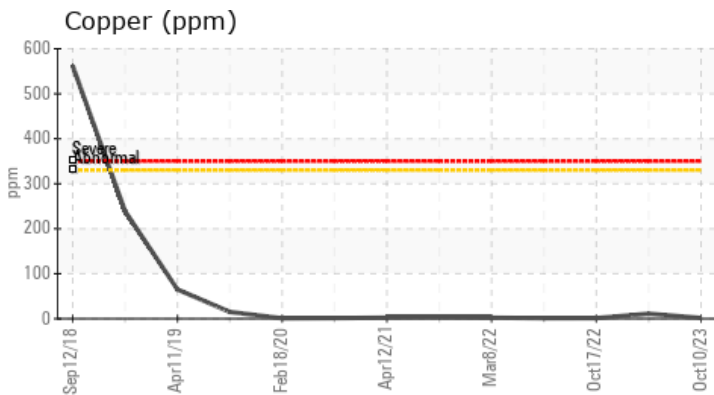
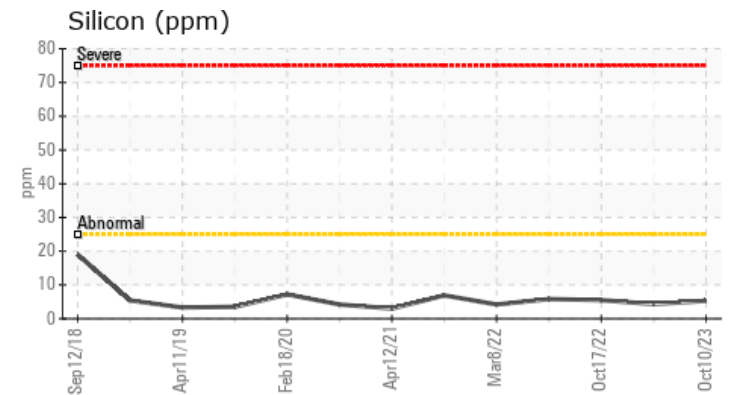
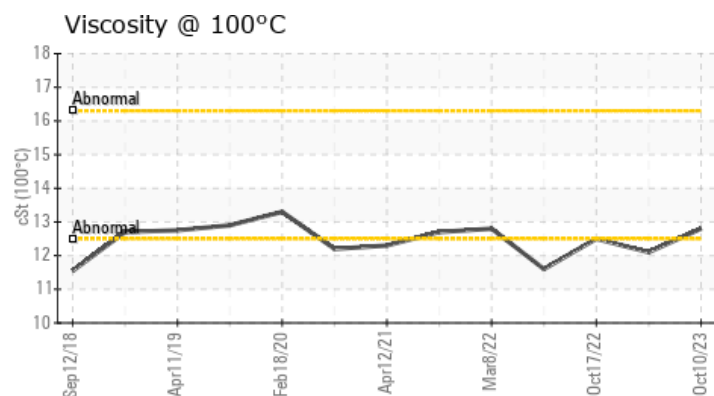
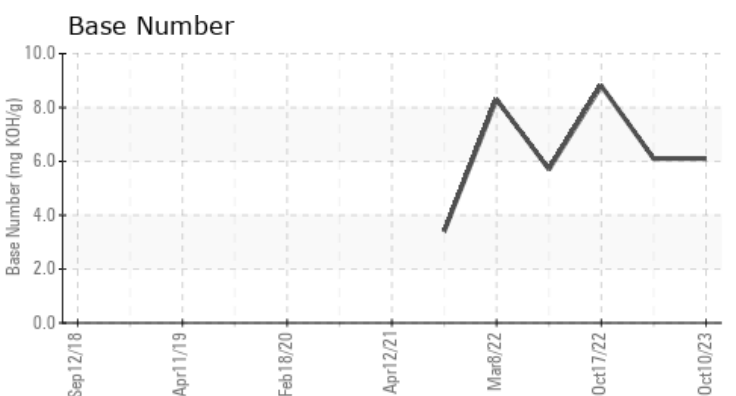
## VOLVO GRAPHS

Resample at the next service interval to monitor. All component wear rates are normal. There is no indication of any contamination in the oil. The BN result indicates that there is suitable alkalinity remaining in the oil. The condition of the oil is suitable for further service.
