CONSTRUCTION EQUIPMENT

SPM620300 VOLVO L150H 6952 - TRANSMISSION (AUTO)

Sample No: VCP415347
Oil Type: VOLVO AUTOMATIC TRANSMISSION FLUID AT102
Job No: SPM620300

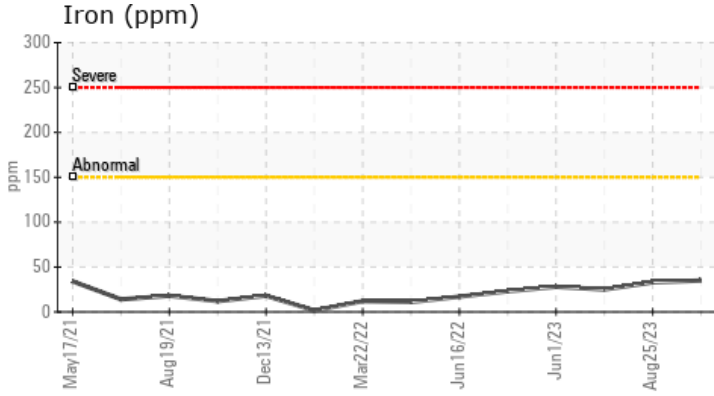
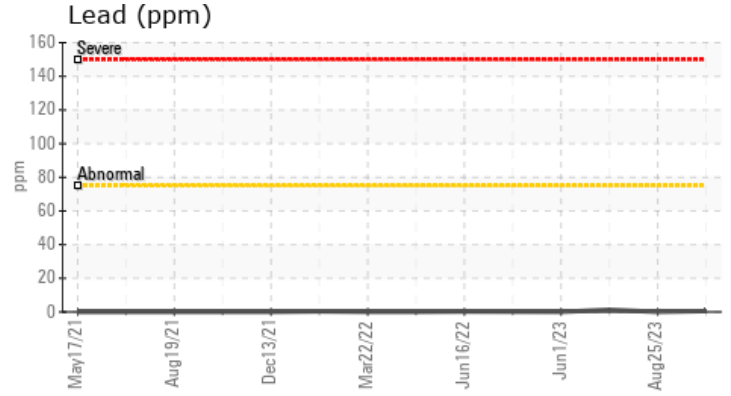
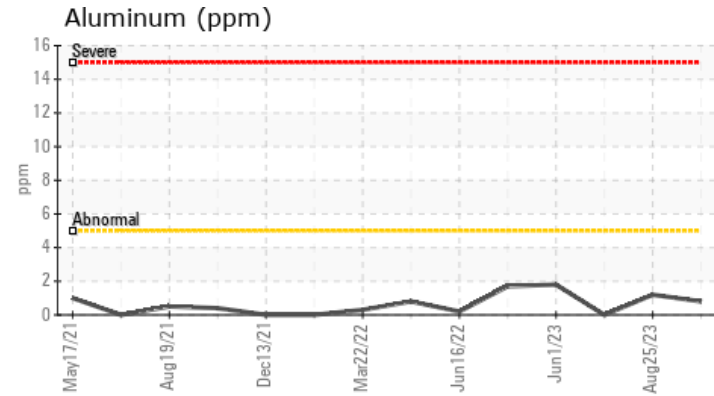
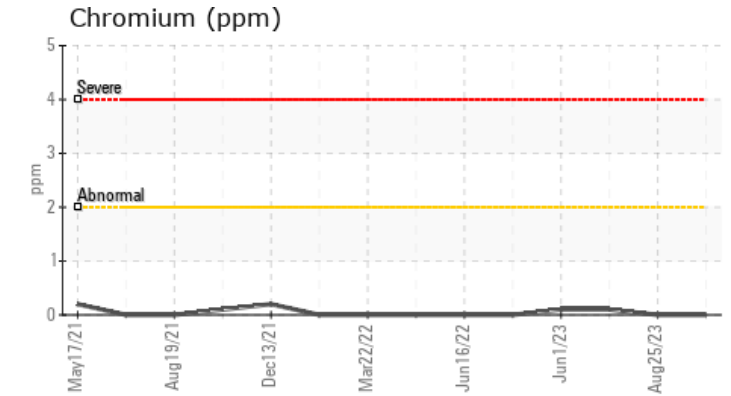
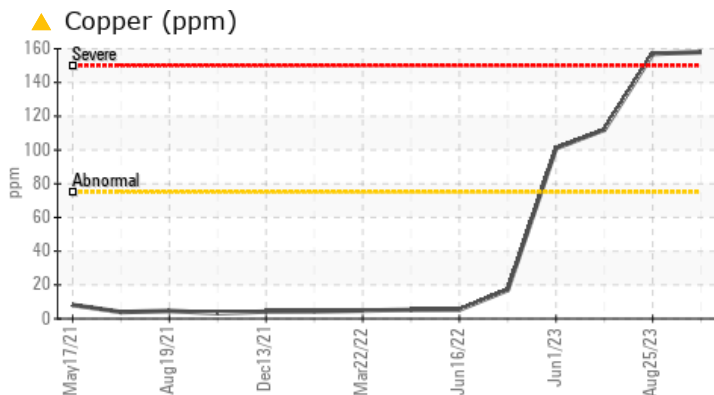
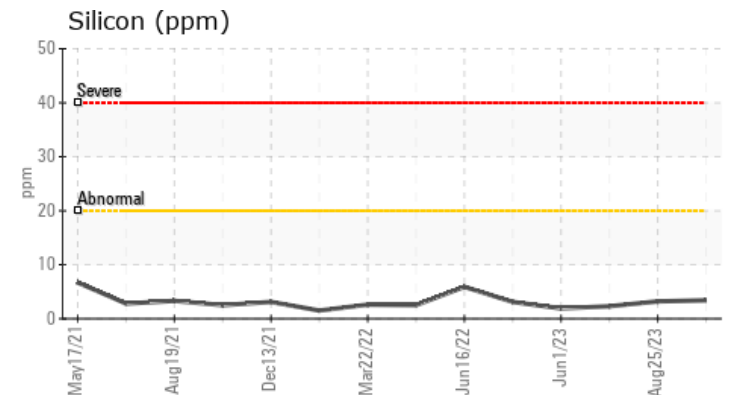
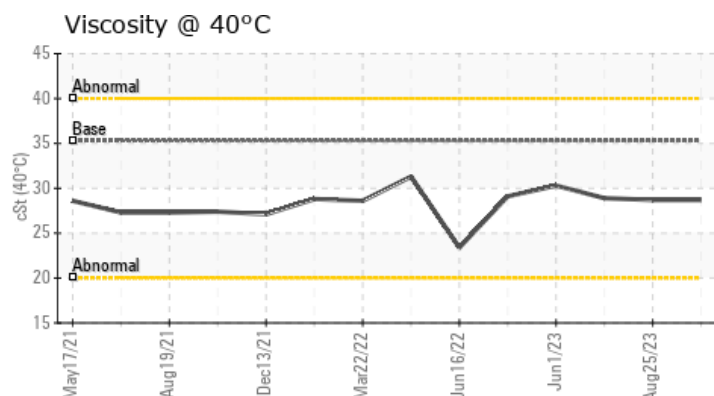
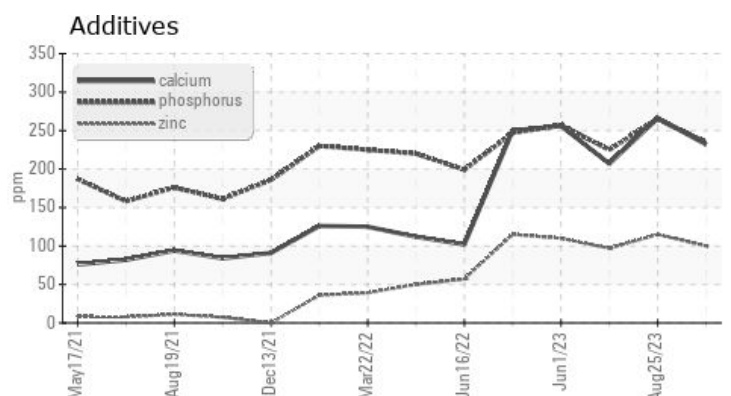
GRAPHS

Iron	ppm	35	33	25	28
Copper	ppm	▲ 158	▲ 157	112	101
Lead	ppm	<1	0	1	0
Tin	ppm	<1	0	0	<1
Aluminum	ppm	<1	1	0	2
Chromium	ppm	0	0	<1	<1
Molybdenum	ppm	1	2	2	2
Nickel	ppm	0	0	0	<1
Titanium	ppm	0	0	<1	0
Silver	ppm	0	<1	0	0
Manganese	ppm	1	1	<1	<1
Vanadium	ppm	0	0	<1	0

No corrective action is recommended at this time. Resample at the next service interval to monitor. Clutch and/or bushing/bearing wear is indicated. All other component wear rates are normal. There is no indication of any contamination in the fluid. The condition of the fluid is acceptable for the time in service.
