24245 VOLVO A40G 352430 - DIESEL ENGINE

Sample No: VCP433231
Oil Type: VOLVO ULTRA DIESEL ENGINE OIL 15W40 VDS-3
Job No: 24245

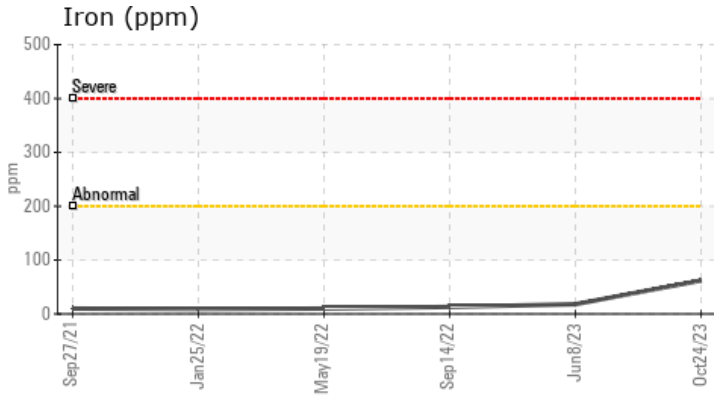
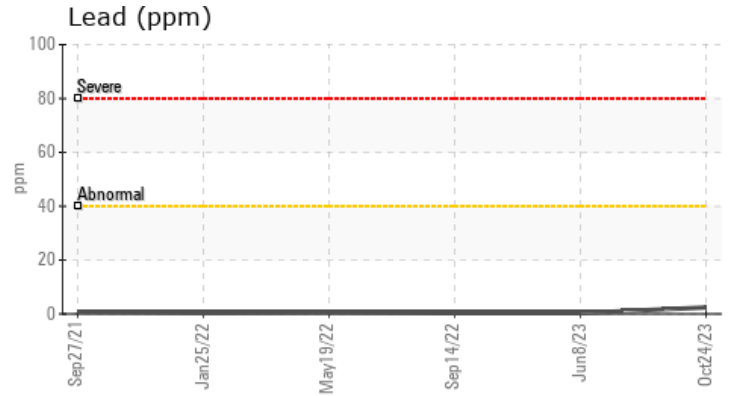
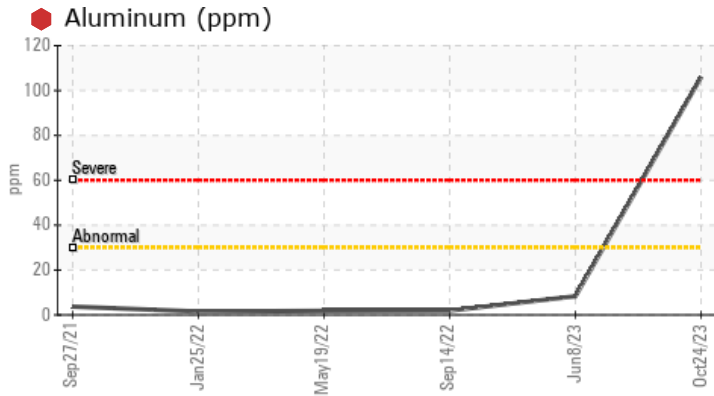
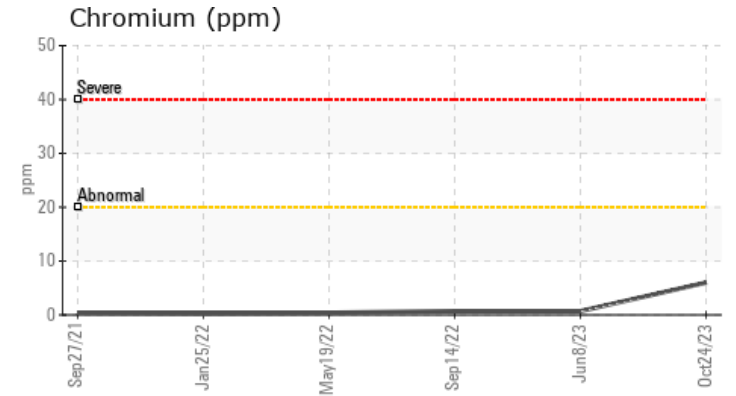
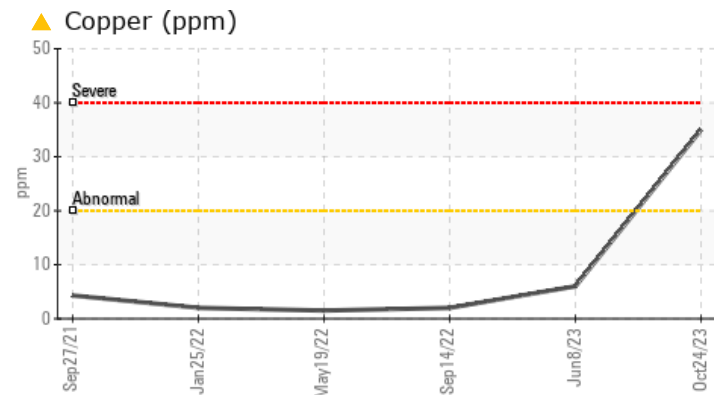
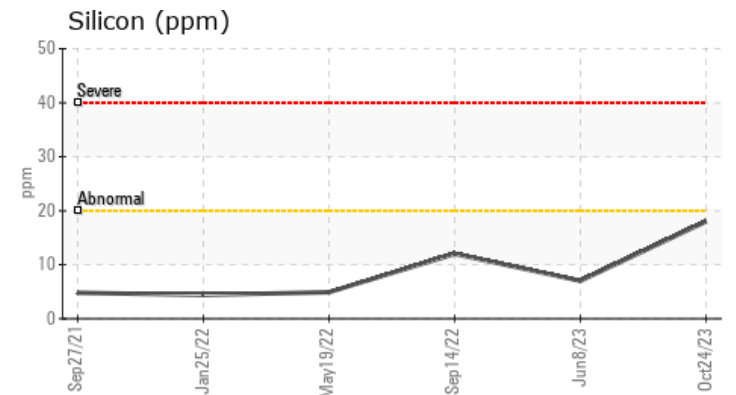
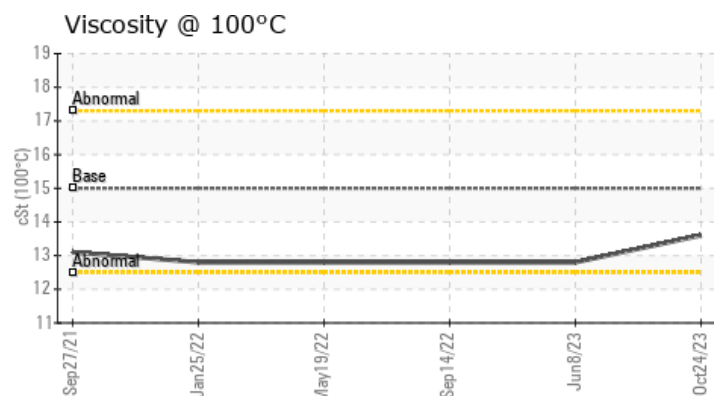
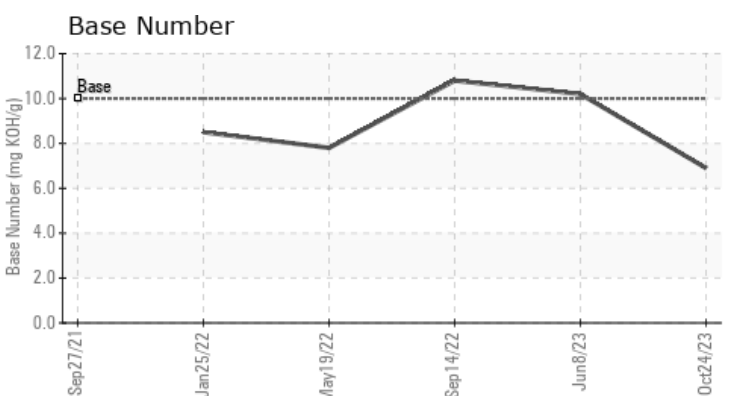
GRAPHS

Oil and filter change at the time of sampling has been noted. We advise that you inspect for the source(s) of wear. We recommend an early resample to monitor this condition. Note that there appears to be a discrepancy in the total time on this component, when compared to the historical data. Piston, ring and cylinder wear is indicated. Bearing and/or bushing wear is indicated. There is no indication of any contamination in the oil. The BN result indicates that there is suitable alkalinity remaining in the oil.
