# CONSTRUCTION EQUIPMENT

## VOLVO L120H 633400 - TRANSMISSION (AUTO)

**Sample No:** VCP442186  
**Oil Type:** VOLVO AUTOMATIC TRANSMISSION FLUID AT102  
**Job No:**

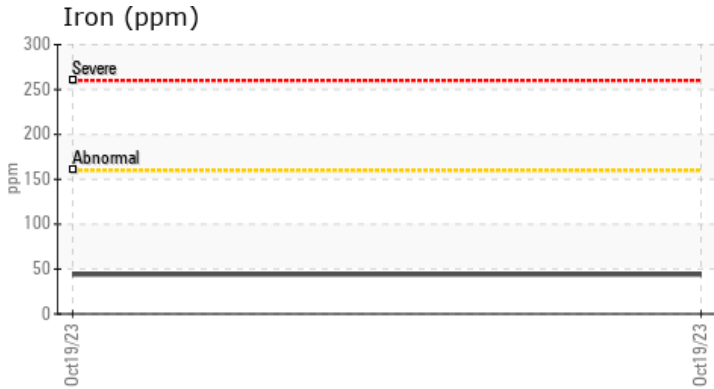
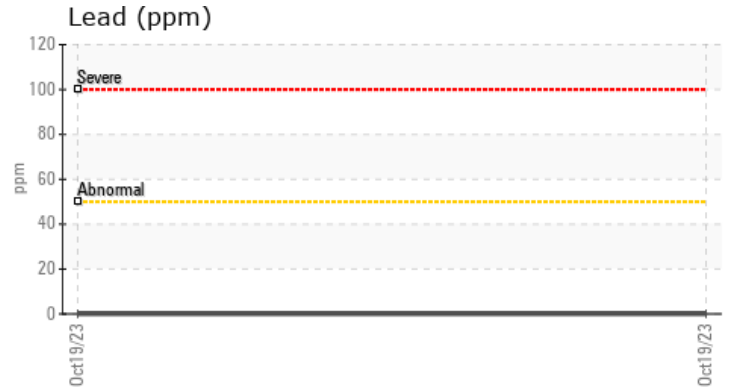
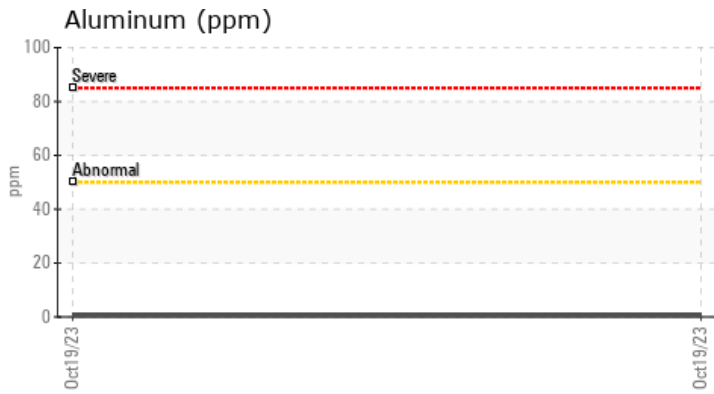
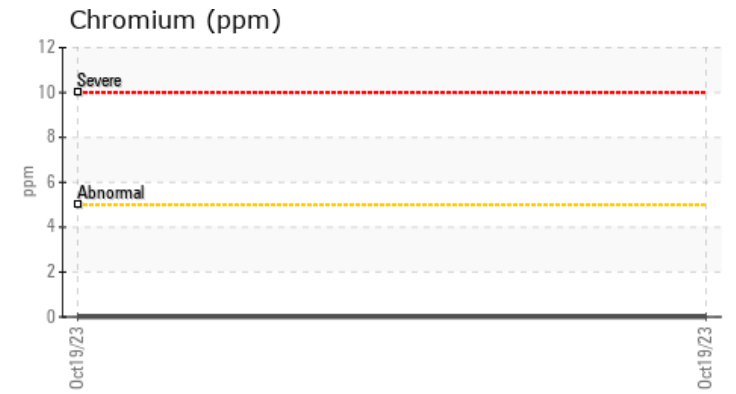
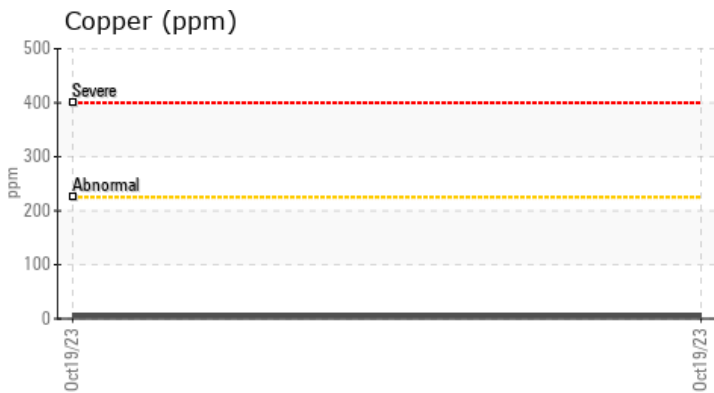
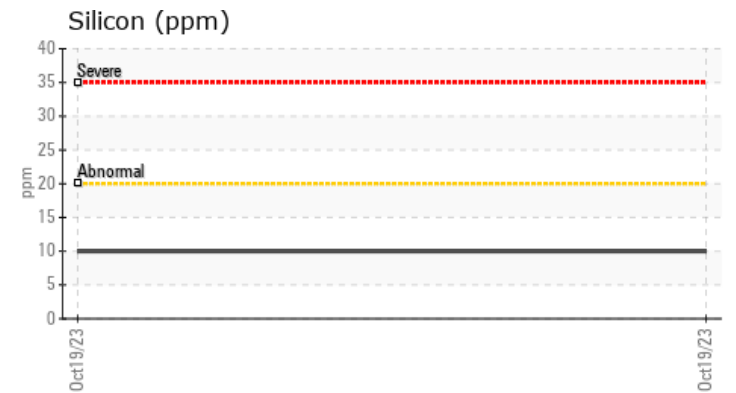
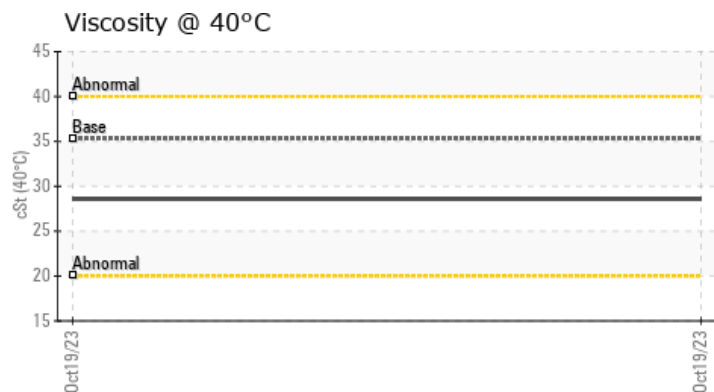
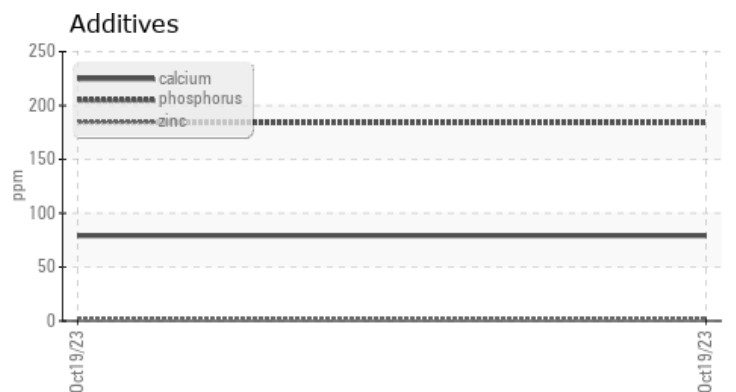
## VOLVO GRAPHS

Resample at the next service interval to monitor. All component wear rates are normal. There is no indication of any contamination in the oil. The condition of the oil is acceptable for the time in service.
