CONSTRUCTION EQUIPMENT

CATERPILLAR M-2 - FRONT AXLE

Sample No: VCP416559
Oil Type: MOBIL MOBILTRANS HD 30
Job No:

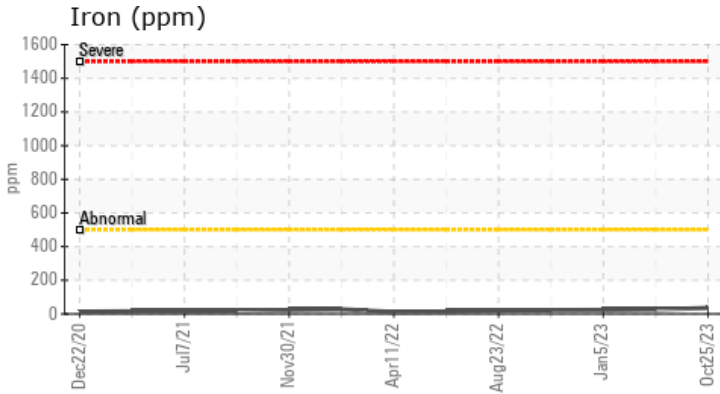
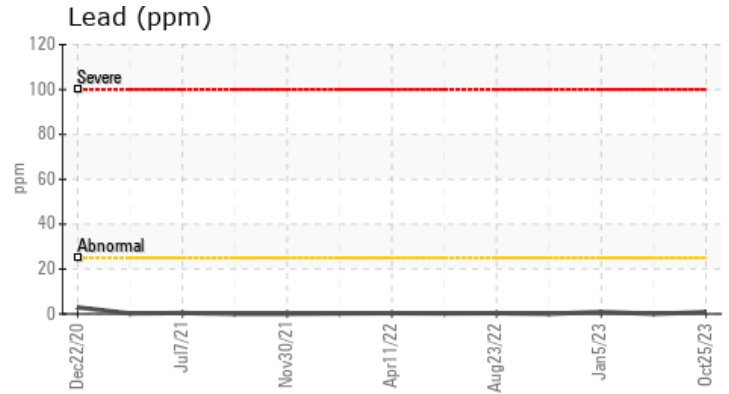
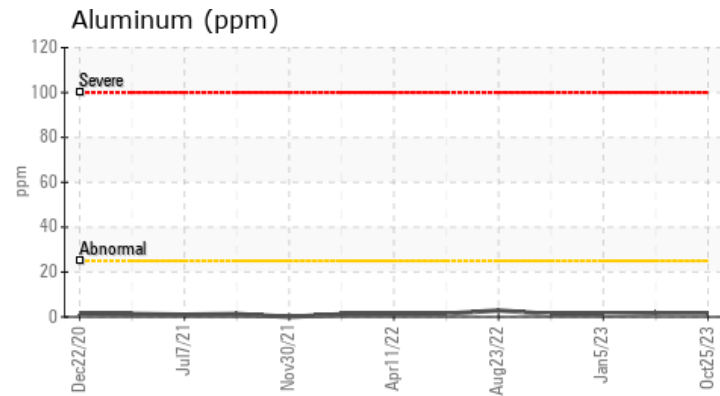
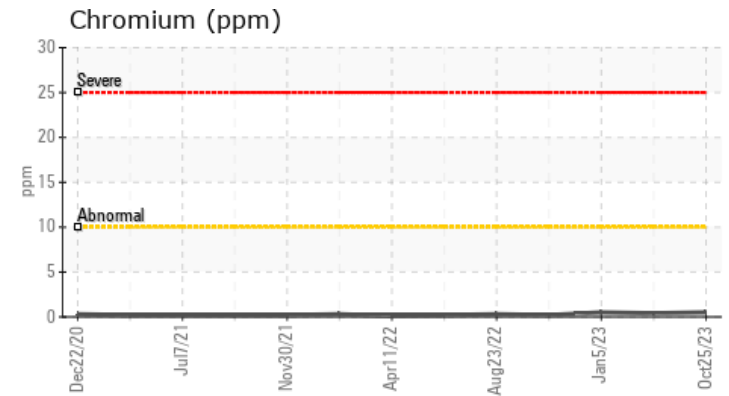
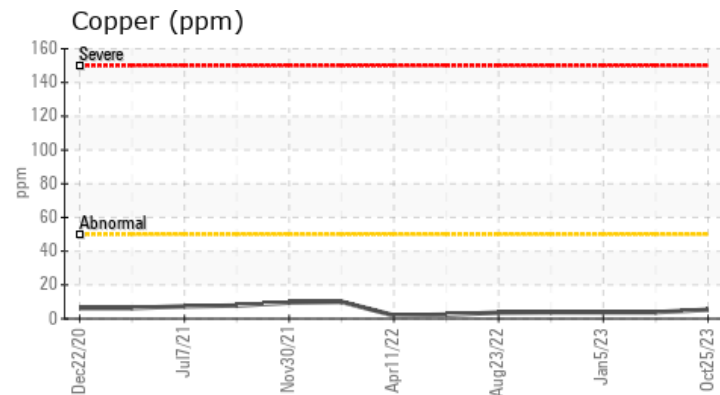
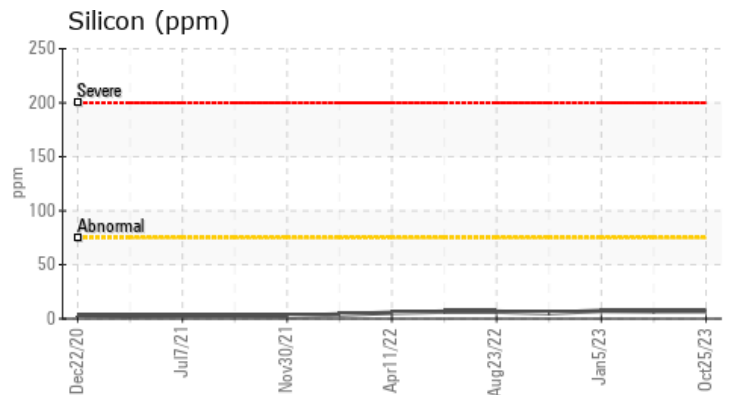
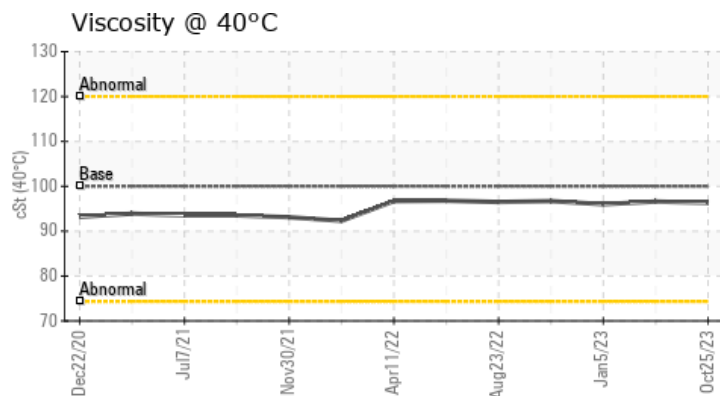
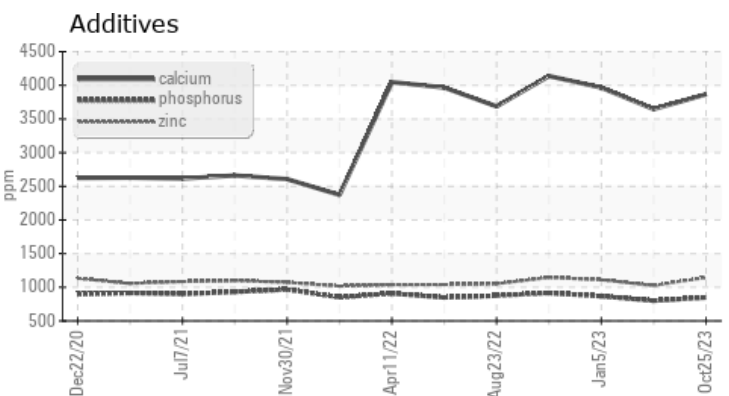
GRAPHS

Resample at the next service interval to monitor. All component wear rates are normal. There is no indication of any contamination in the oil. The condition of the oil is acceptable for the time in service.
