# CONSTRUCTION EQUIPMENT

## VOLVO A30G 15-1091 - REAR TRANSMISSION

**Sample No:** VCP432472  
**Oil Type:** DIESEL ENGINE OIL SAE 15W40  
**Job No:**

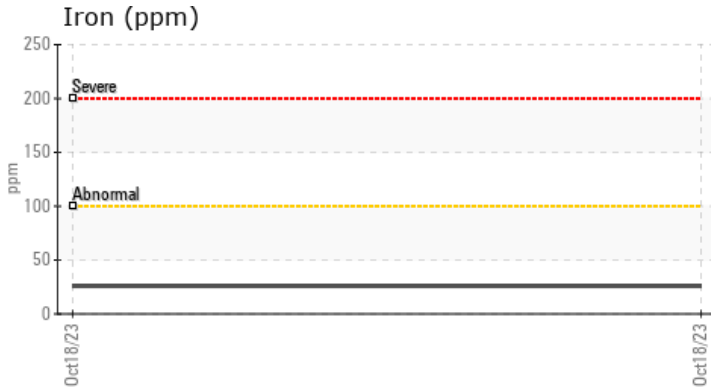
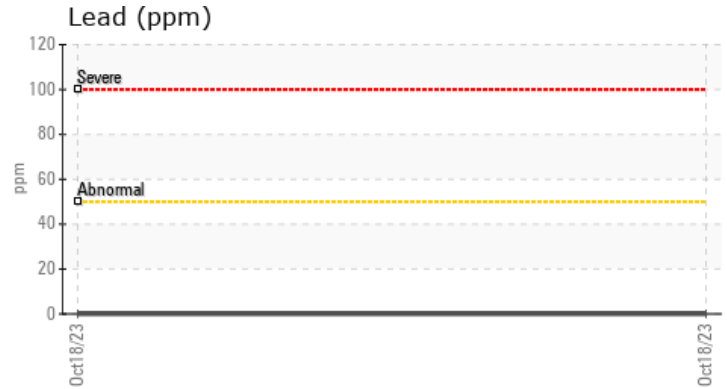
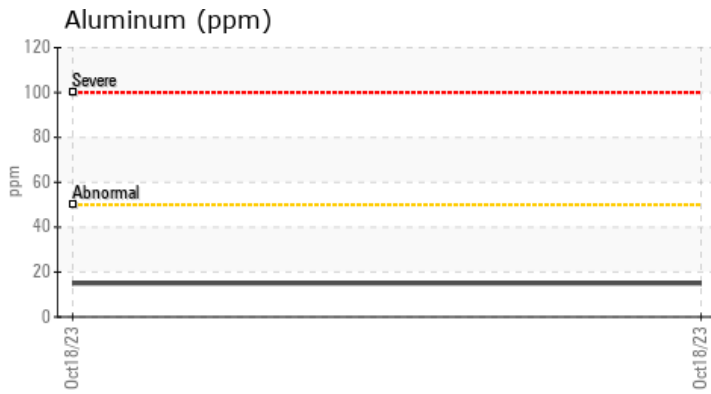
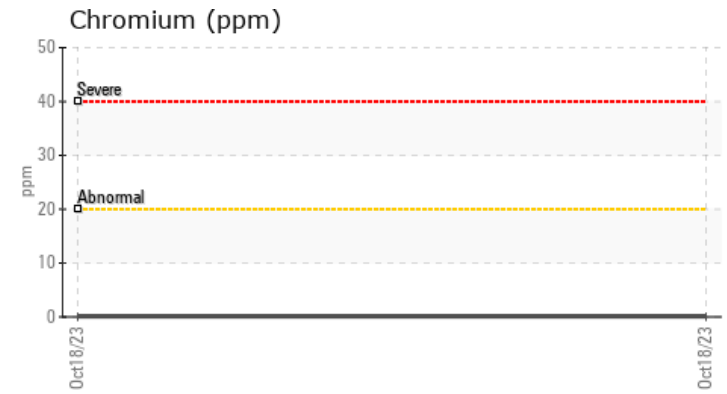
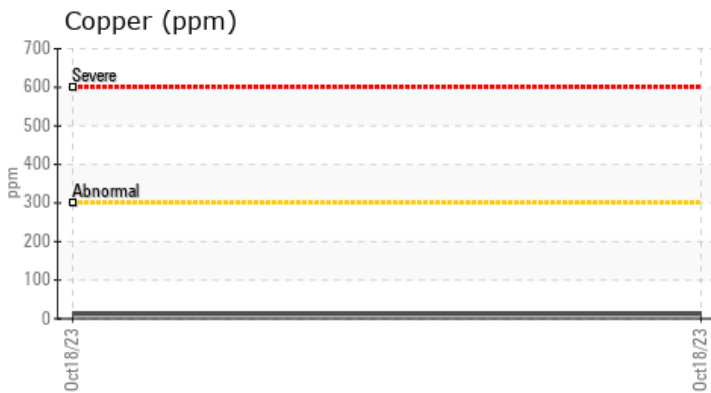
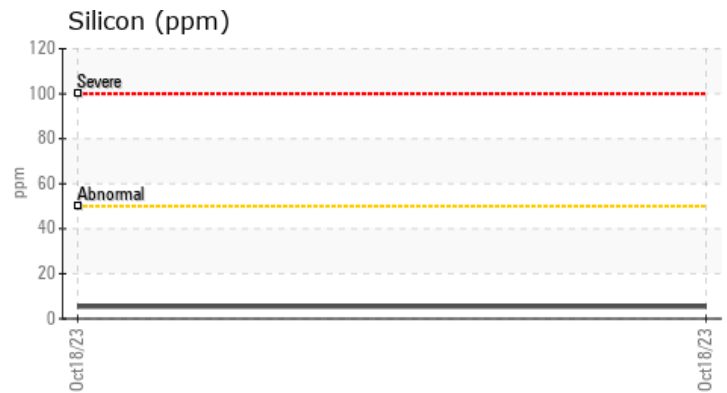
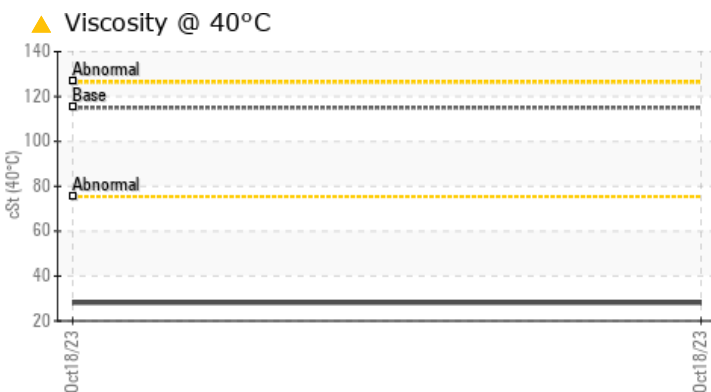
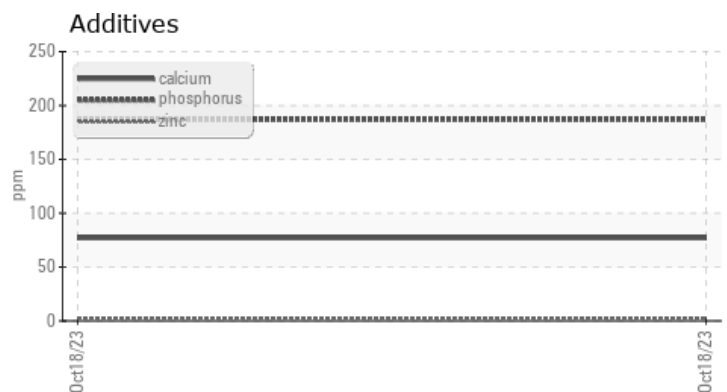
## GRAPHS

Resample at the next service interval to monitor. All component wear rates are normal. There is no indication of any contamination in the fluid. The fluid viscosity is lower than normal. This plus the additive levels indicates the addition of a different brand, or type of oil. Confirm oil type.
