# CONSTRUCTION EQUIPMENT GROOT VOLVO L 15 OH 6799 - COOLANT

Sample No: VCP433146

Job No: GROOT

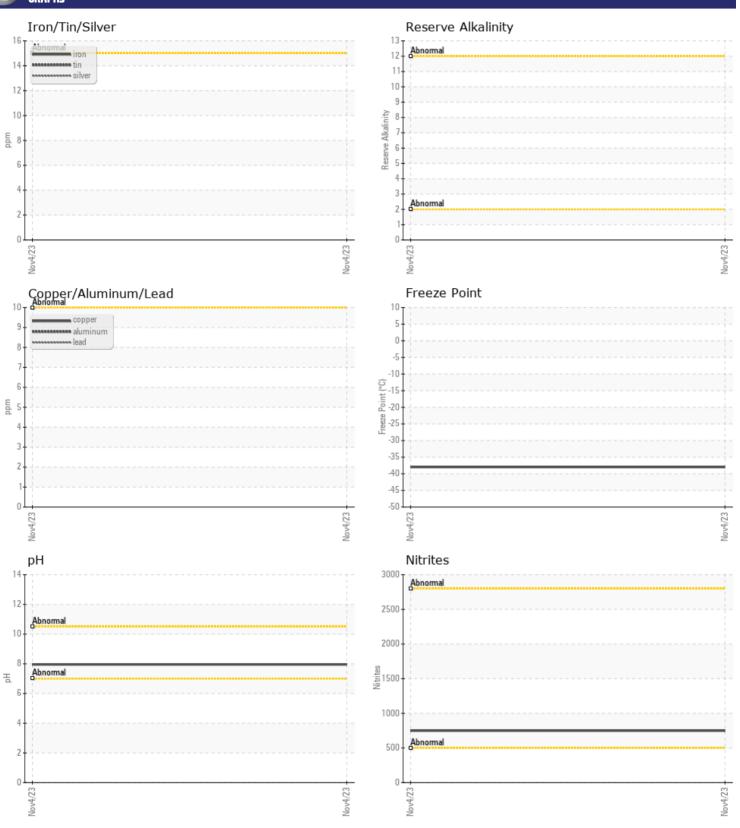
### GRAPHS

CAMPLE IN	FORMATION				
	II OMMATION		=		=
Sample Number		VCP433146			
Sample Date		04 Nov 2023			
Machine Hours		0			
Sample Status		NORMAL			
COOLANT CONDITION					
LUULANI	LUNDITIUN				
рН	Scale 0-14	<b>7.95</b>			
Reserve Alkalinity	Scale 0-20				
Nitrites	ppm	<b>748</b>			
Percentage Glycol	%	<b>■51.0</b>			
Freezing Point	°C	<b>■</b> -38			
VOLVO	IATION				
CONTAMINATION					
Coolant Appearance		normal			
Coolant Color		Green

No corrective action is recommended at this time. The fluid is suitable for further service. There is no indication of any contamination in the coolant. Carboxylate test failed. Glycol and nitrite levels are acceptable. The pH level of this fluid is within the acceptable limits.
