CONSTRUCTION EQUIPMENT

W02007688 VOLVO A35G 340132 - DIESEL ENGINE

Sample No: VCP426062
Oil Type: MOBIL 15W40
Job No: W02007688

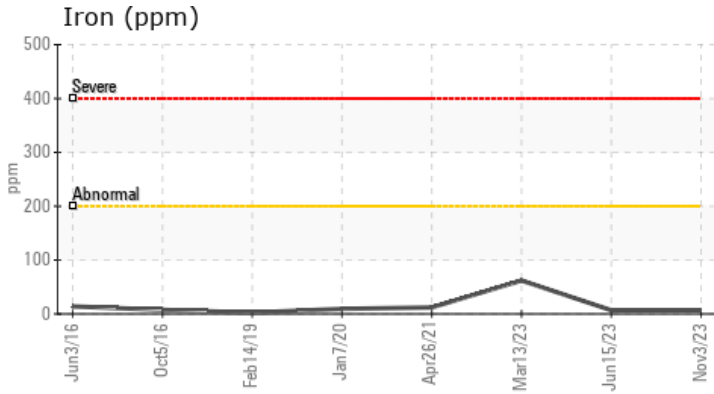
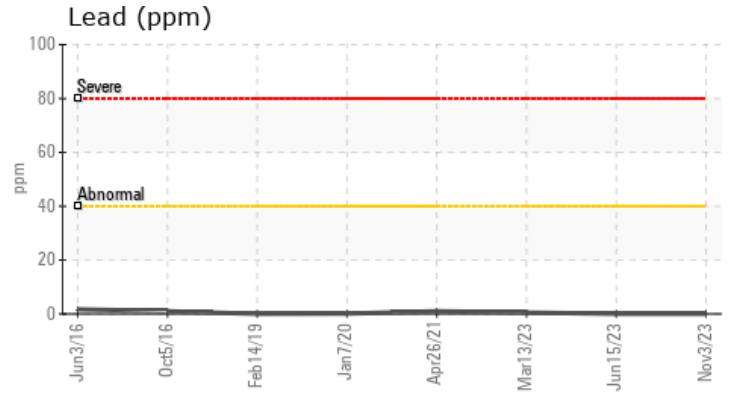
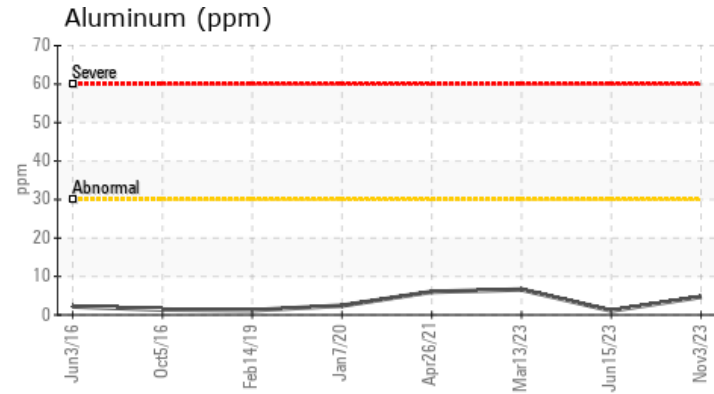
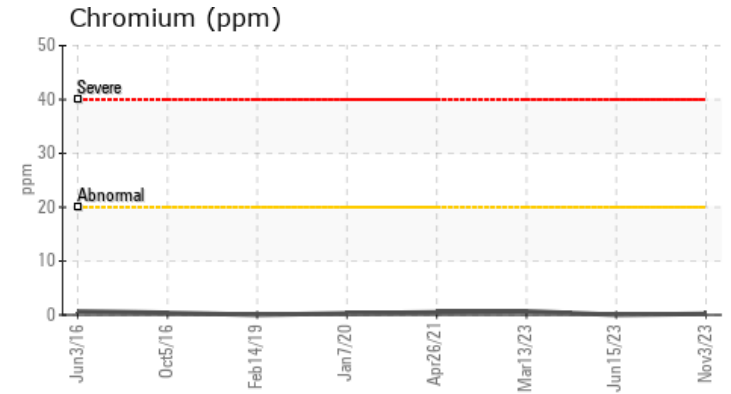
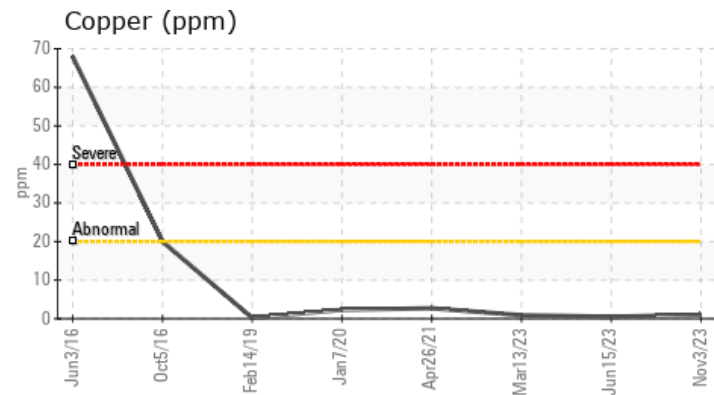
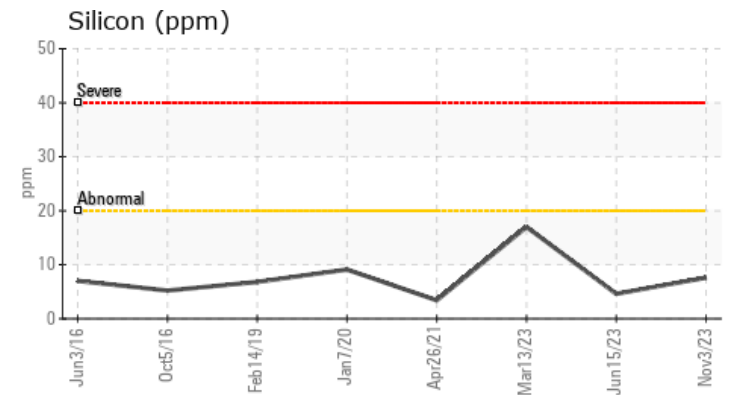
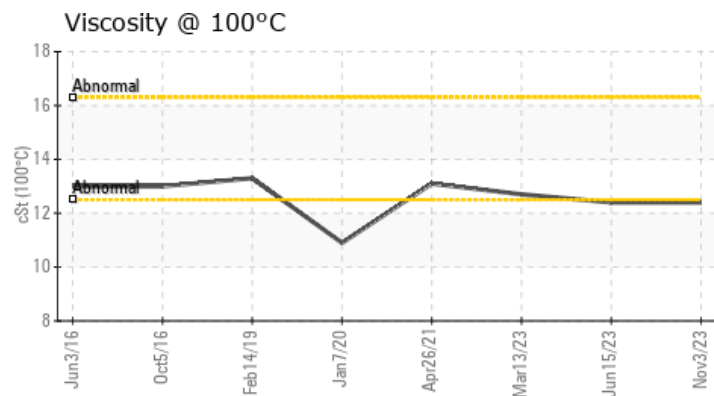
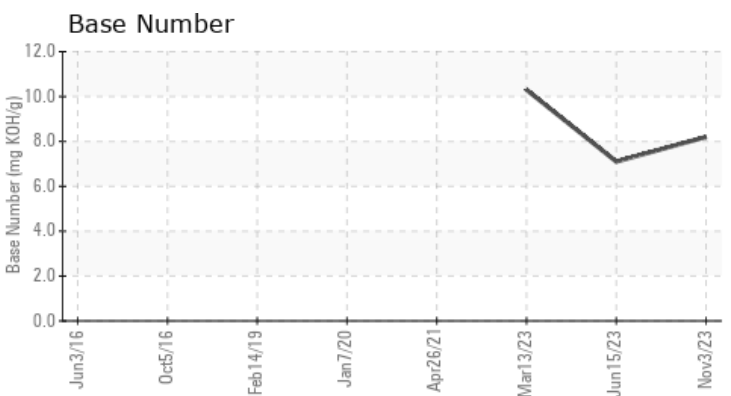
GRAPHS

Soot %	%	█ 0.2	█ 0.3	█ 0.3	█ 0.3
Nitration (PA)	%	█ 63	█ 69	█ 71	█ 71
Sulfation (PA)	%	█ 62	█ 55	█ 62	█ 56
Glycol	%	█ NEG	█ NEG	█ NEG	█ NEG
Fuel	%	█ <1.0	█ 0.5	█ <1.0	█ <1.0
Silicon	ppm	█ 8	█ 5	█ 17	█ 3
Sodium	ppm	▲ 314	▲ 274	▲ 87	█ 3
Potassium	ppm	▲ 40	▲ 39	▲ 35	█ 4

We advise that you check for the source of the coolant leak. Check for low coolant level. Oil and filter change at the time of sampling has been noted. We recommend an early resample to monitor this condition. All component wear rates are normal. Sodium and/or potassium levels are high. The BN result indicates that there is suitable alkalinity remaining in the oil.
