CONSTRUCTION EQUIPMENT

24356 VOLVO L110H 632301 - REAR TRANSMISSION (AUTO)

Sample No: VCP420554
Oil Type: VOLVO AUTOMATIC TRANSMISSION FLUID AT102
Job No: 24356

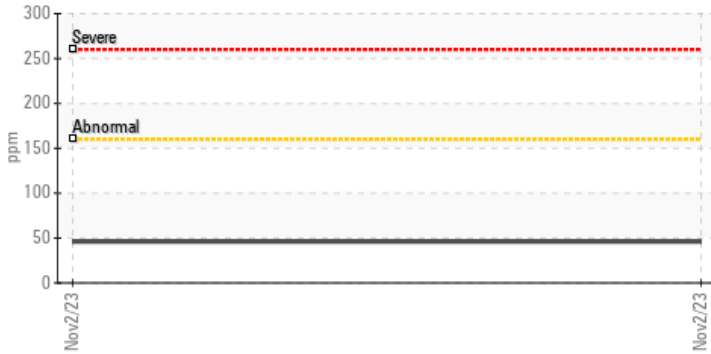
Iron (ppm)

Iron	ppm	█ 46	---	---	---
Copper	ppm	█ 15	---	---	---
Lead	ppm	█ 0	---	---	---
Tin	ppm	█ 0	---	---	---
Aluminum	ppm	█ 10	---	---	---
Chromium	ppm	█ 0	---	---	---
Molybdenum	ppm	█ 3	---	---	---
Nickel	ppm	█ 0	---	---	---
Titanium	ppm	0	---	---	---
Silver	ppm	█ 0	---	---	---
Manganese	ppm	█ 3	---	---	---
Vanadium	ppm	0	---	---	---

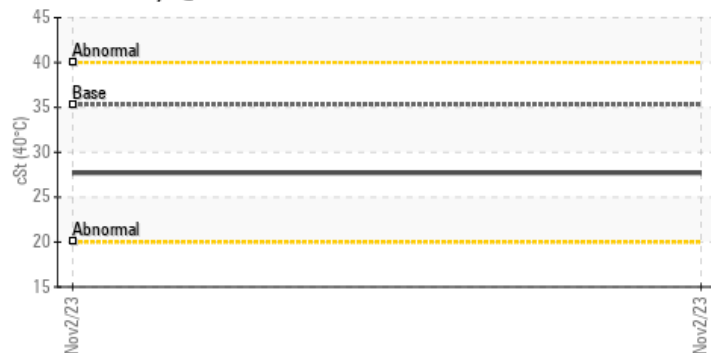
Viscosity @ 40°C

Visc @ 40°C	cSt	█ 27.7	---	---	---
-------------	-----	--------	-----	-----	-----

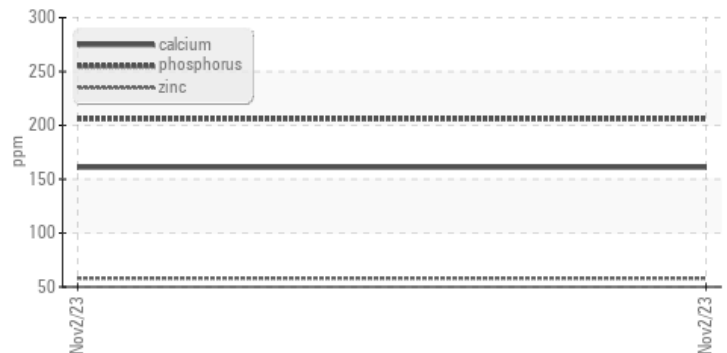
Additives

Calcium	ppm	█ 161	---	---	---
Magnesium	ppm	█ 20	---	---	---
Zinc	ppm	█ 58	---	---	---
Phosphorus	ppm	█ 206	---	---	---
Barium	ppm	█ 3	---	---	---
Boron	ppm	█ 69	---	---	---
