# CONSTRUCTION EQUIPMENT

633493 VOLVO A45G 353505 - TRANSMISSION (AUTO)

**Sample No:** VCP432954  
**Oil Type:** VOLVO AUTOMATIC TRANSMISSION FLUID AT102  
**Job No:** 633493

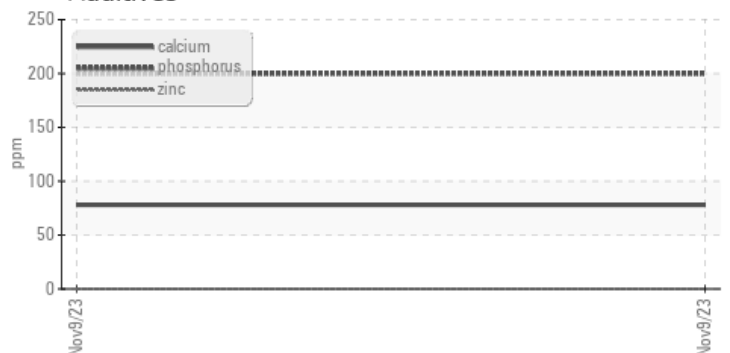
### Additives

Calcium	ppm	█ 78	---	---	---
Magnesium	ppm	█ 2	---	---	---
Zinc	ppm	█ 0	---	---	---
Phosphorus	ppm	█ 200	---	---	---
Barium	ppm	█ 0	---	---	---
Boron	ppm	█ 82	---	---	---
