# CONSTRUCTION EQUIPMENT

## VOLVO A45G 352704 - FRONT AXLE

**Sample No:** VCP431883  
**Oil Type:** GEAR OIL SAE 80W90  
**Job No:**

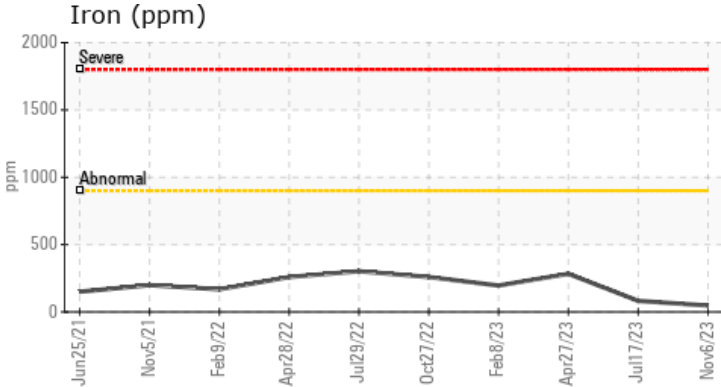
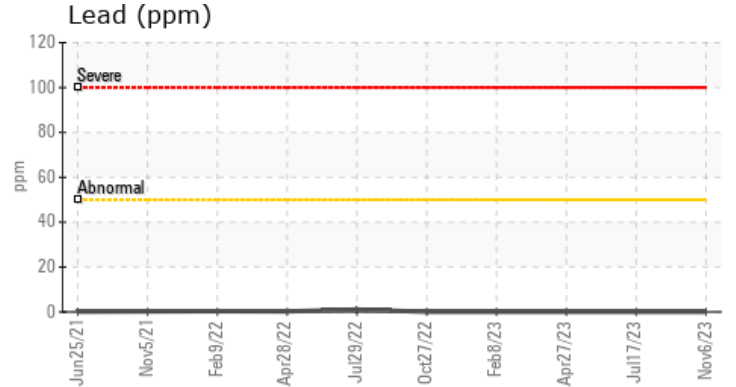
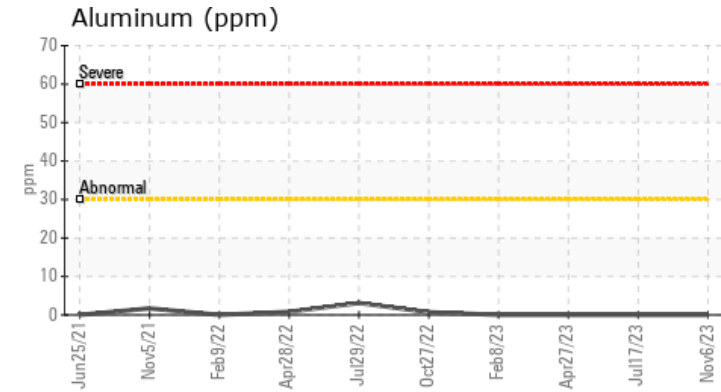
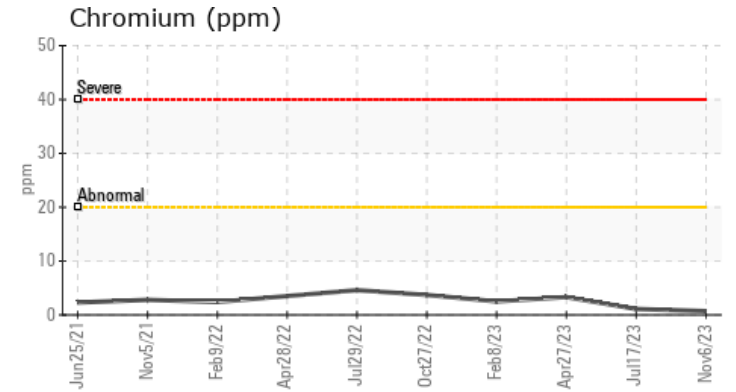
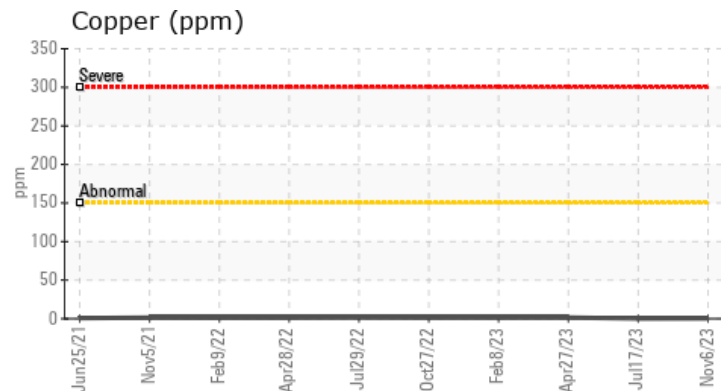
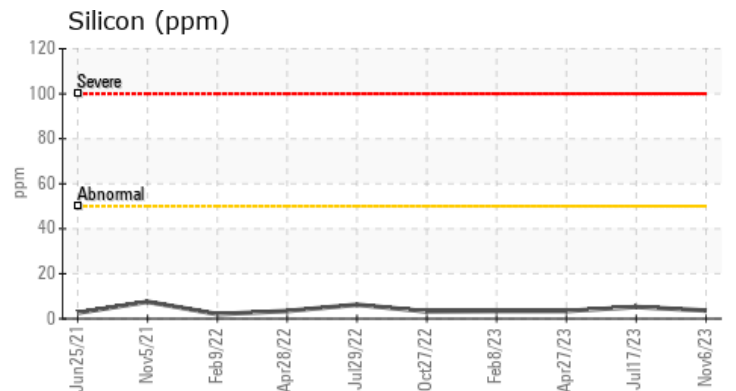
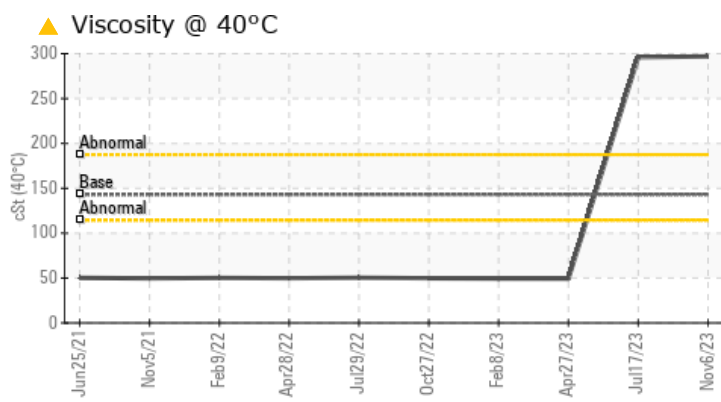
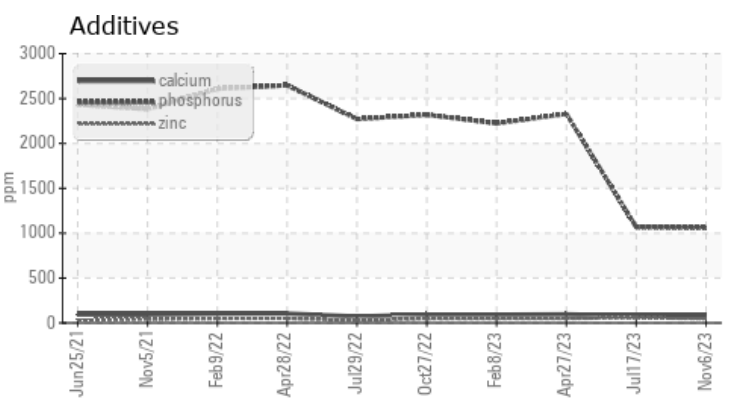
## VOLVO GRAPHS

**Diagnosis**  
 No corrective action is recommended at this time. Resample at the next service interval to monitor. All component wear rates are normal. There is no indication of any contamination in the oil. The oil viscosity is higher than normal. Confirm oil type.
