CONSTRUCTION EQUIPMENT

CATERPILLAR M-2 - FRONT AXLE

Sample No: VCP404392
Oil Type: MOBIL MOBILTRANS HD 30
Job No:

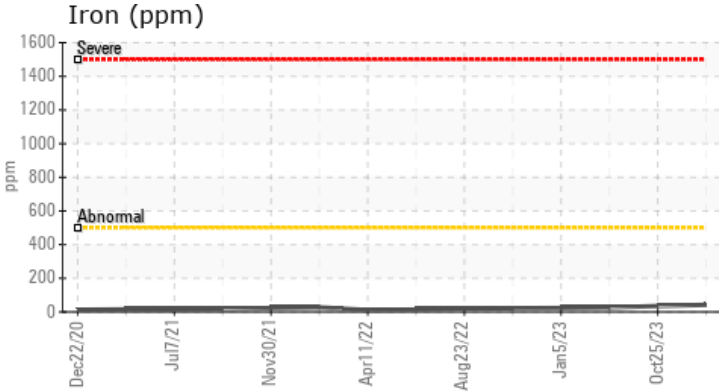
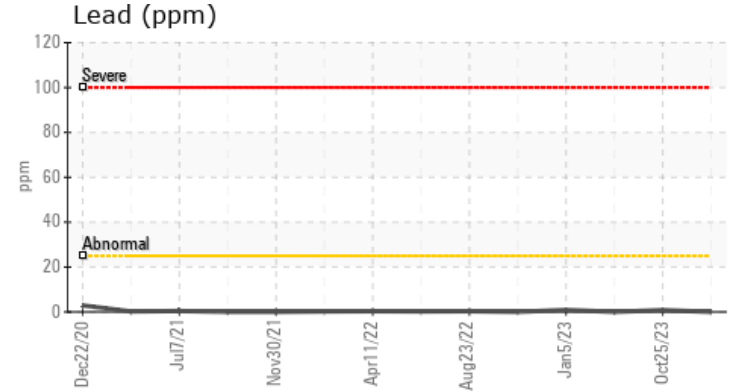
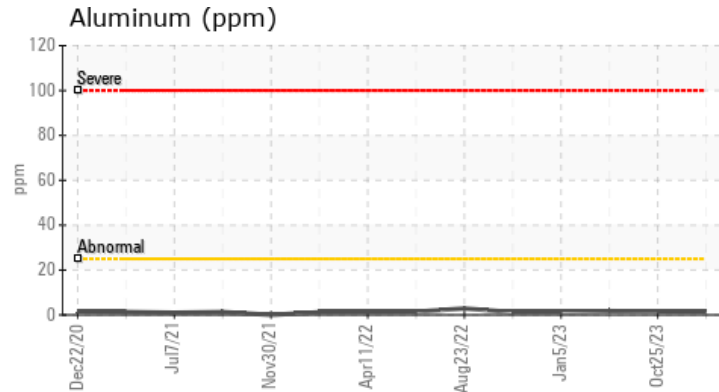
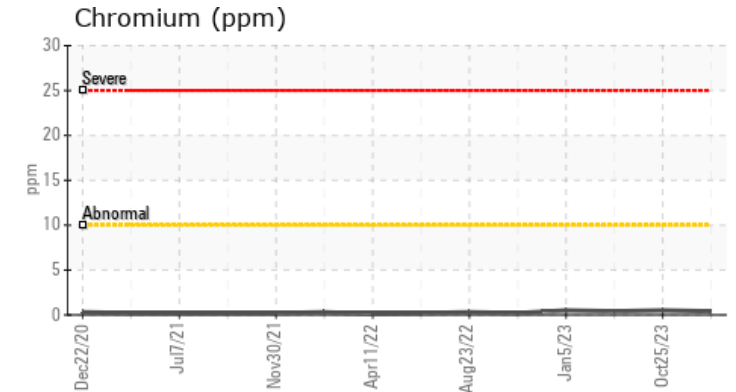
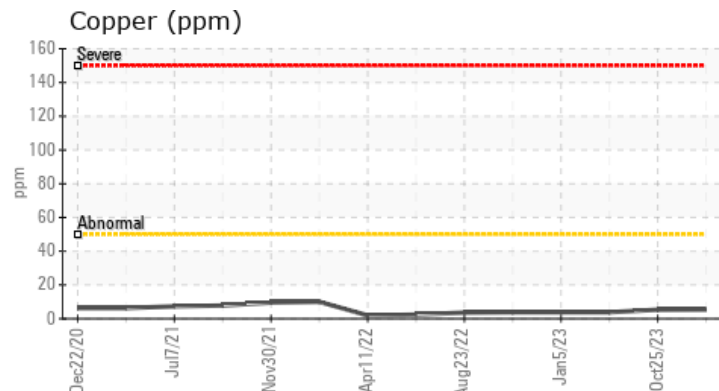
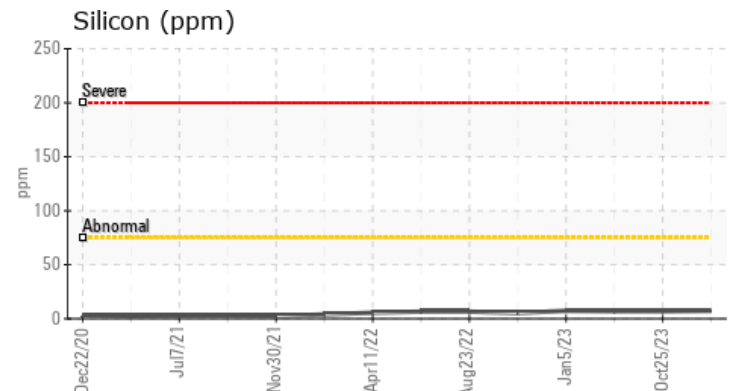
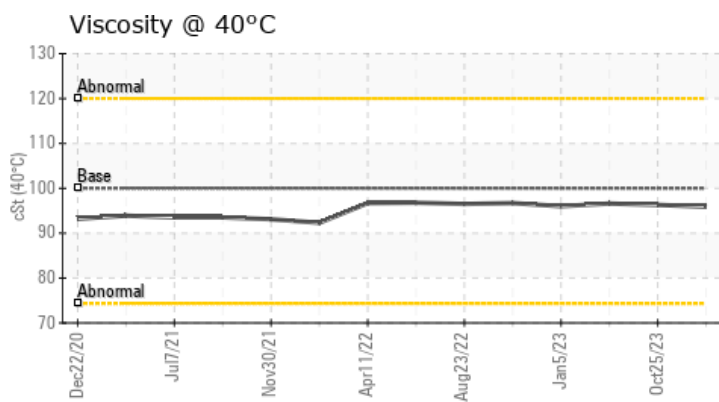
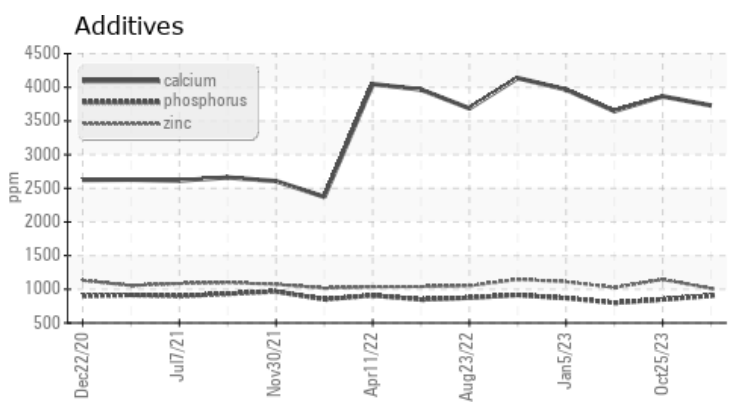
GRAPHS

Resample at the next service interval to monitor. All component wear rates are normal. There is no indication of any contamination in the oil. The condition of the oil is acceptable for the time in service.
