633462 APTIM VOLVO A35G 340227 - TRANSMISSION (AUTO)

Sample No: VCP426181
Oil Type: VOLVO AUTOMATIC TRANSMISSION FLUID AT102
Job No: 633462 APTIM

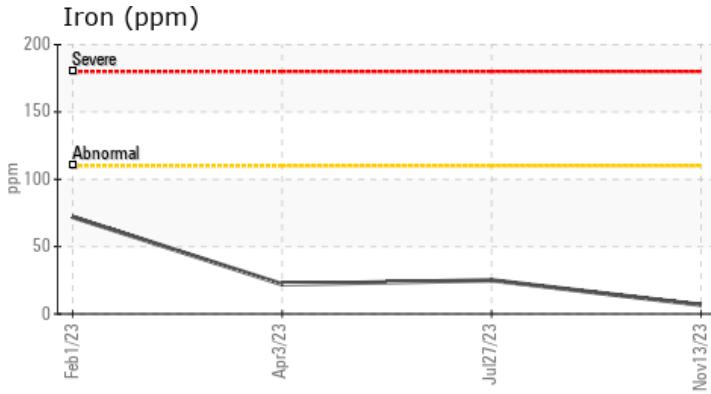
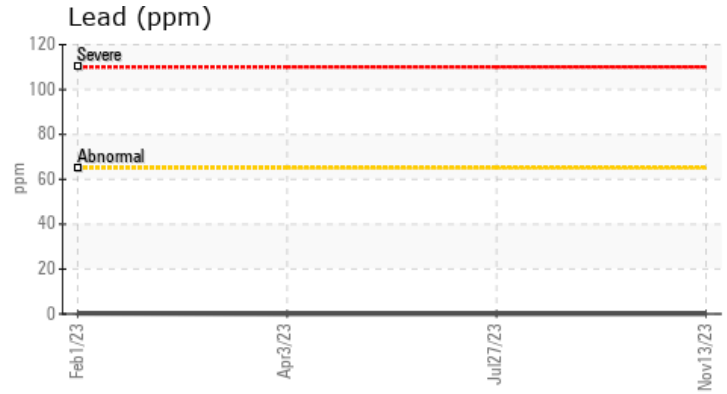
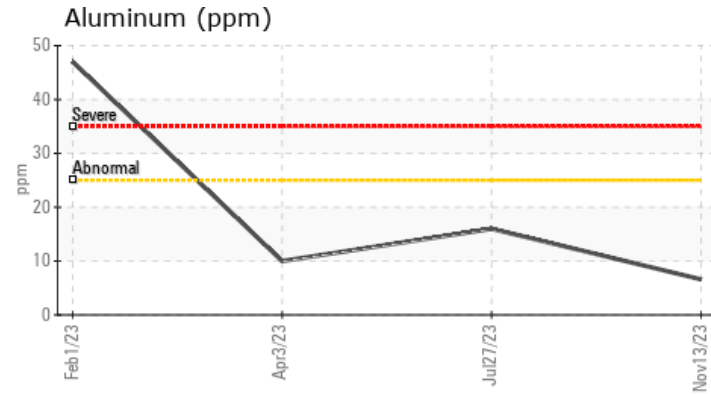
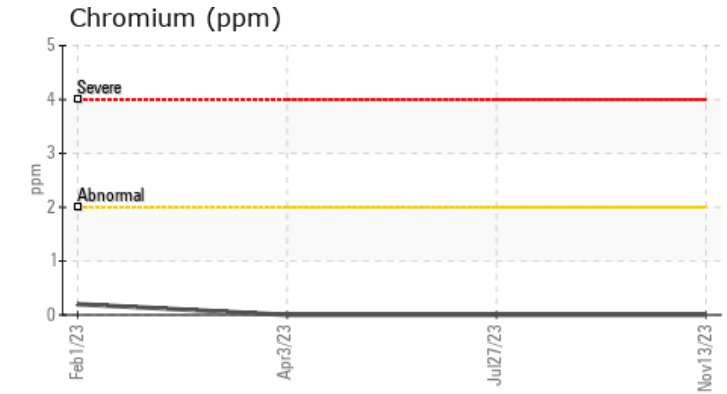
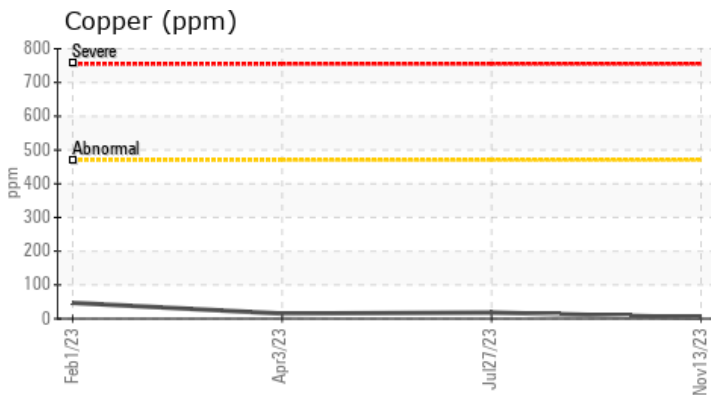
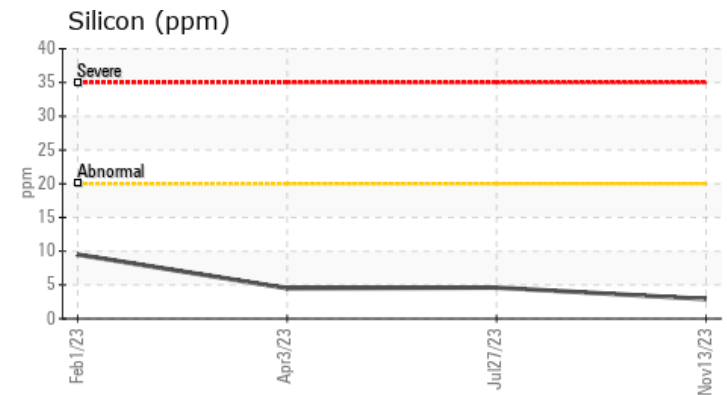
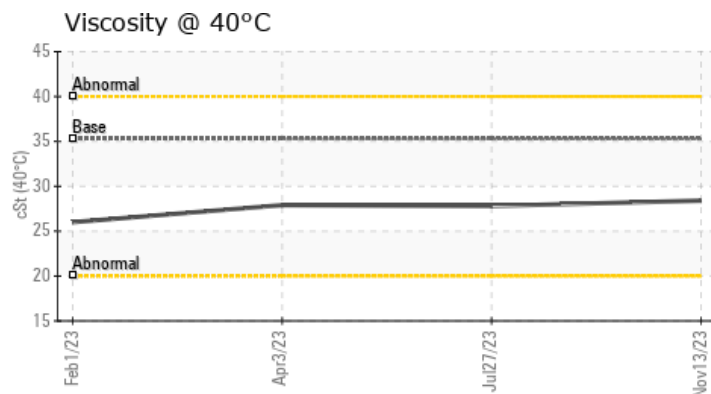
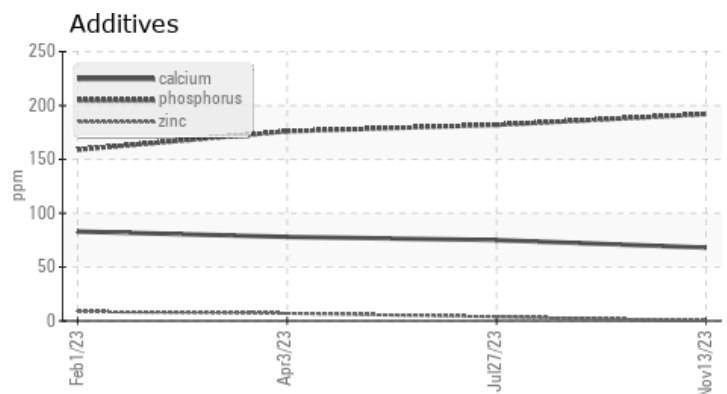
GRAPHS

Resample at the next service interval to monitor. All component wear rates are normal. There is no indication of any contamination in the fluid. The condition of the fluid is acceptable for the time in service.

Iron	ppm	7	25	22	72
Copper	ppm	3	18	15	47
Lead	ppm	0	0	0	<1
Tin	ppm	<1	4	3	11
Aluminum	ppm	7	16	10	▲ 47
Chromium	ppm	0	0	0	<1
Molybdenum	ppm	0	<1	<1	<1
Nickel	ppm	<1	3	2	7
Titanium	ppm	0	0	0	0
Silver	ppm	0	<1	0	0
Manganese	ppm	<1	<1	<1	4
Vanadium	ppm	0	0	0	0
