CONSTRUCTION EQUIPMENT

VOLVO L180H I153 - TRANSMISSION (AUTO)

Sample No: VCP0007956

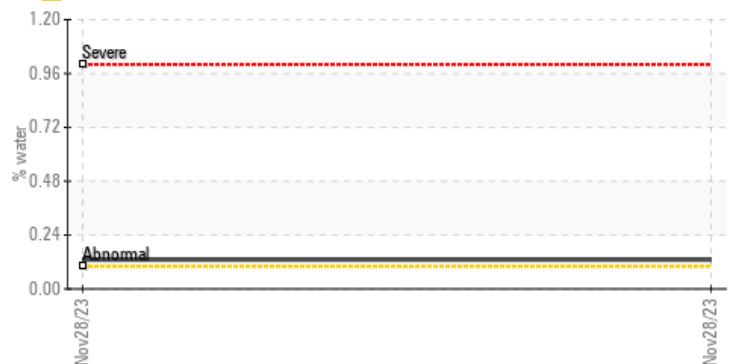
Water

No corrective action is recommended at this time. Resample at the next service interval to monitor. All component wear rates are normal. There is a trace of moisture present in the fluid. The condition of the fluid is acceptable for the time in service.
