CONSTRUCTION EQUIPMENT

SWA412551 VOLVO MCT135C 1640446 - DIESEL ENGINE

Sample No: VCP430843
Oil Type: DIESEL ENGINE OIL SAE 15W40
Job No: SWA412551

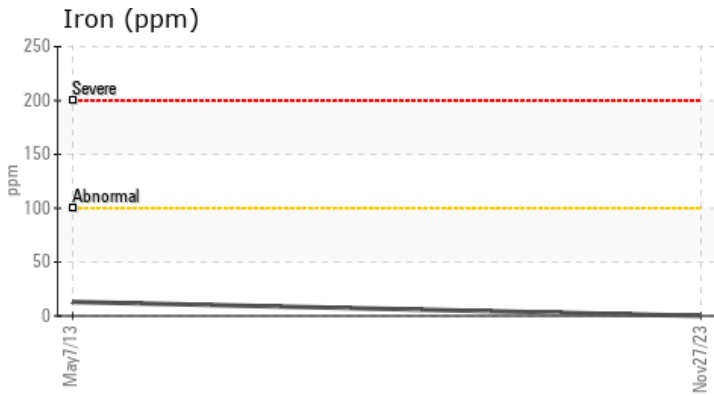
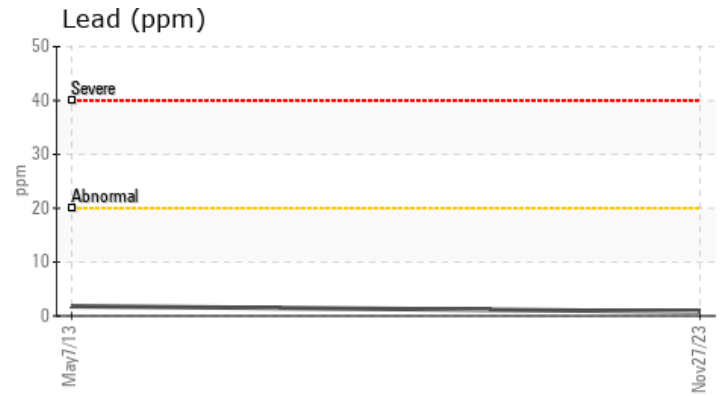
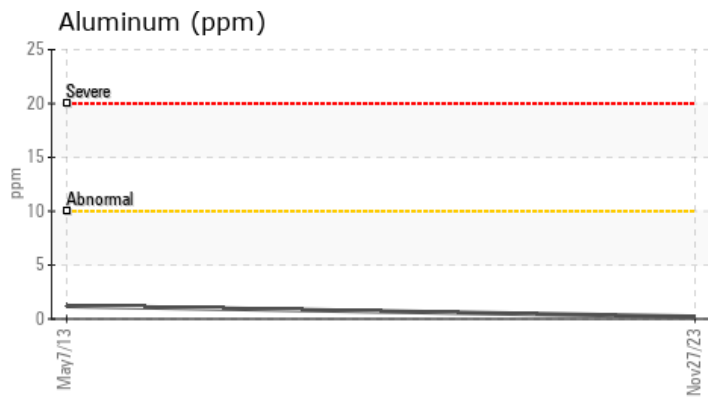
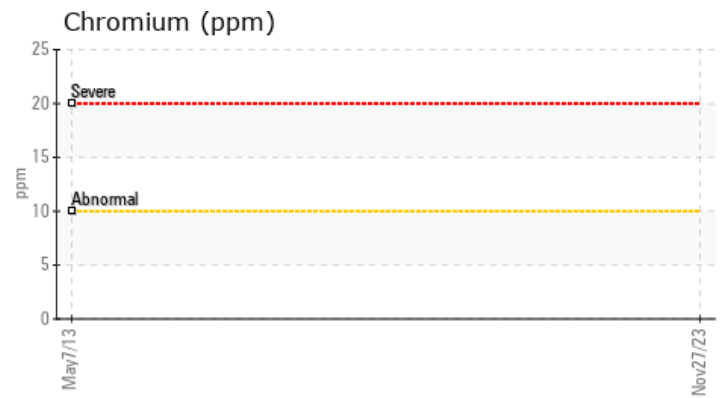
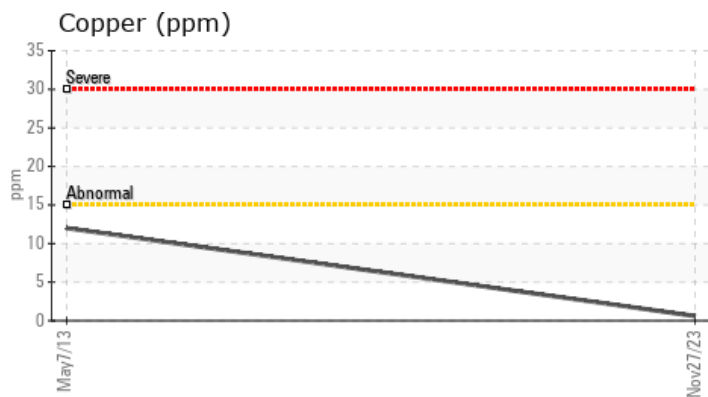
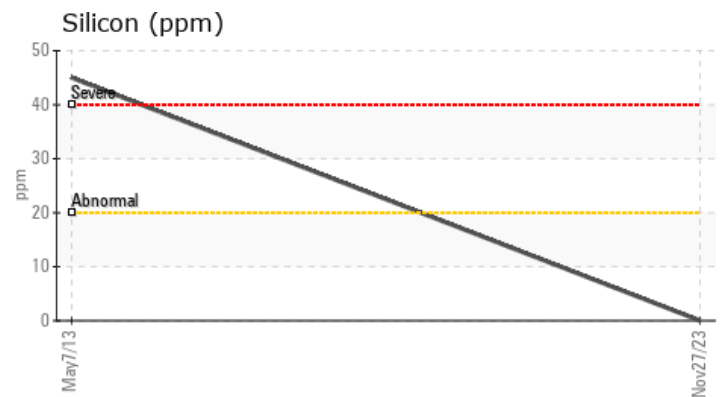
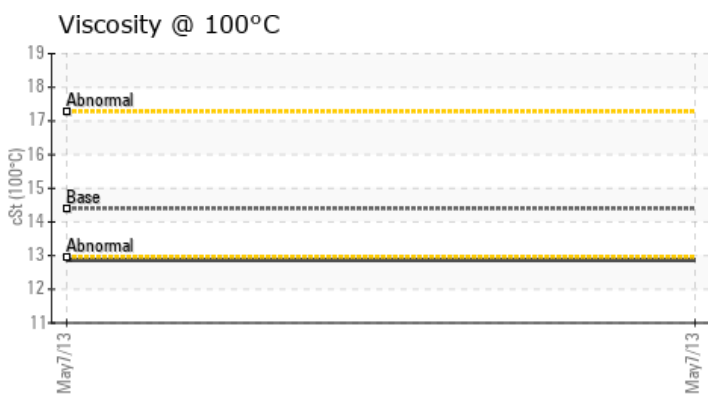
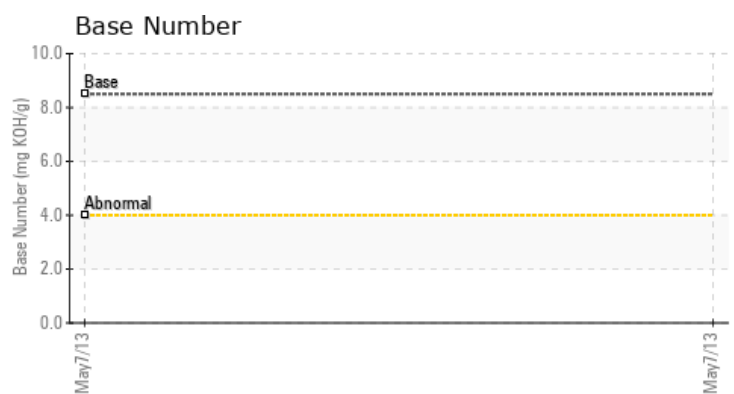
GRAPHS

We recommend that you drain the oil and perform a filter service on this component if not already done. We recommend an early resample to monitor this condition. Please note that there was too much water present in the oil to perform a viscosity test. All component wear rates are normal. Sample consists almost entirely of free water. There is a high concentration of water present in the oil. The oil is no longer serviceable due to the presence of contaminants.
