CONSTRUCTION EQUIPMENT

HERC RENTALS VOLVO ECR145EL 315866 - DIESEL ENGINE

Sample No: VCP436218
Oil Type: DIESEL ENGINE OIL SAE 40
Job No: HERC RENTALS

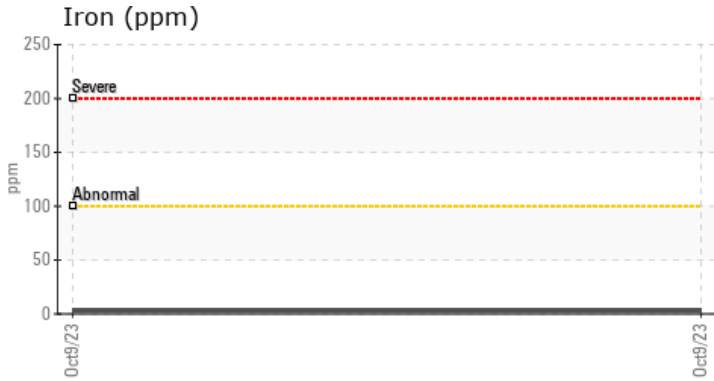
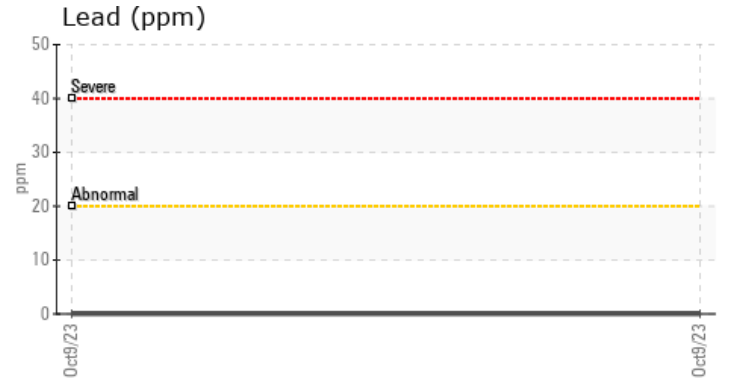
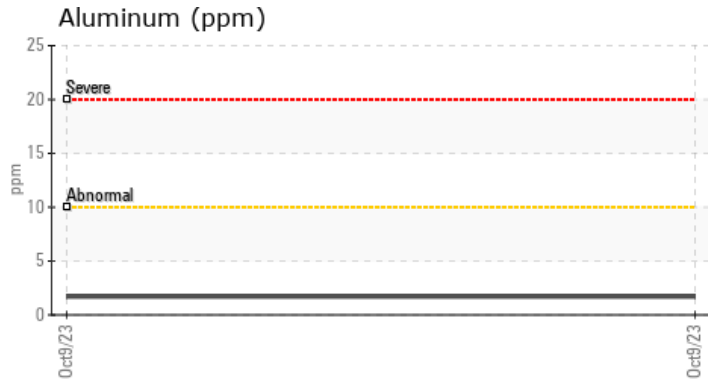
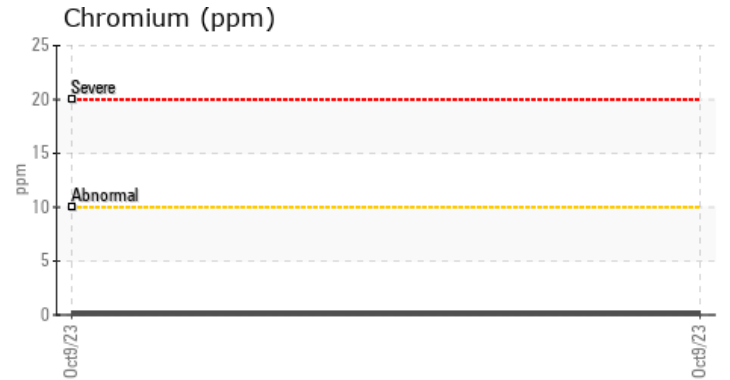
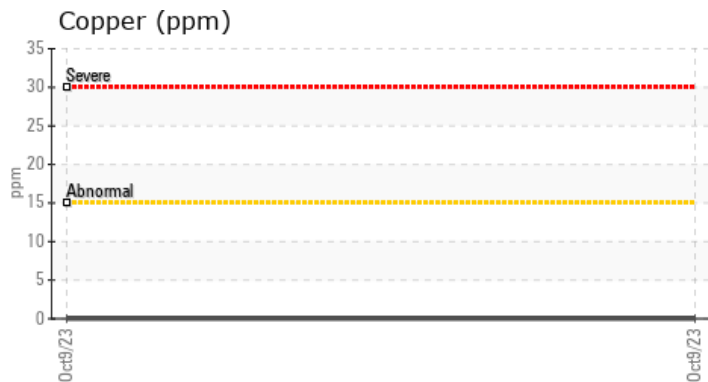
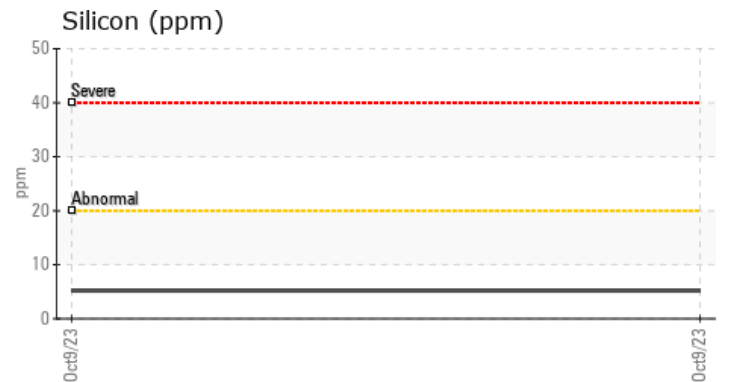
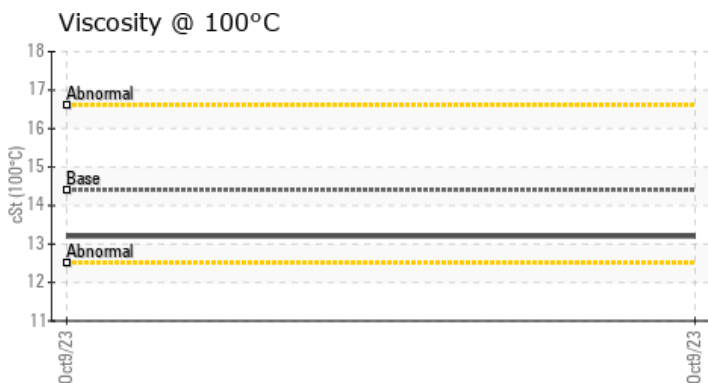
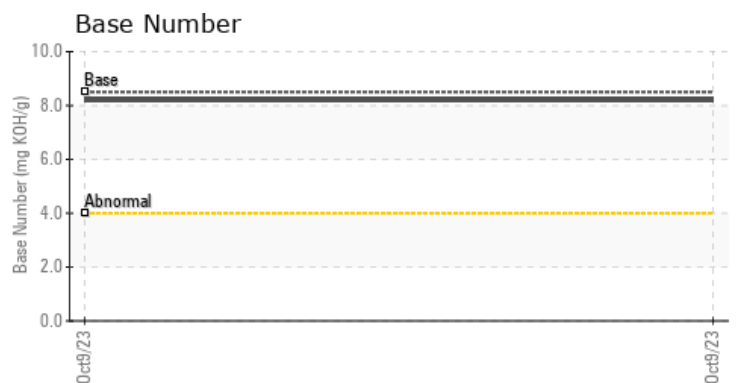
GRAPHS

Resample at the next service interval to monitor. The fluid was not specified, however, a fluid match indicates that this fluid is (GENERIC) DIESEL ENGINE OIL SAE 40. Please confirm.
Metal levels are typical for a new component breaking in. There is no indication of any contamination in the oil. The BN result indicates that there is suitable alkalinity remaining in the oil. The condition of the oil is suitable for further service.
