SW1027392 CUSTOM LS VOLVO L220H 3310 - TRANSMISSION

Sample No: VCP441023
Oil Type: ATF
Job No: SW1027392 CUSTOM LS

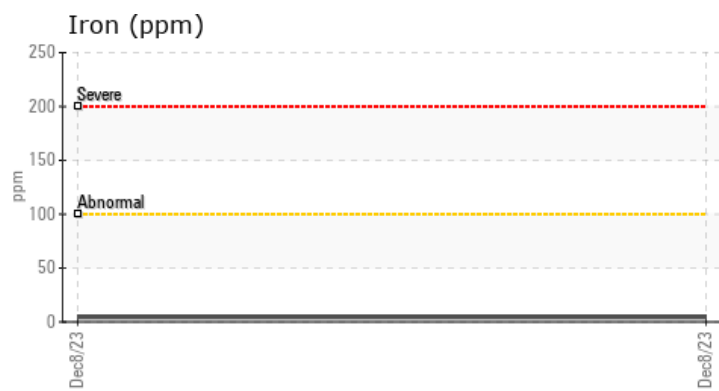
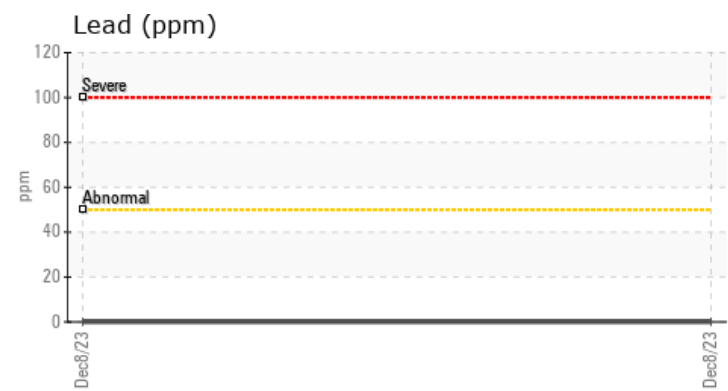
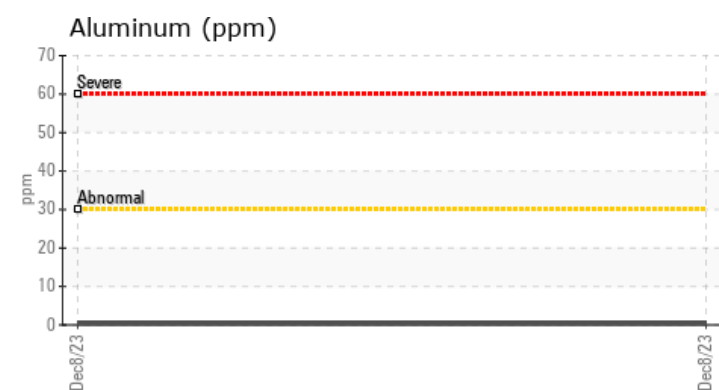
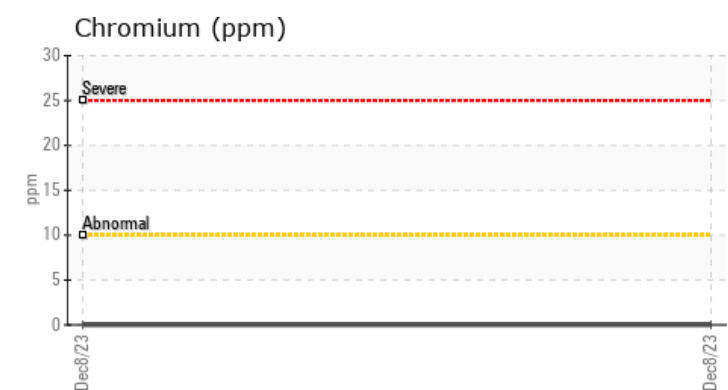
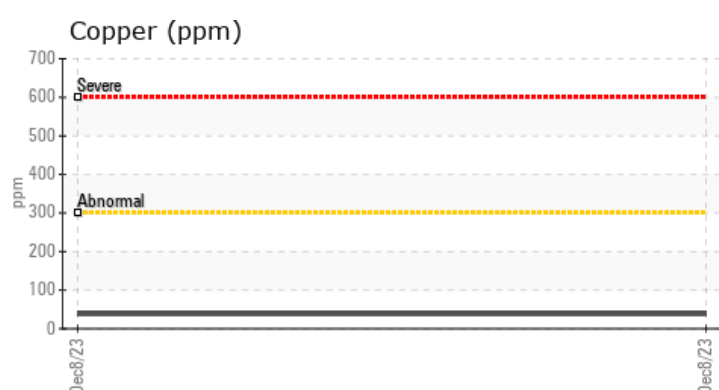
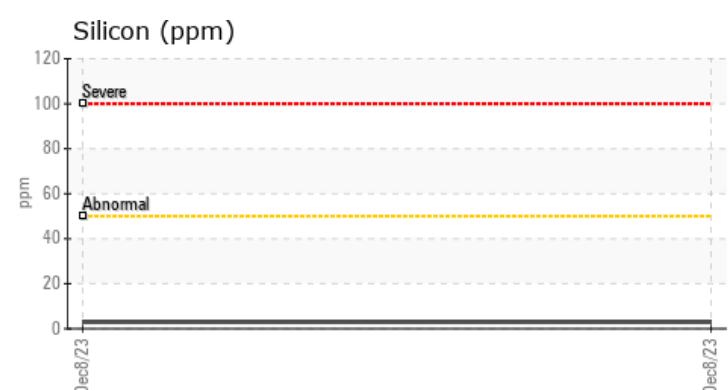
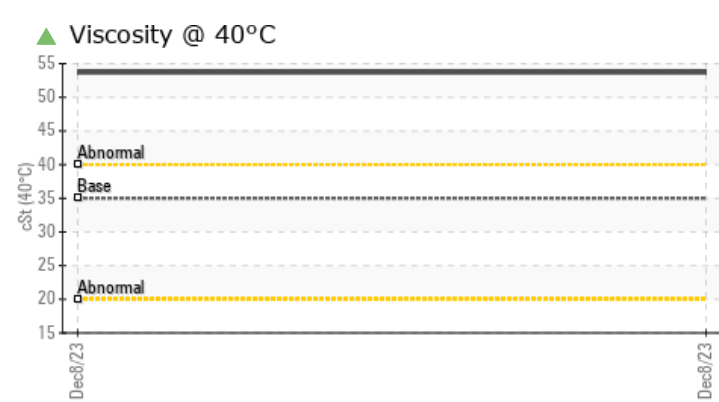
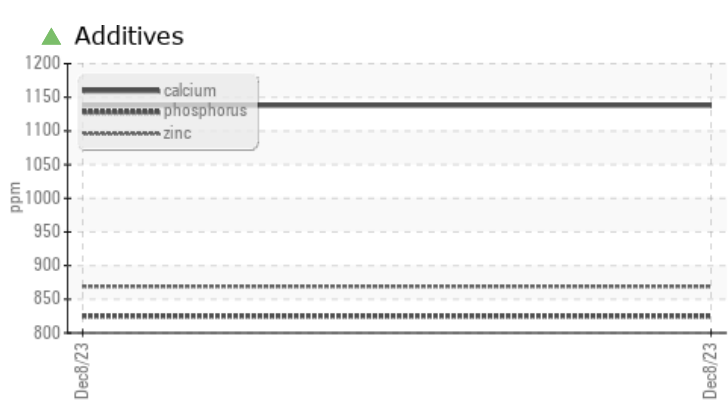
VOLVO GRAPHS

Oil and filter change at the time of sampling has been noted. Resample at the next service interval to monitor. All component wear rates are normal. There is no indication of any contamination in the fluid. The fluid viscosity is higher than normal. Additive levels indicate the addition of a different brand, or type of fluid. Confirm oil type.
