WASTE CONNECTION VOLVO L150H 7103 - TRANSMISSION (AUTO)

Sample No: VCP432205
Oil Type: VOLVO AT 102
Job No: WASTE CONNECTION

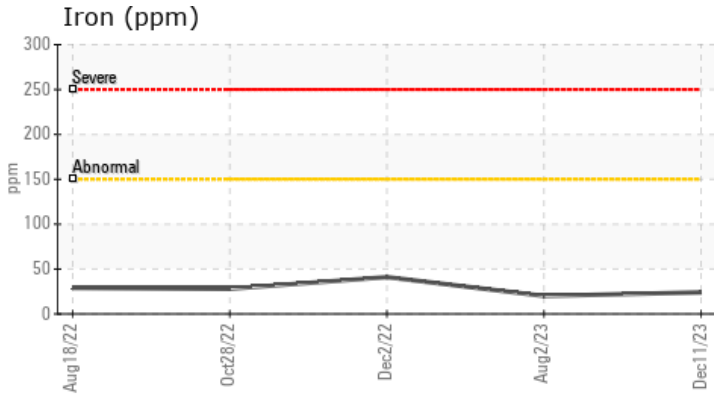
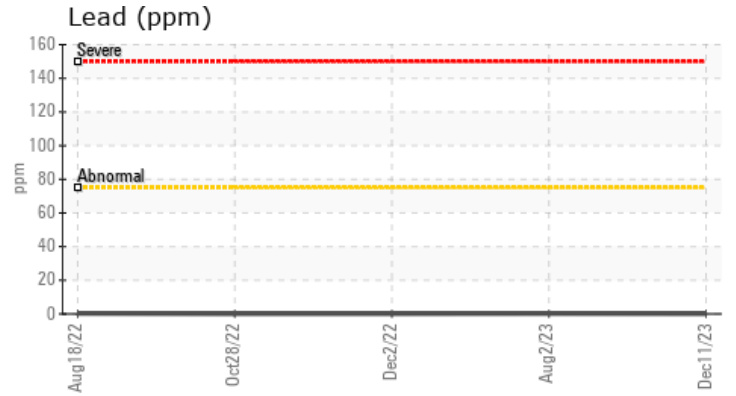
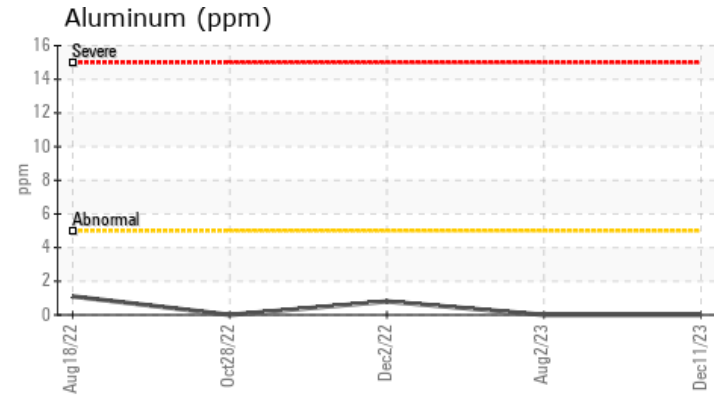
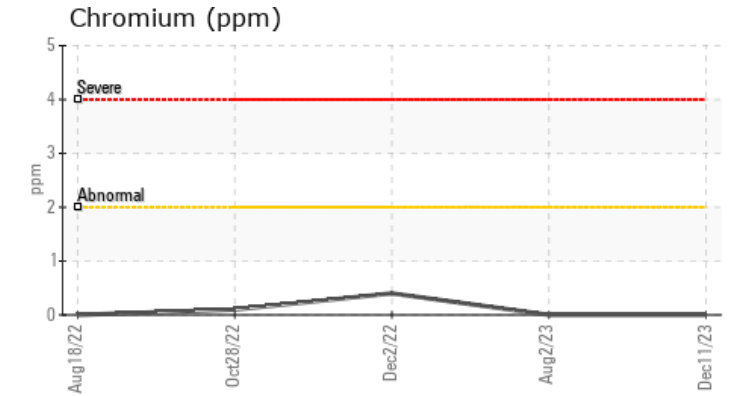
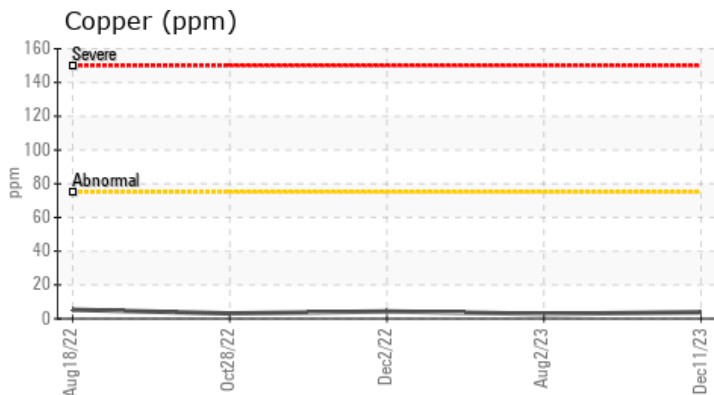
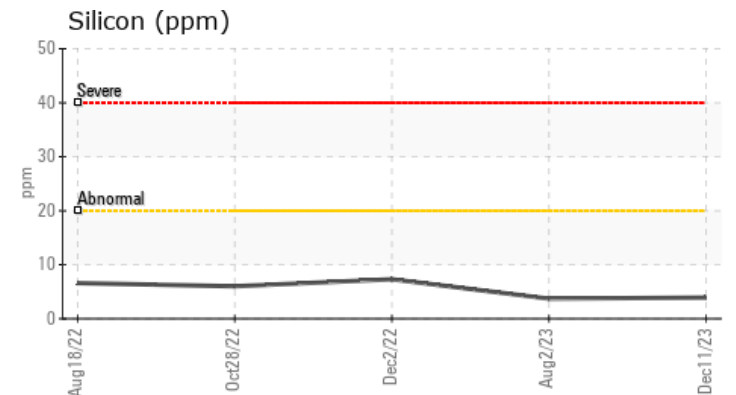
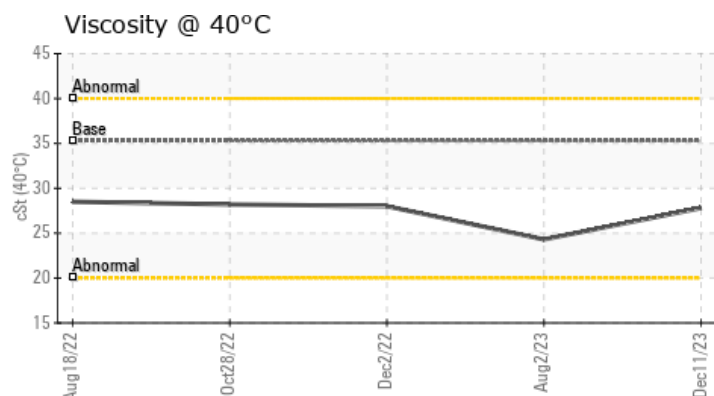
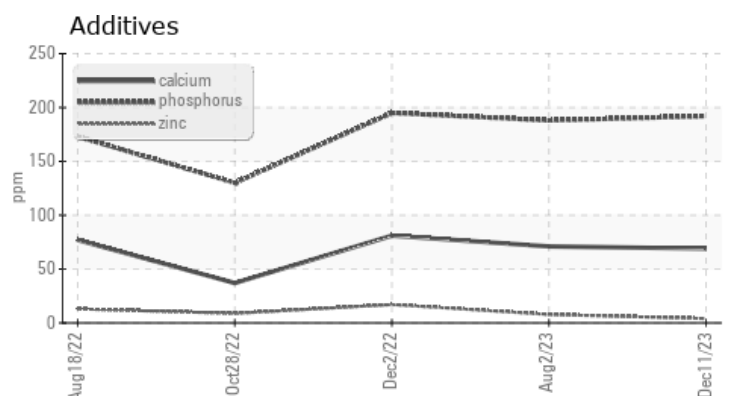
VOLVO GRAPHS

Resample at the next service interval to monitor. All component wear rates are normal. There is no indication of any contamination in the fluid. The condition of the fluid is acceptable for the time in service.
