CONSTRUCTION EQUIPMENT

ROWE FENCE TAKEUCHI TL8 200803881 - DIESEL ENGINE

Sample No: VCP447957
Oil Type: DIESEL ENGINE OIL SAE 15W40
Job No: ROWE FENCE

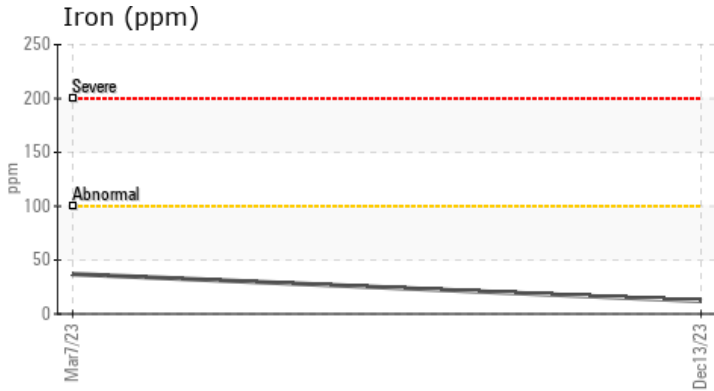
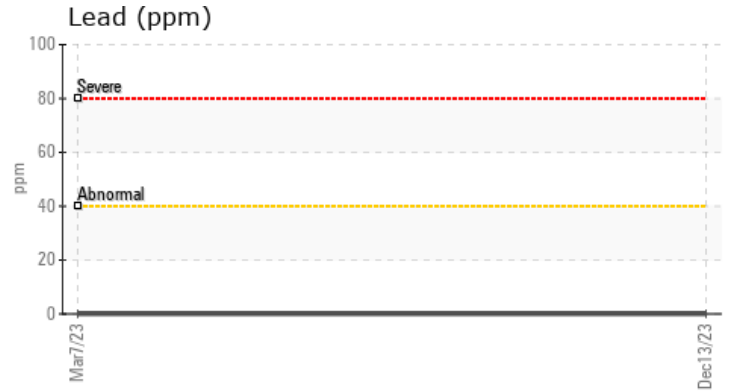
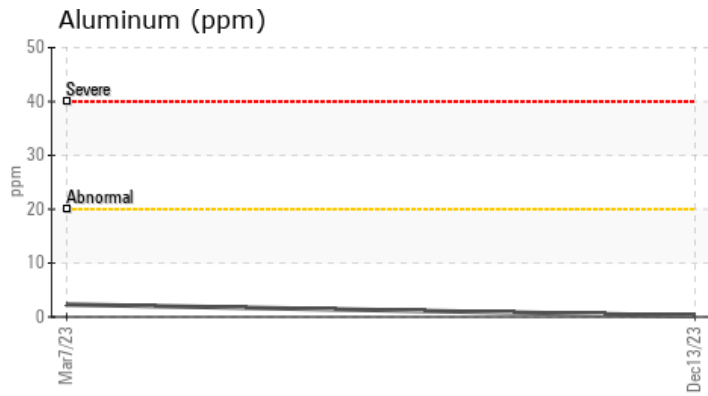
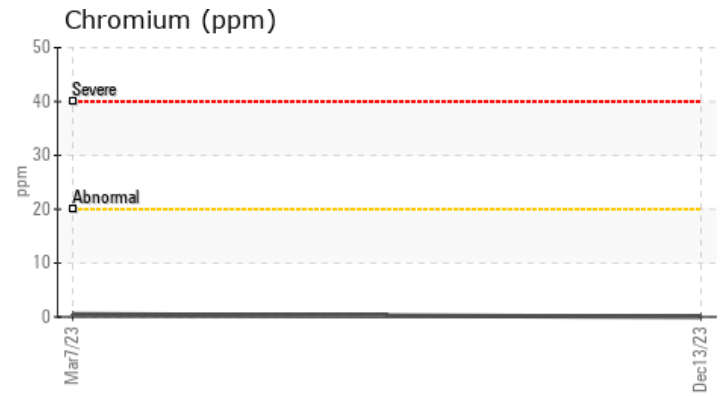
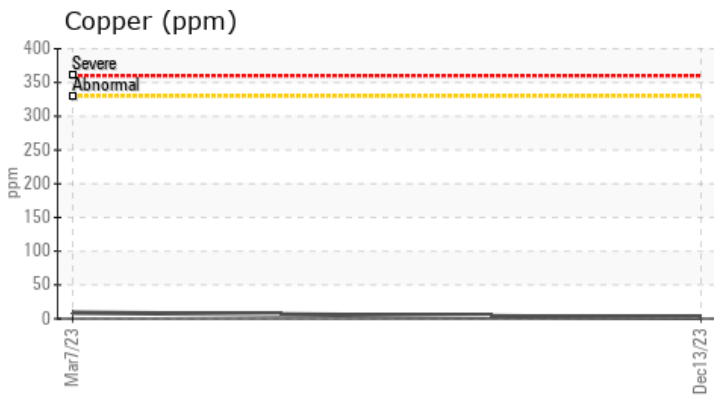
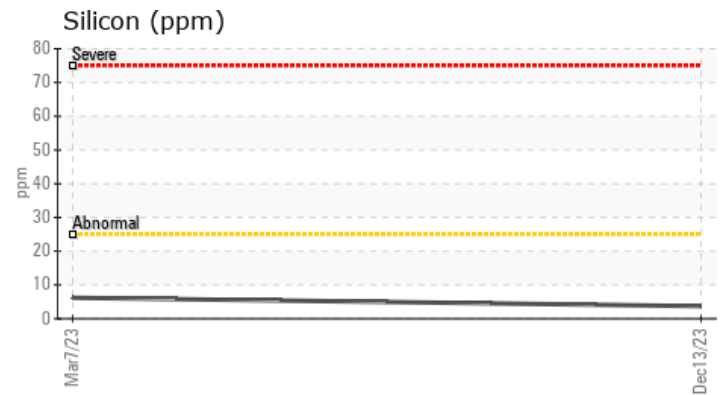
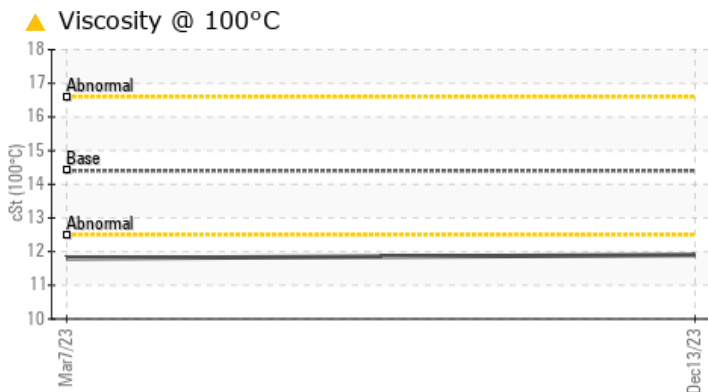
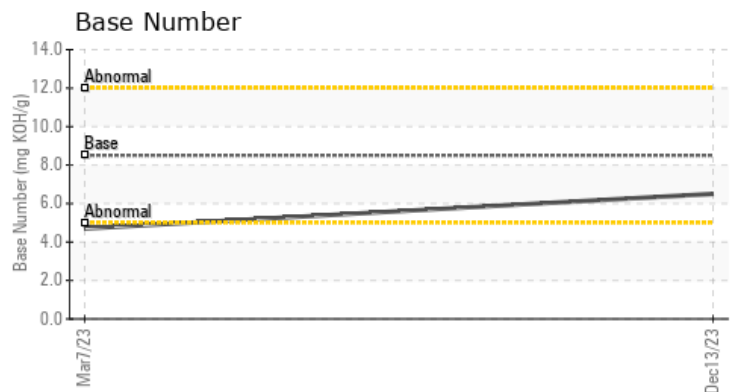
GRAPHS

The oil change at the time of sampling has been noted. We recommend an early resample to monitor this condition. All component wear rates are normal. There is a moderate amount of fuel present in the oil. Tests confirm the presence of fuel in the oil. The BN result indicates that there is suitable alkalinity remaining in the oil. The oil is no longer serviceable due to the presence of contaminants.
