CONSTRUCTION EQUIPMENT

633427 VOLVO L260H 1296 - TRANSMISSION (AUTO)

Sample No: VCP431785
Oil Type: VOLVO AT 102
Job No: 633427

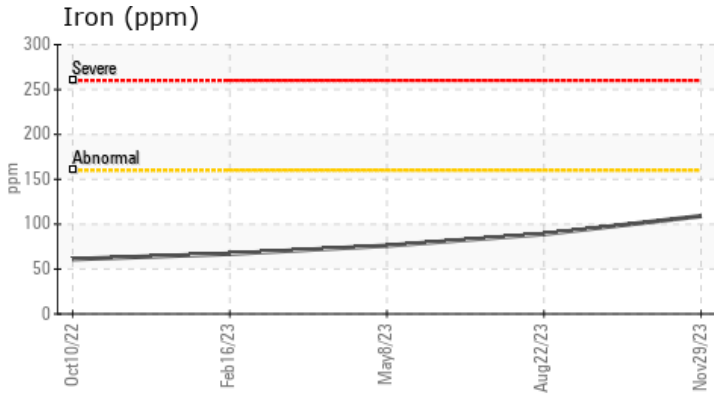
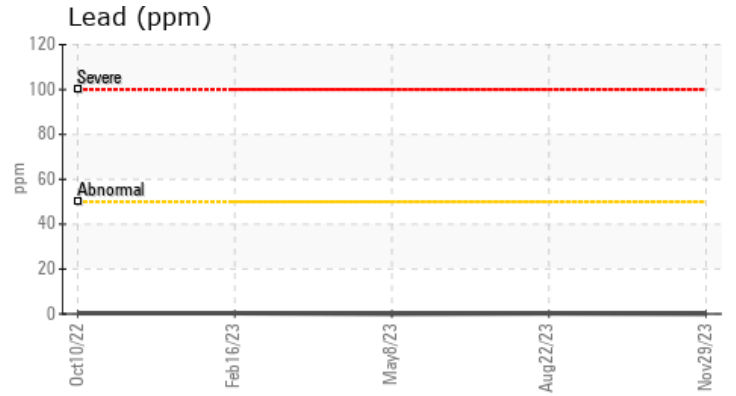
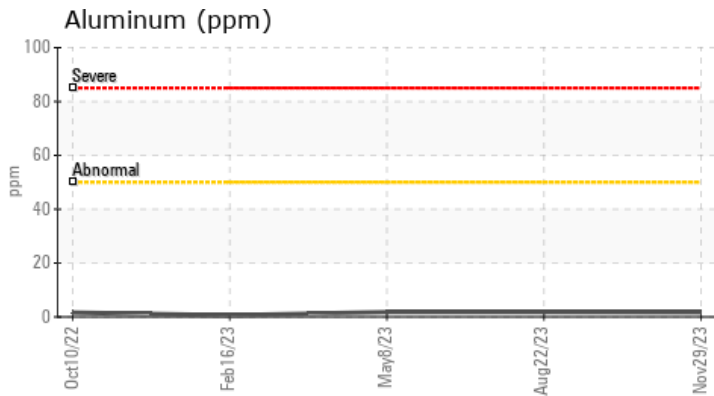
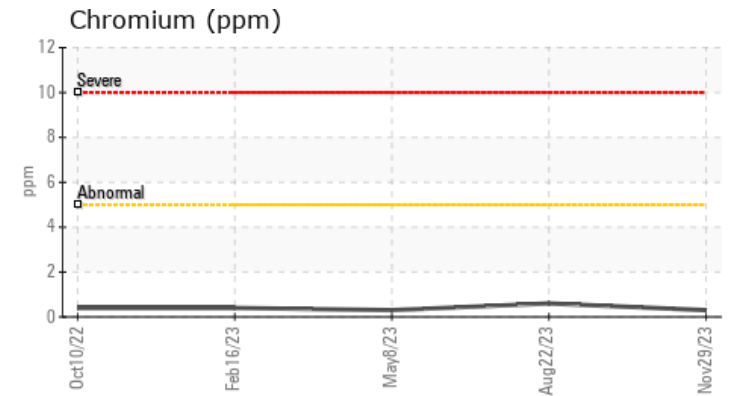
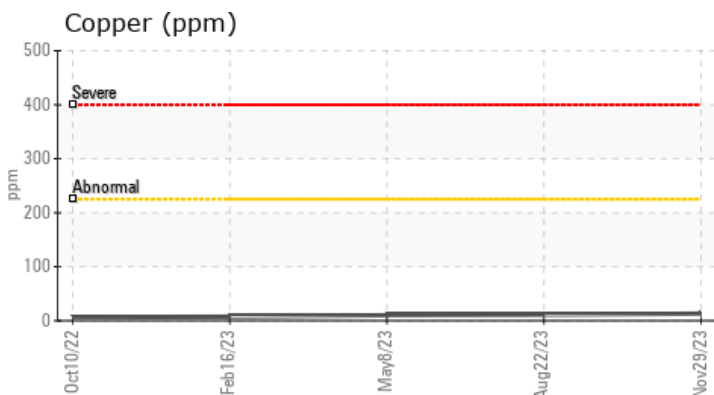
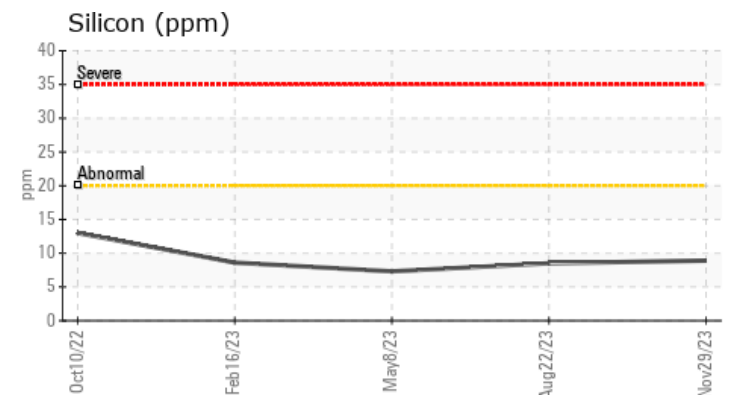
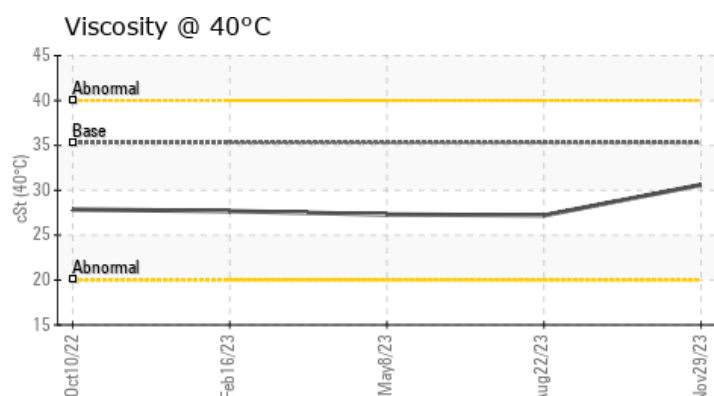
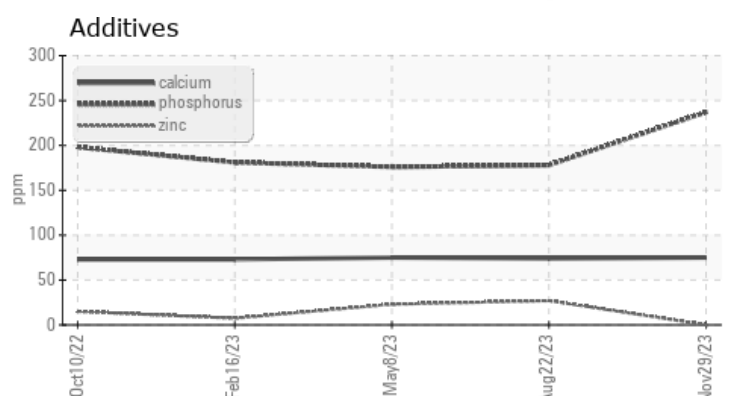
VOLVO GRAPHS

Resample at the next service interval to monitor. All component wear rates are normal. There is no indication of any contamination in the fluid. The condition of the fluid is acceptable for the time in service.
