# CONSTRUCTION EQUIPMENT

## 659877 VOLVO L120H 632860 - TRANSMISSION (AUTO)

**Sample No:** VCP437447  
**Oil Type:** VOLVO AT 102  
**Job No:** 659877

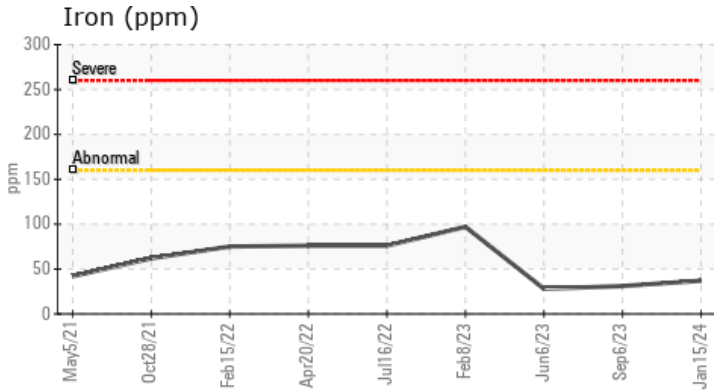
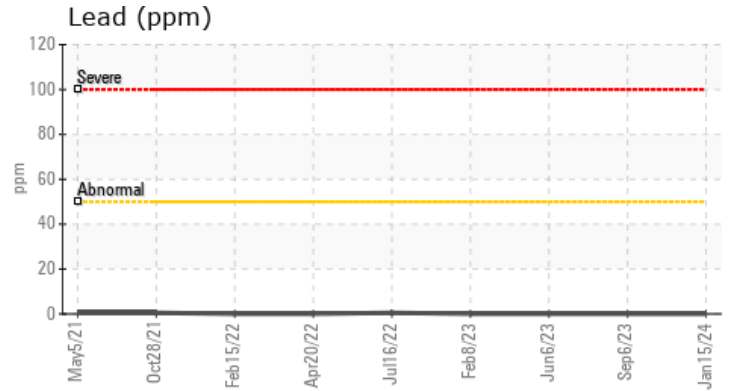
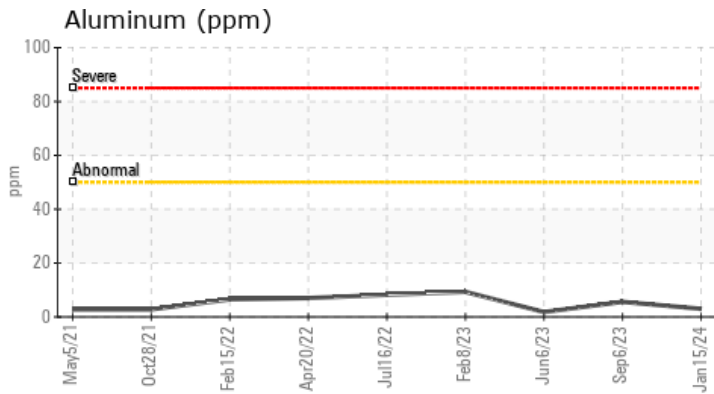
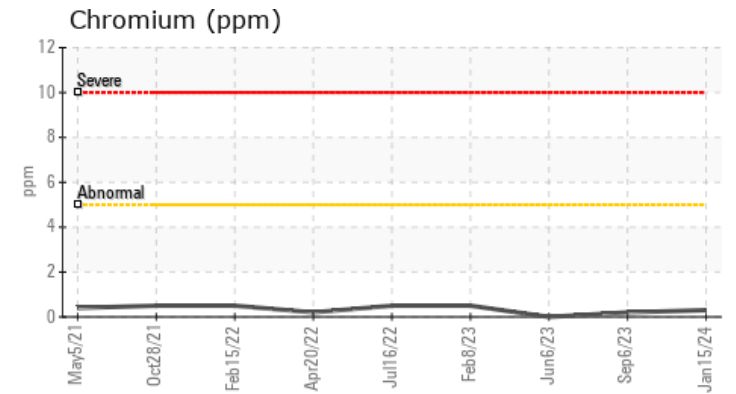
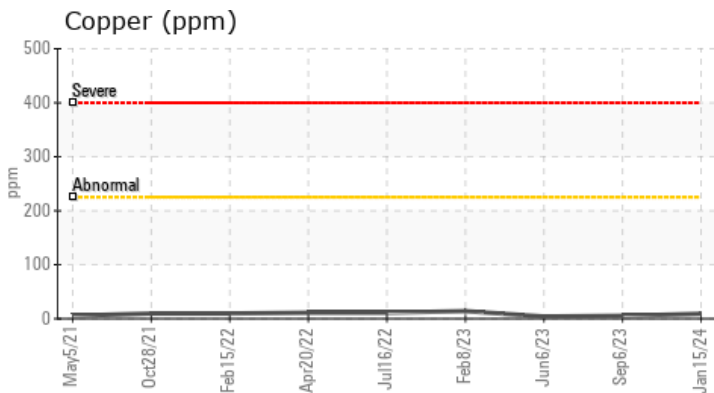
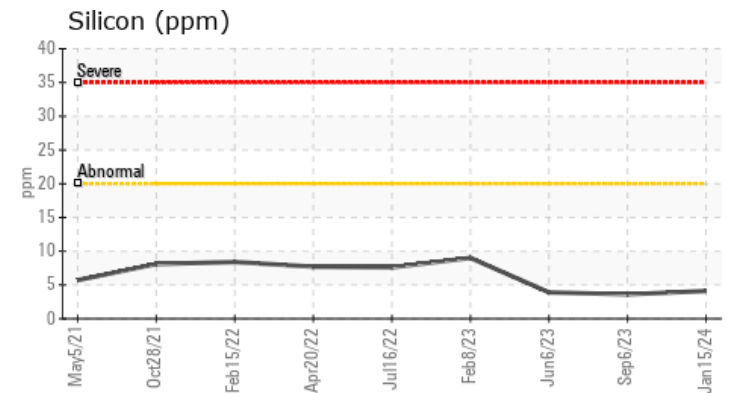
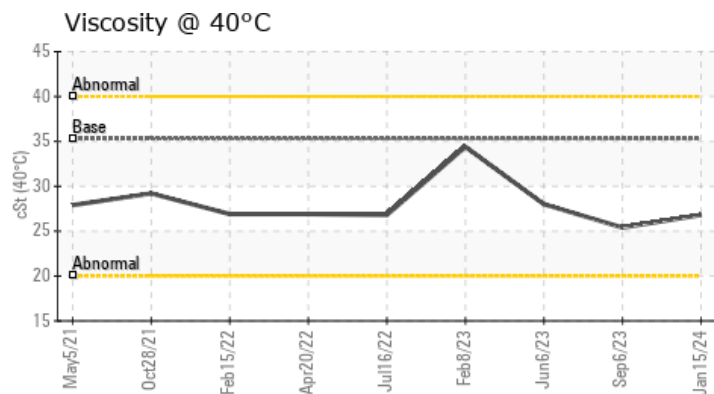
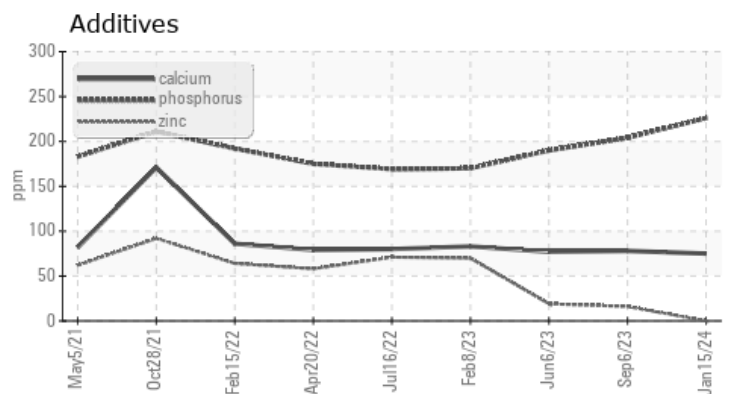
## VOLVO GRAPHS

Resample at the next service interval to monitor. All component wear rates are normal. There is no indication of any contamination in the fluid. The condition of the fluid is acceptable for the time in service.
