CONSTRUCTION EQUIPMENT

CATERPILLAR M-2 - REAR AXLE

Sample No: VCP442898
Oil Type: MOBIL MOBILTRANS HD 30
Job No:

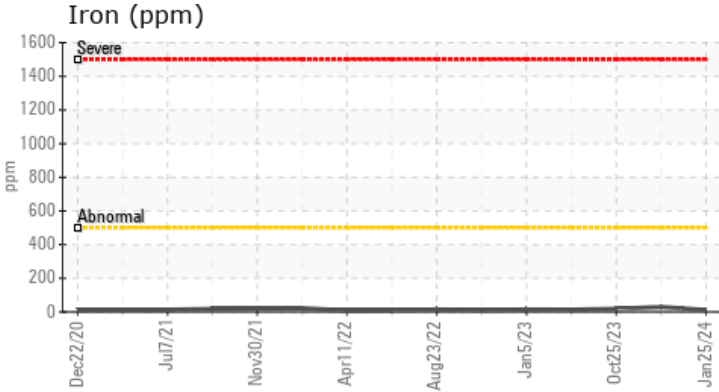
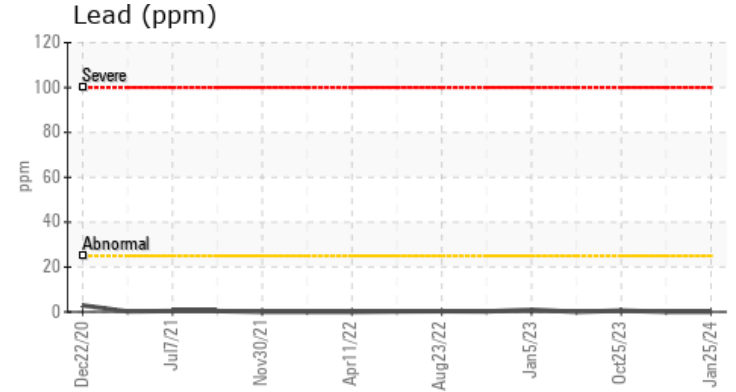
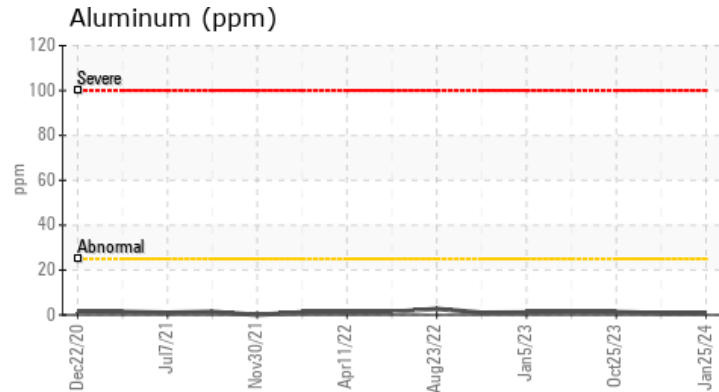
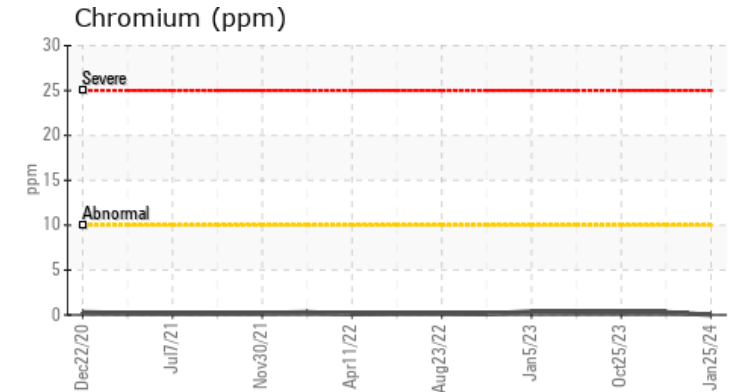
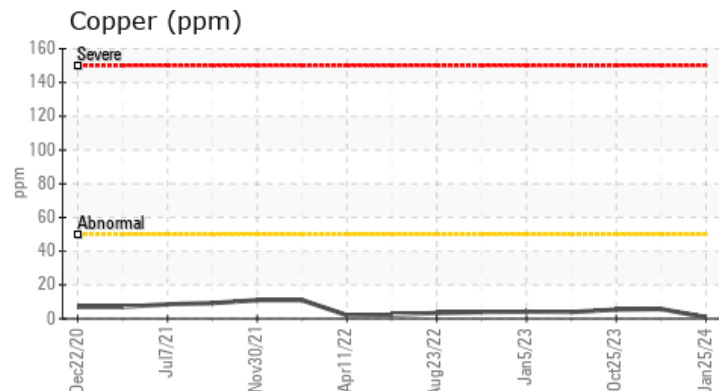
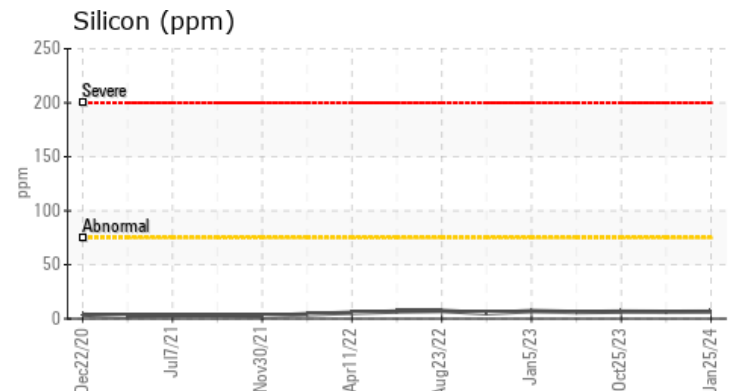
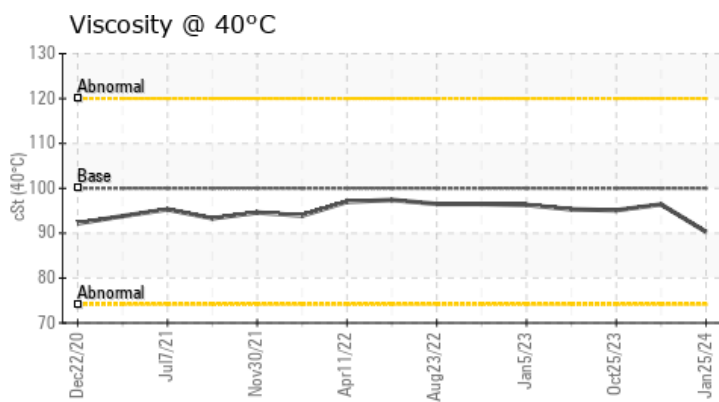
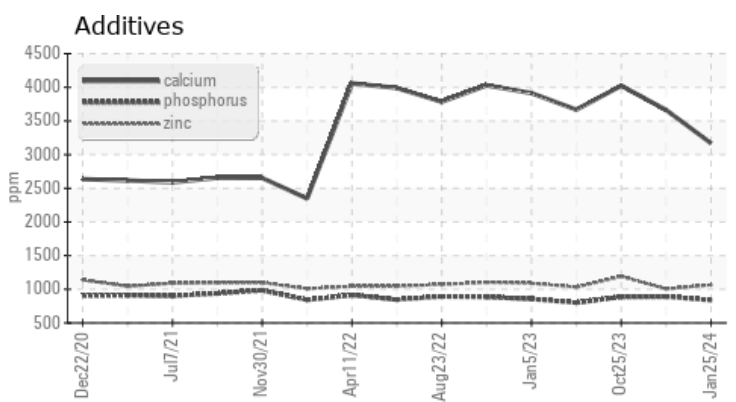
VOLVO GRAPHS

Resample at the next service interval to monitor. All component wear rates are normal. There is no indication of any contamination in the oil. The condition of the oil is acceptable for the time in service.
