661545 VOLVO L120 633396 - TRANSMISSION (AUTO)

Sample No: VCP439087
Oil Type: VOLVO AUTOMATIC TRANSMISSION FLUID AT102
Job No: 661545

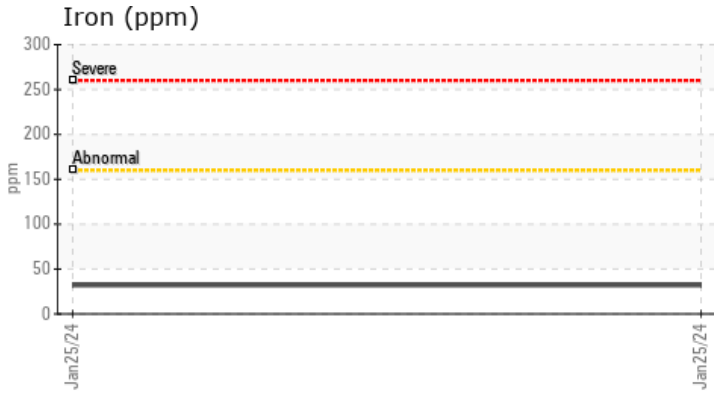
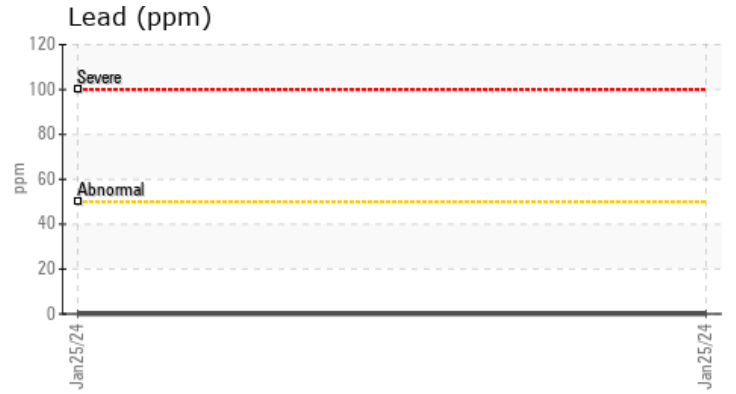
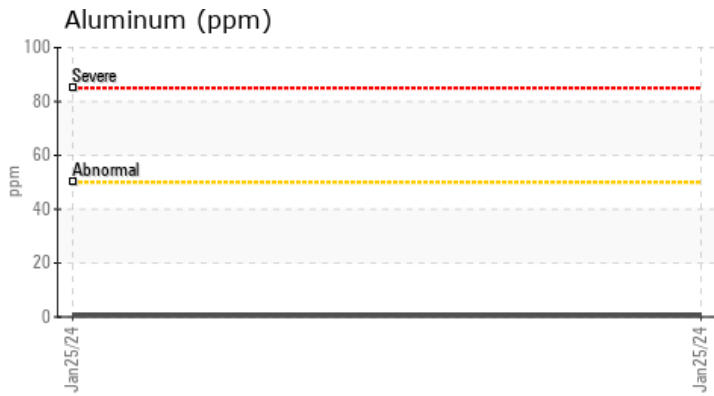
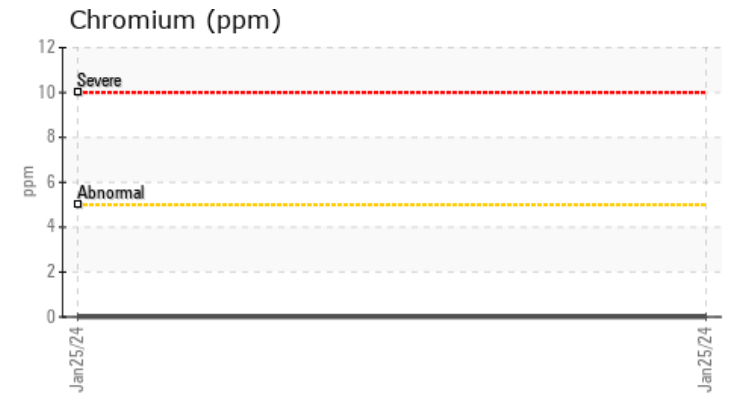
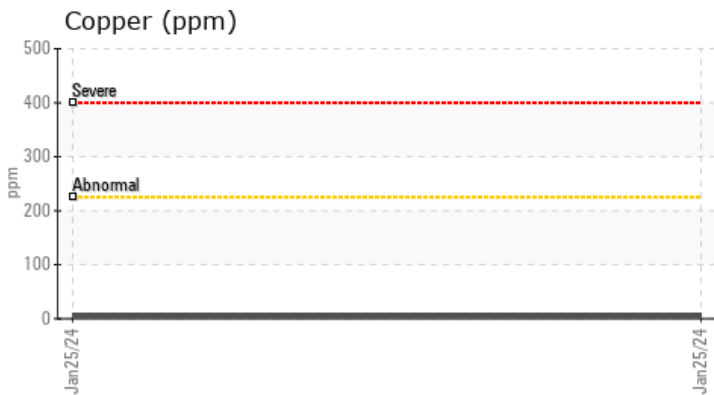
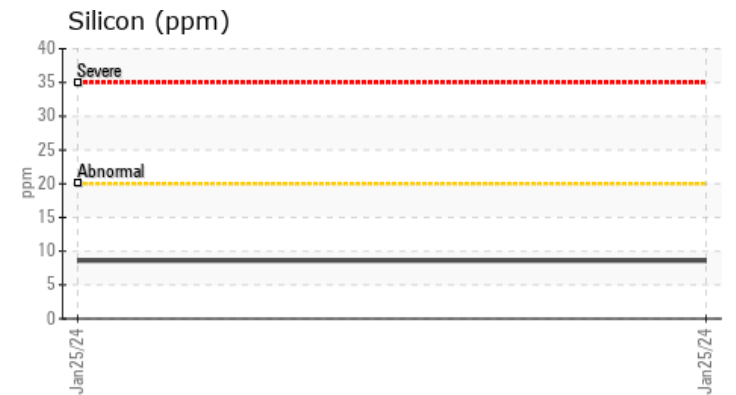
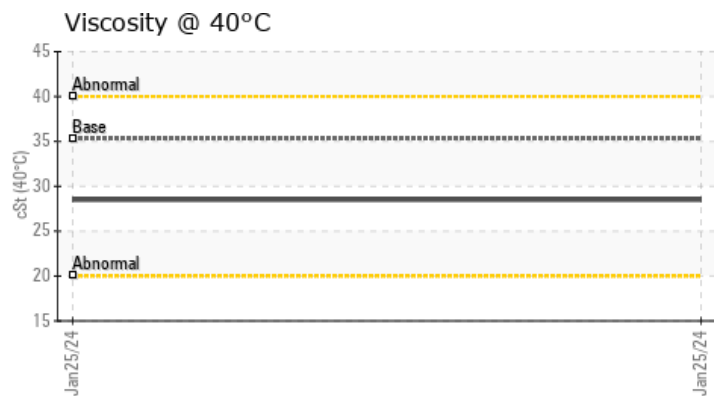
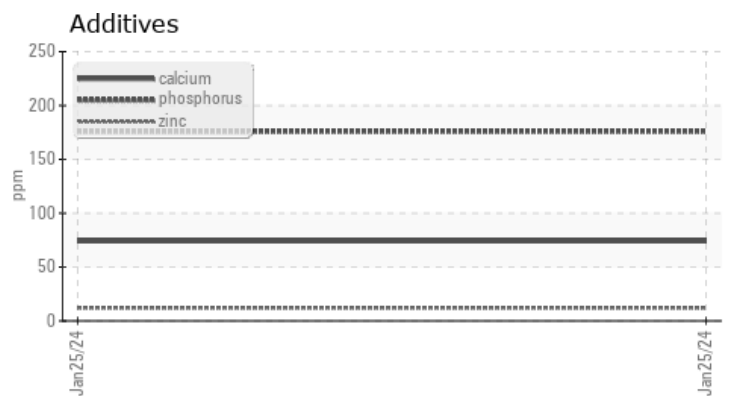
VOLVO GRAPHS

Resample at the next service interval to monitor. All component wear rates are normal. There is no indication of any contamination in the fluid. The condition of the fluid is acceptable for the time in service.
