## 469737 WATER FRONT VOLVO A40G 342355 - DROP BOX

**Sample No:** VCP441648  
**Oil Type:** VOLVO PREMIUM GEAR OIL 85W-140 GL-5  
**Job No:** 469737 WATER FRONT

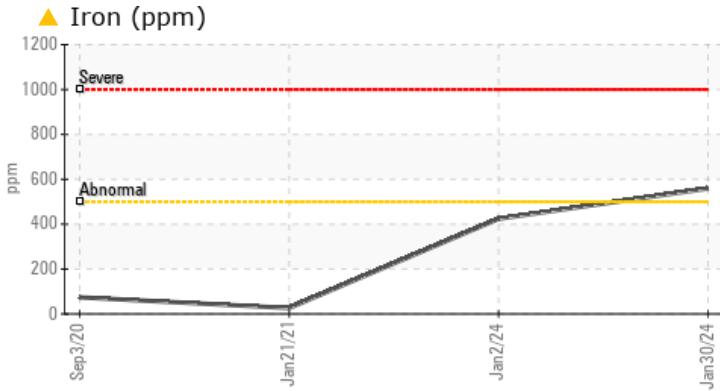
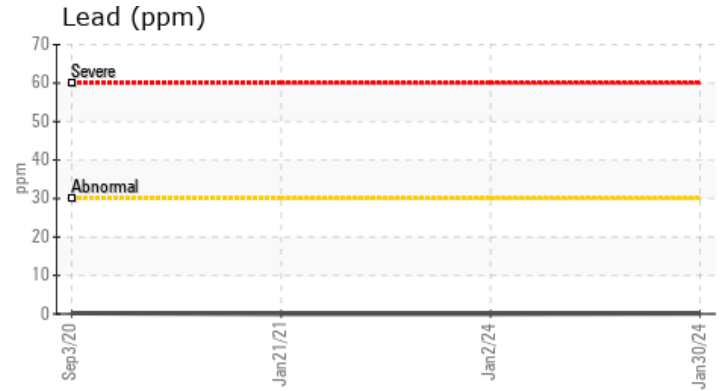
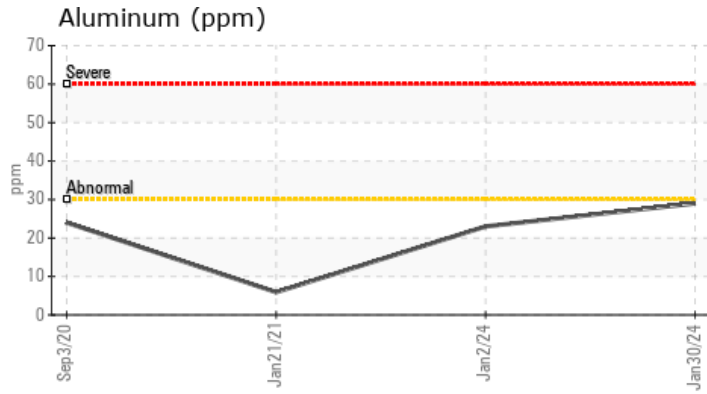
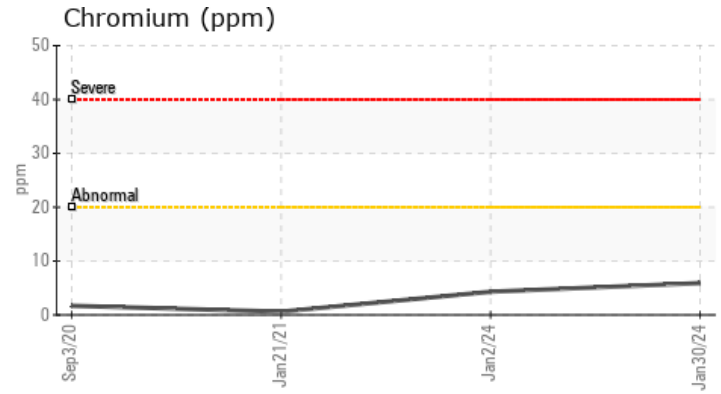
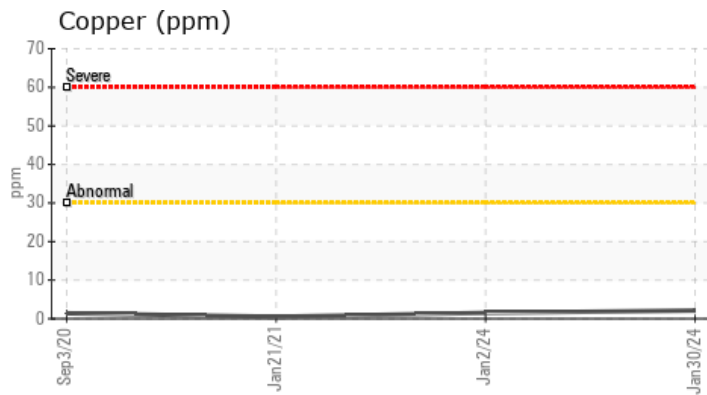
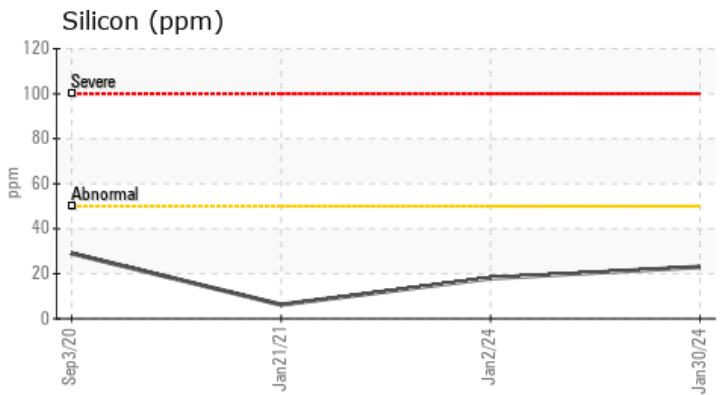
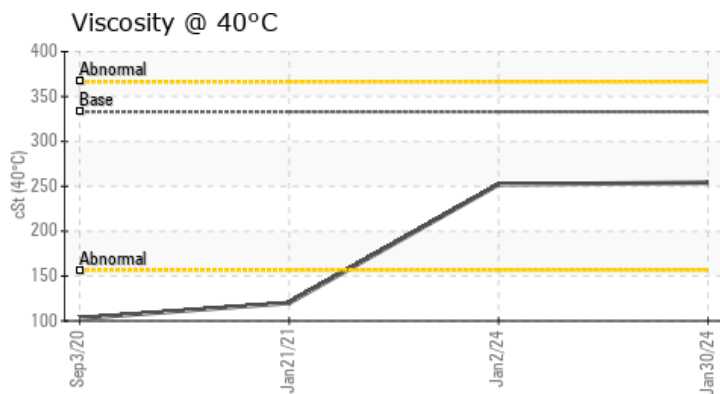
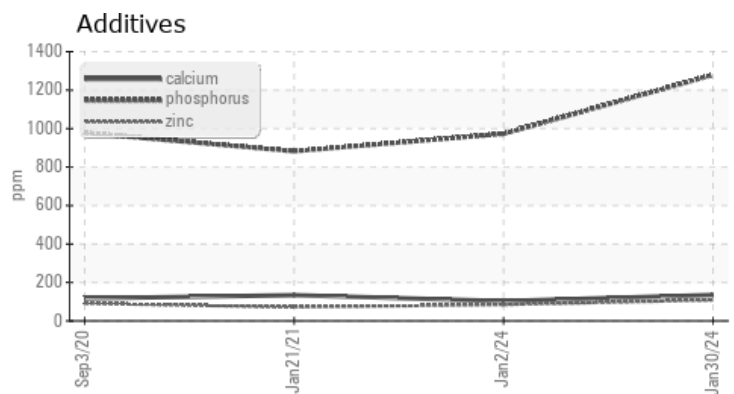
## GRAPHS

The oil change at the time of sampling has been noted. No corrective action is recommended at this time. Resample at the next service interval to monitor. Gear wear is indicated. All other component wear rates are normal. There is no indication of any contamination in the oil. The condition of the oil is acceptable for the time in service.
