# CONSTRUCTION EQUIPMENT

## VOLVO L220H 3440 - DIESEL ENGINE

**Sample No:** VCP432423  
**Oil Type:** SHELL ROTELLA T3 15W40  
**Job No:**

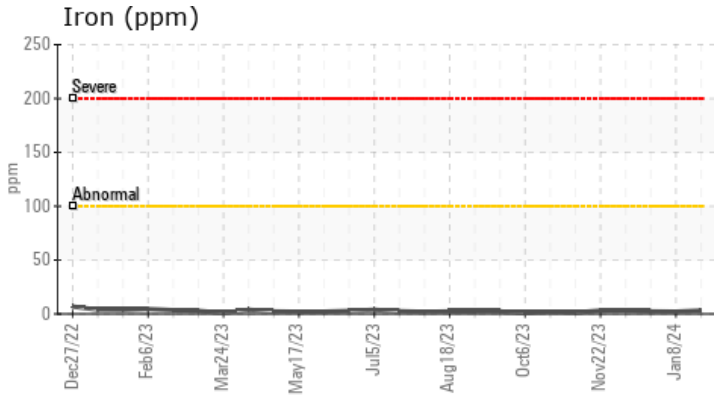
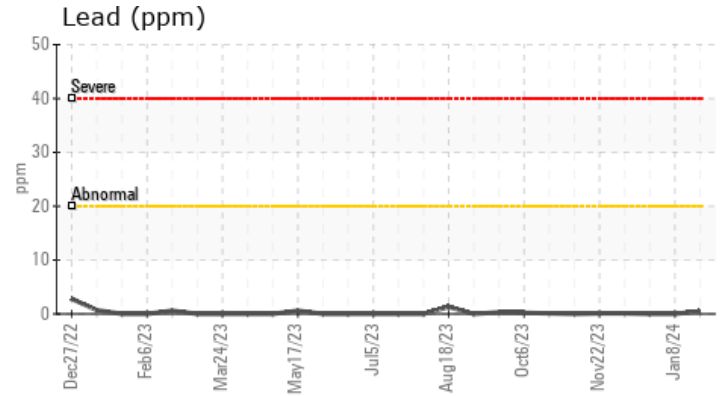
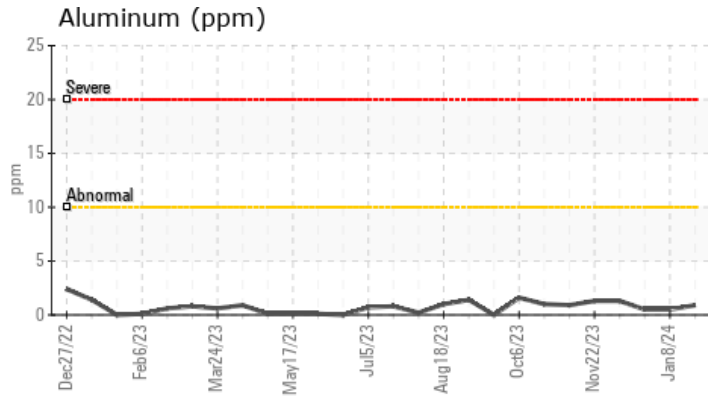
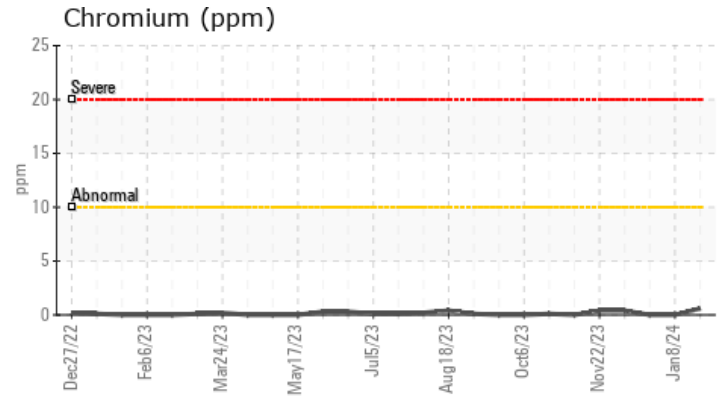
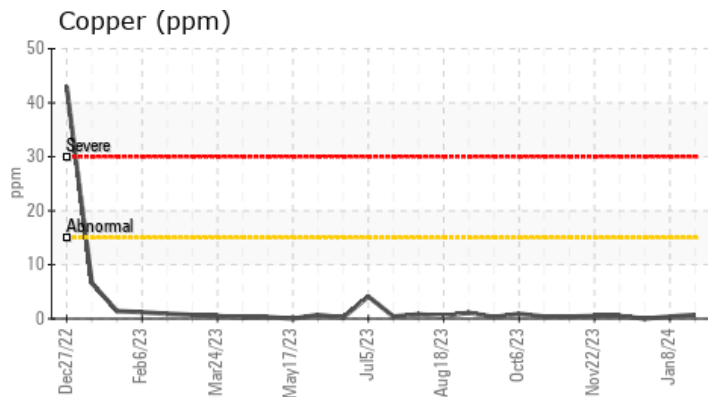
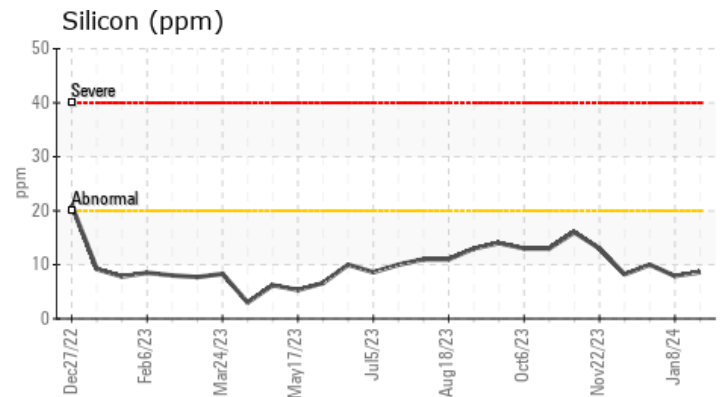
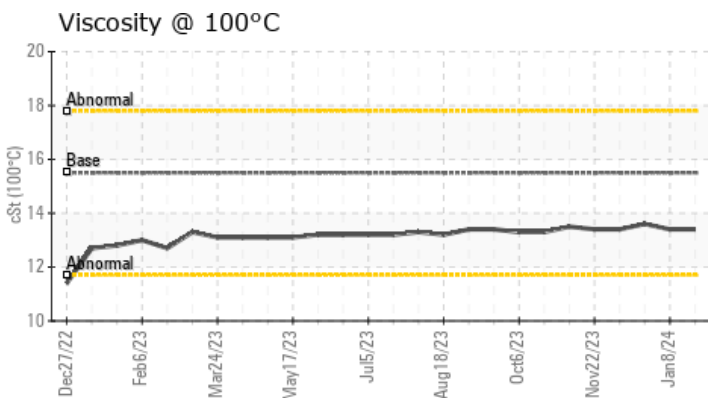
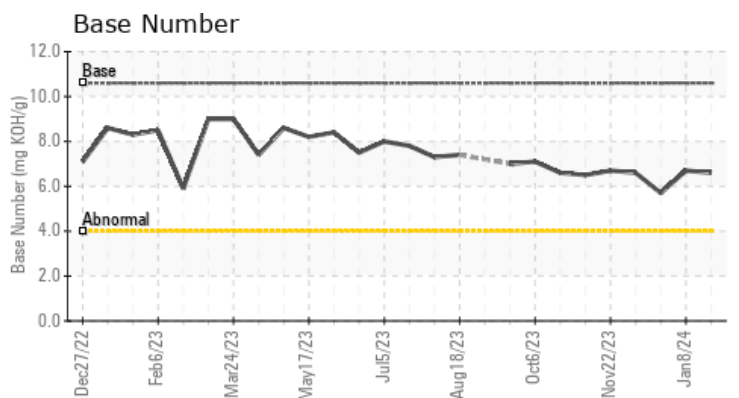
## GRAPHS

Resample at the next service interval to monitor. All component wear rates are normal. There is no indication of any contamination in the oil. The BN result indicates that there is suitable alkalinity remaining in the oil. The condition of the oil is suitable for further service.
