## 600189 WASTE MGMT VOLVO L120H 632191 - TRANSMISSION (AUTO)

**Sample No:** VCP349201  
**Oil Type:** VOLVO AUTOMATIC TRANSMISSION FLUID AT102  
**Job No:** 600189 WASTE MGMT

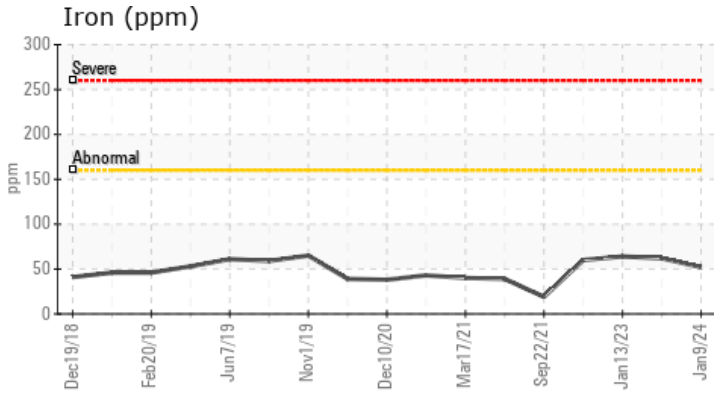
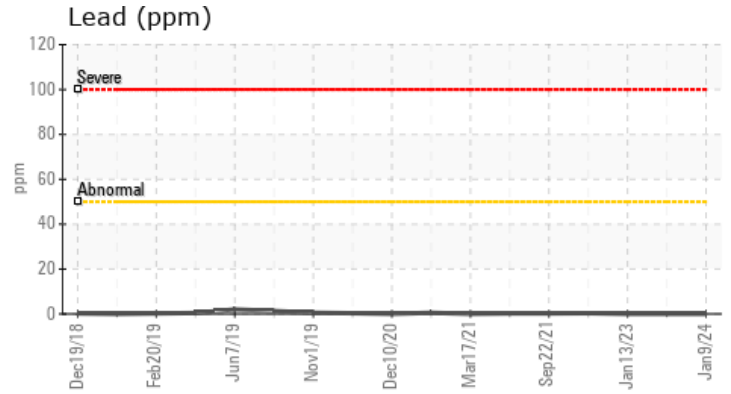
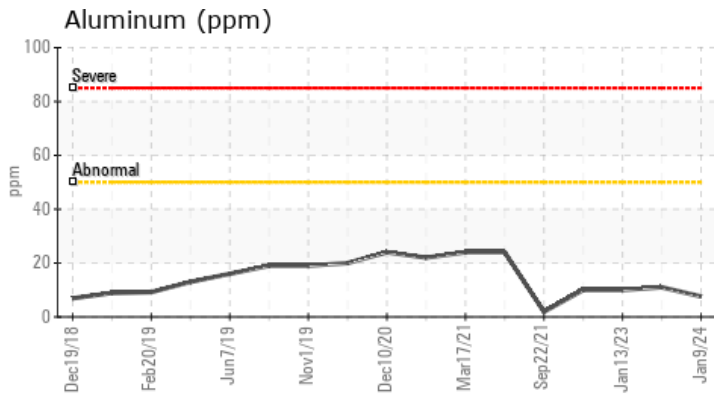
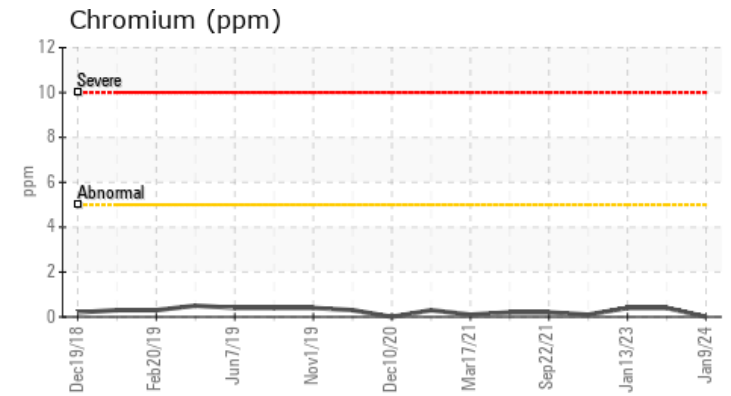
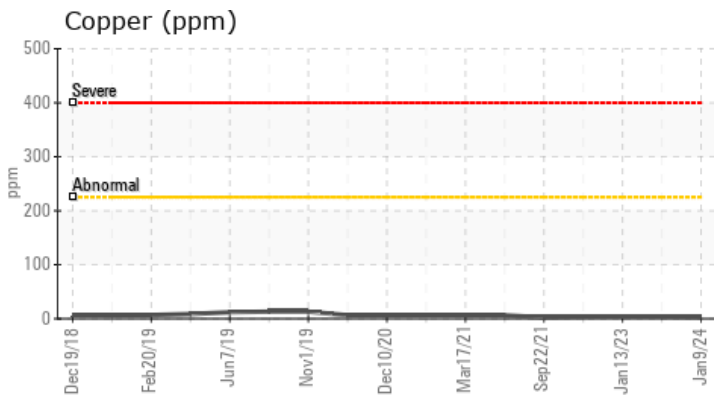
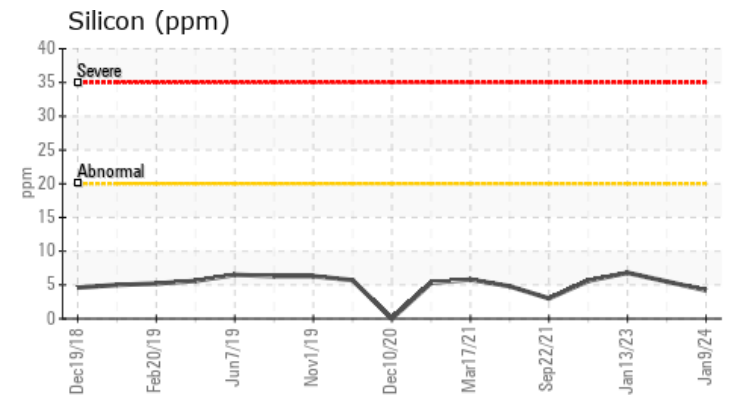
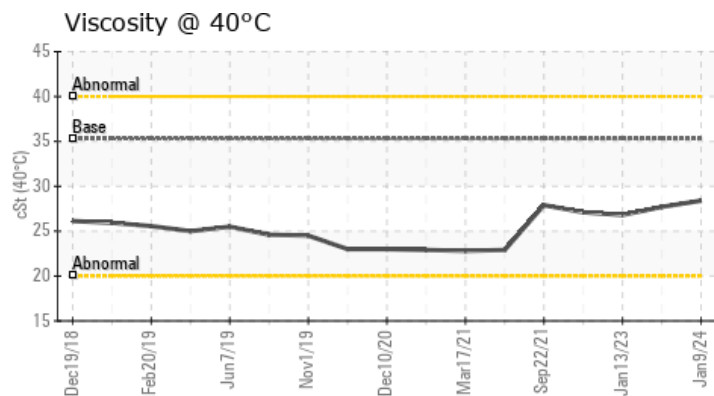
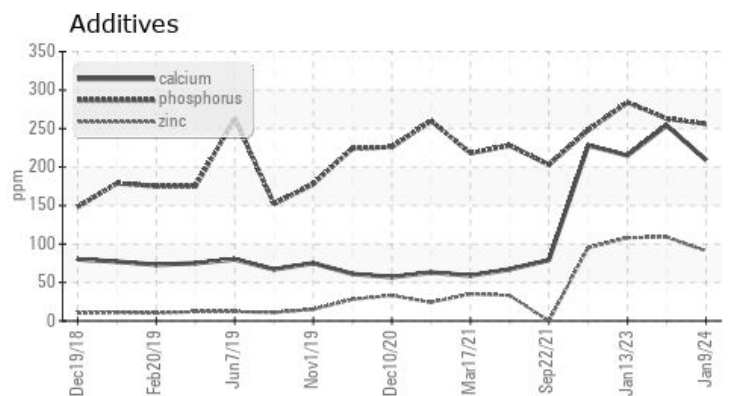
## VOLVO GRAPHS

Resample at the next service interval to monitor. All component wear rates are normal. There is no indication of any contamination in the fluid. The condition of the fluid is acceptable for the time in service.
