# CONSTRUCTION EQUIPMENT

## VOLVO L110H 631322 - TRANSMISSION (AUTO)

**Sample No:** VCP432127

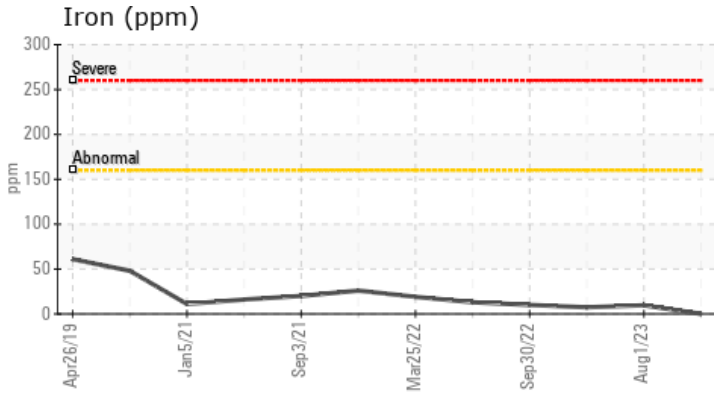
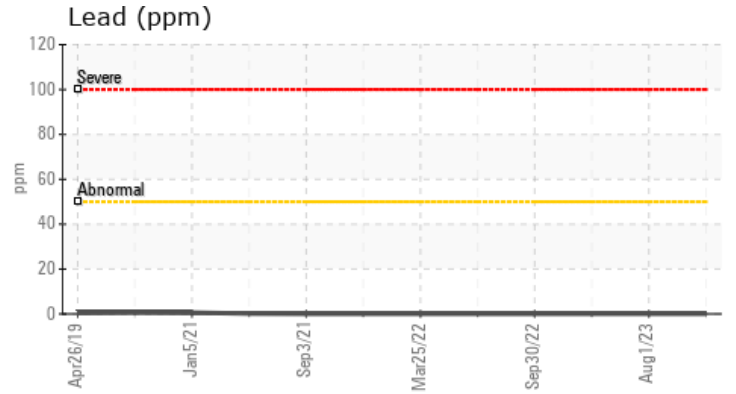
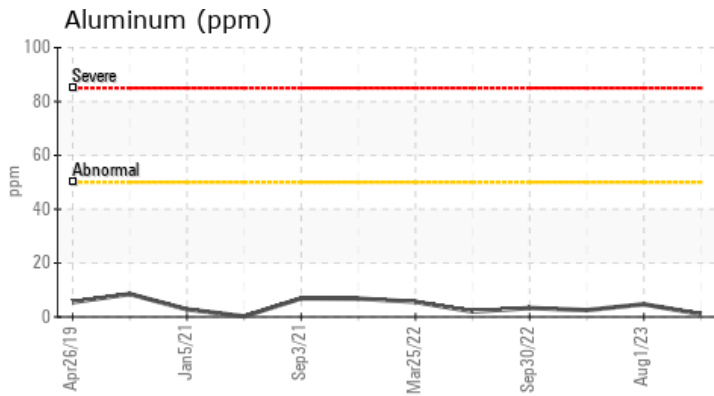
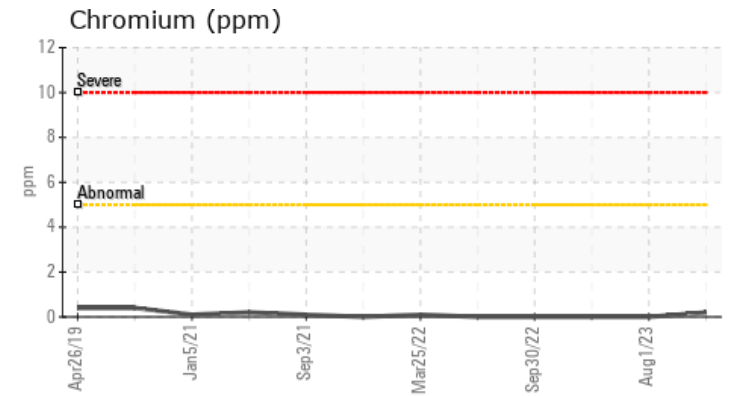
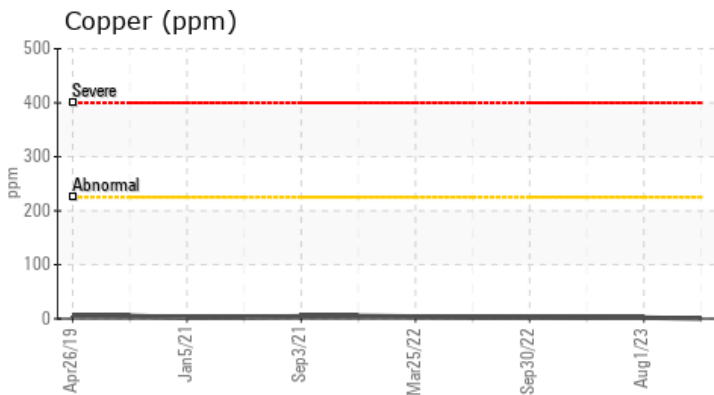
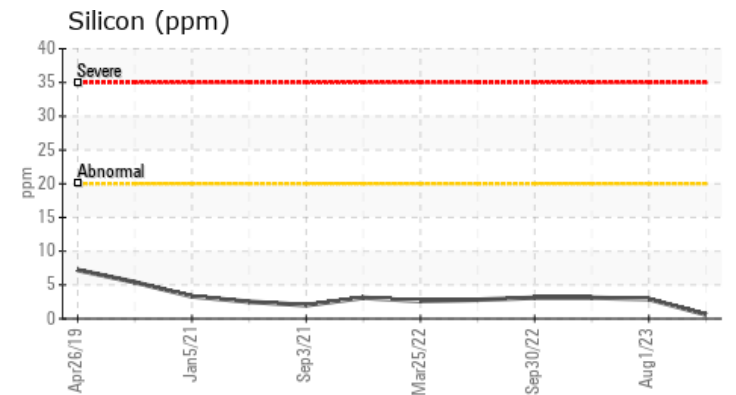
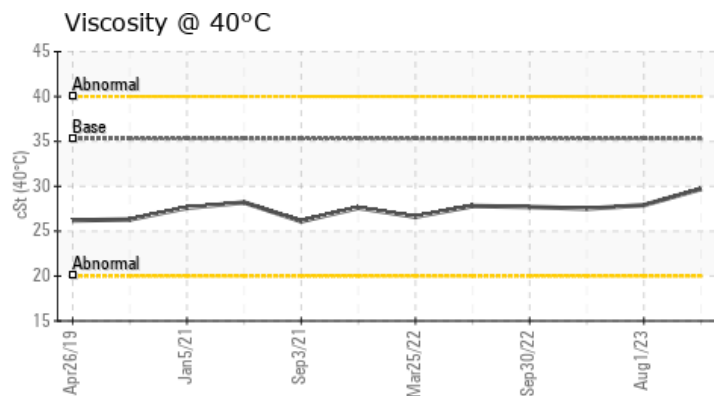
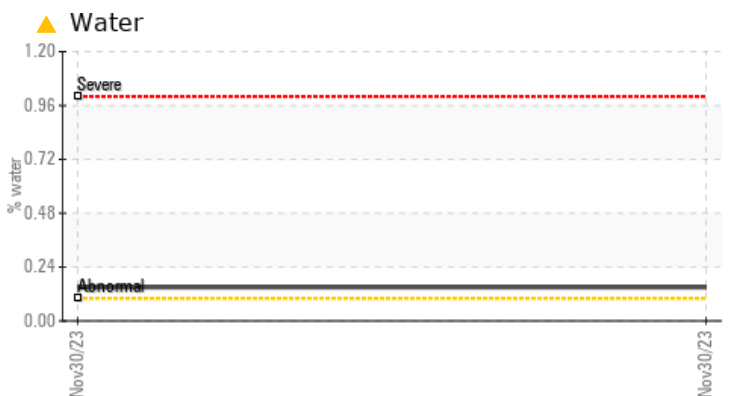
## VOLVO GRAPHS

Resample at the next service interval to monitor. All component wear rates are normal. There is a light concentration of water present in the fluid. The condition of the fluid is acceptable for the time in service.
