CONSTRUCTION EQUIPMENT

VOLVO L260 001349 - TRANSMISSION (AUTO)

Sample No: VCP430398
Oil Type: VOLVO AUTOMATIC TRANSMISSION FLUID AT102
Job No:

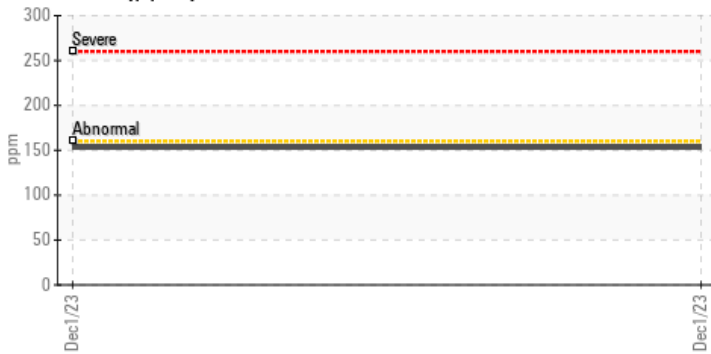
Iron (ppm)

Iron	ppm	█ 153	---	---	---
Copper	ppm	█ 12	---	---	---
Lead	ppm	█ <1	---	---	---
Tin	ppm	█ <1	---	---	---
Aluminum	ppm	█ 5	---	---	---
Chromium	ppm	█ 1	---	---	---
Molybdenum	ppm	█ <1	---	---	---
Nickel	ppm	█ <1	---	---	---
Titanium	ppm	<1	---	---	---
Silver	ppm	█ 0	---	---	---
Manganese	ppm	█ 7	---	---	---
Vanadium	ppm	0	---	---	---

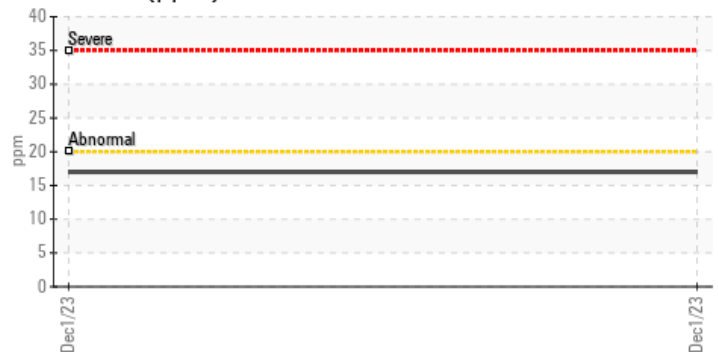
Silicon (ppm)

Water	%	NEG	---	---	---
Silicon	ppm	█ 17	---	---	---
Sodium	ppm	█ 0	---	---	---
Potassium	ppm	█ 2	---	---	---

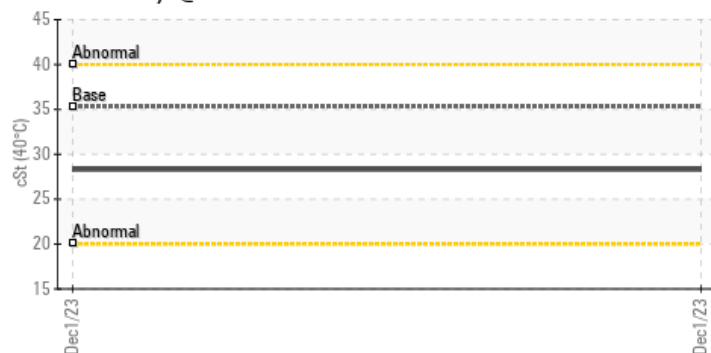
Viscosity @ 40°C

Visc @ 40°C	cSt	█ 28.3	---	---	---
-------------	-----	--------	-----	-----	-----

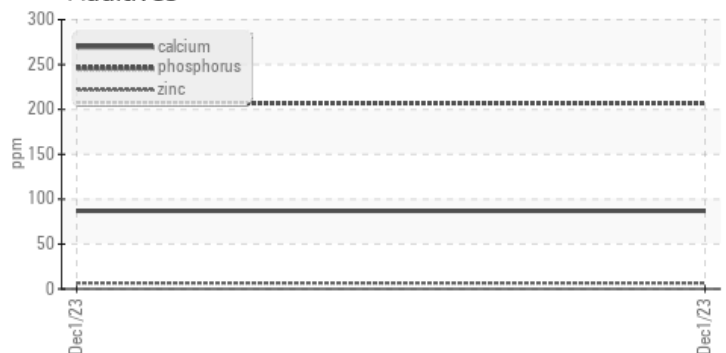
Additives

Calcium	ppm	█ 87	---	---	---
Magnesium	ppm	█ 1	---	---	---
Zinc	ppm	6	---	---	---
Phosphorus	ppm	█ 207	---	---	---
Barium	ppm	█ 0	---	---	---
Boron	ppm	█ 69	---	---	---
