SPM658877 VOLVO A25G 752898 - DIESEL ENGINE

Sample No: VCP429135
Oil Type: DIESEL ENGINE OIL SAE 15W40
Job No: SPM658877

Sample Number	VCP429135	---	---	---
Sample Date	15 Sep 2023	---	---	---
Machine Hours	567	---	---	---
Oil Hours	0	---	---	---
Oil Changed	Changed	---	---	---
Sample Status	ABNORMAL	---	---	---

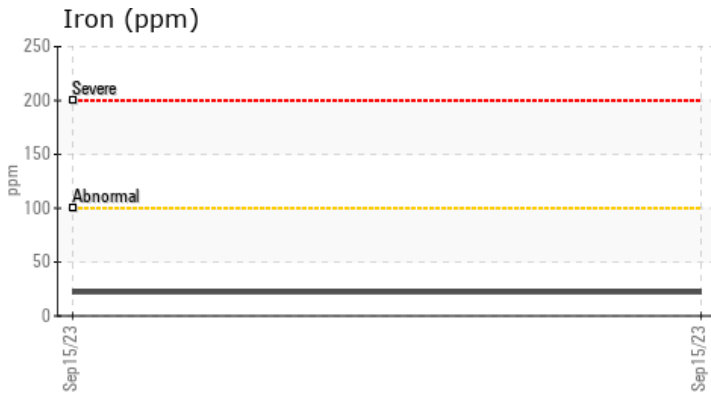
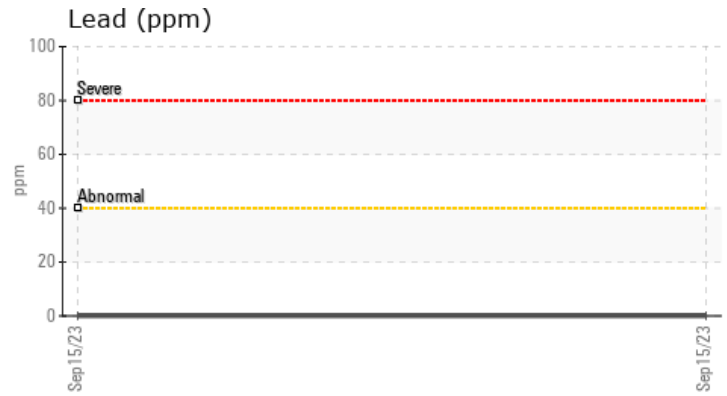
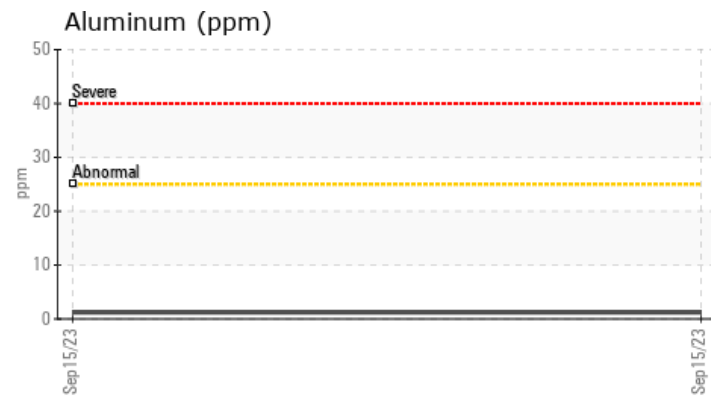
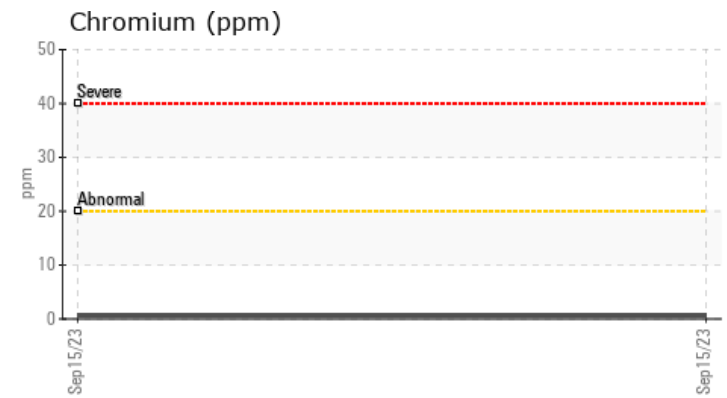
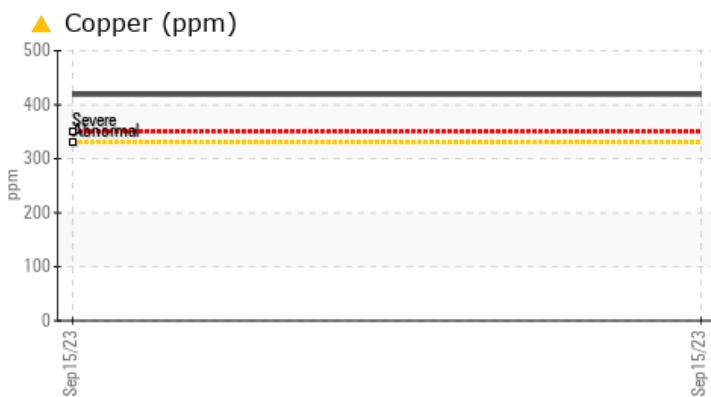
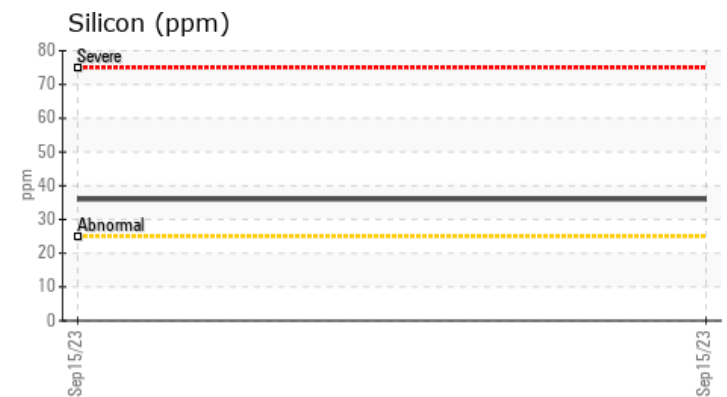
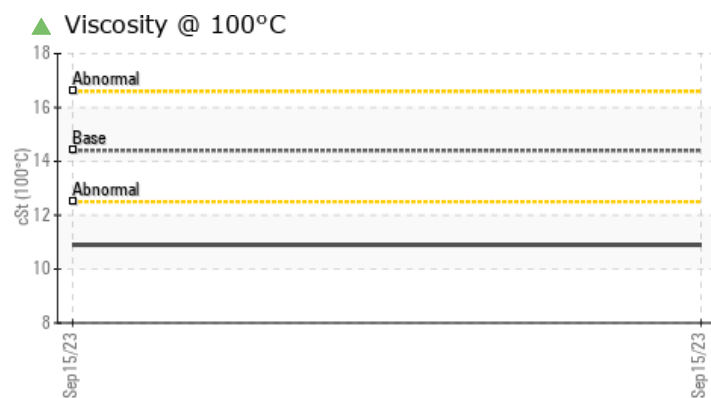
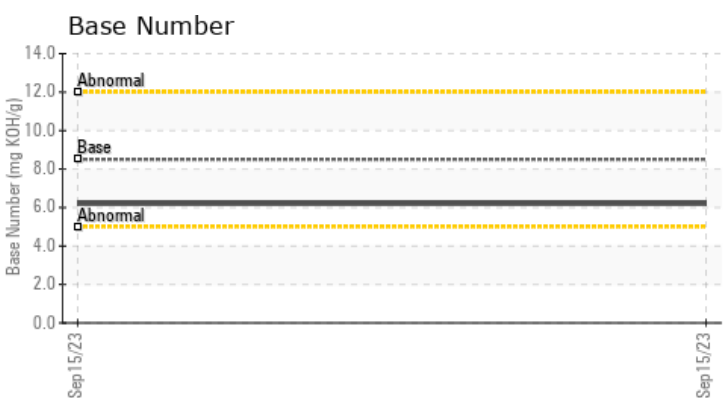
GRAPHS

Oil and filter change at the time of sampling has been noted. Resample at the next service interval to monitor. The copper level is abnormal. In the absence of other significant wear metals, suspect copper due to sources other than wear (i.e. cooling core). All other metal levels are typical for a new component breaking in. Fuel content negligible. There is no indication of any contamination in the oil. The oil viscosity is lower than normal. The BN result indicates that there is suitable alkalinity remaining in the oil. Confirm oil type.
