CONSTRUCTION EQUIPMENT

433891 PATRICK OHMST VOLVO SD25D 194145 - COOLANT

Sample No: VCP368539
Oil Type: VOLVO COOLANT (GREEN)
Job No: 433891 PATRICK OHMST

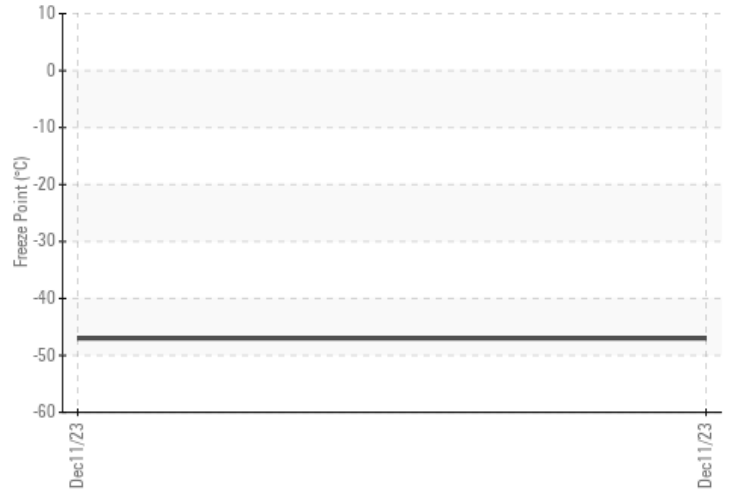
Freeze Point

pH	Scale 0-14	■ 8.69	---	---	---
Reserve Alkalinity	Scale 0-20	---	---	---	---
Nitrites	ppm	■ 560	---	---	---
Percentage Glycol	%	■ 55.3	---	---	---
Freezing Point	°C	■ -47	---	---	---

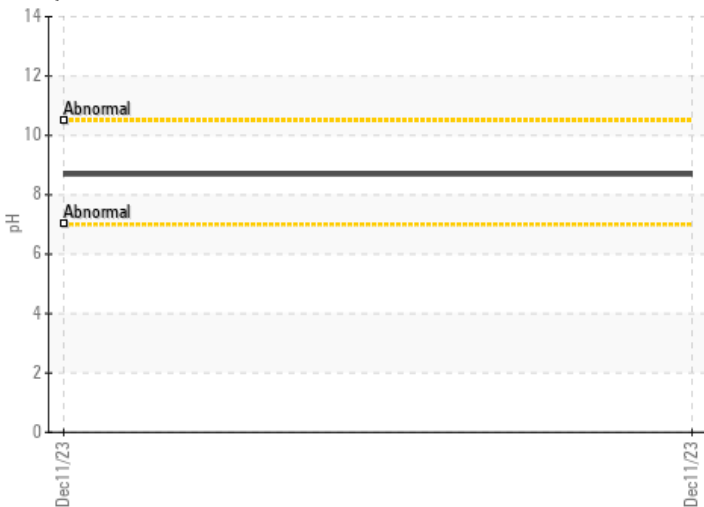
We recommend drain/flush system, and refill with 50/50 antifreeze water mixture. Sediment present. Glycol and nitrite levels are acceptable. The pH level of this fluid is within the acceptable limits.
