# CONSTRUCTION EQUIPMENT

TMR-PUNTA GORDA SWA488068 467142 VOLVO L90H 624974 - TRANSMISSION (AUTO)

**Sample No:** VCP437762  
**Oil Type:** VOLVO AT 102  
**Job No:** SWA488068

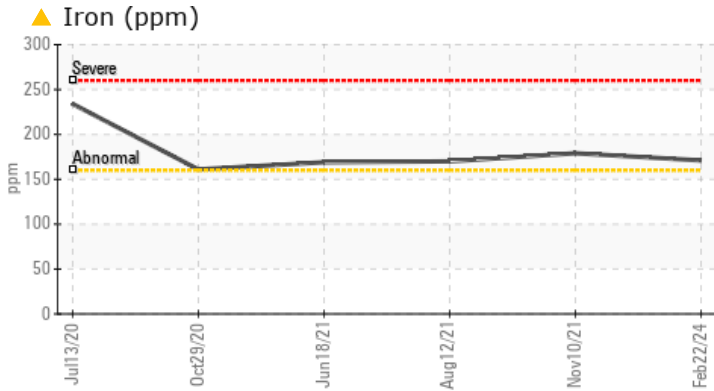
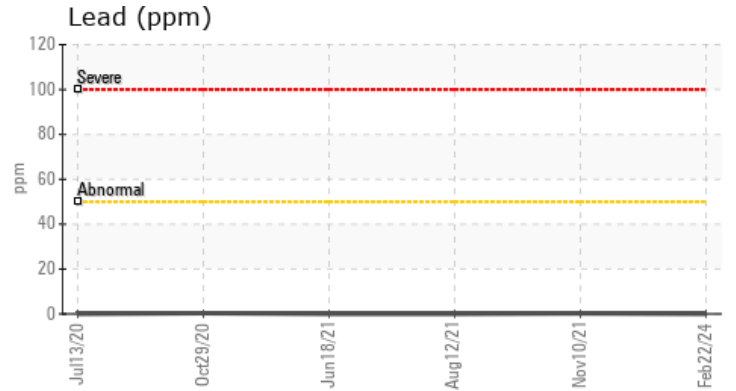
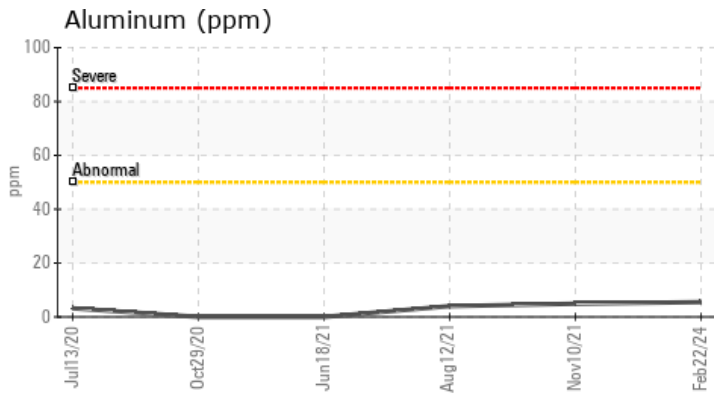
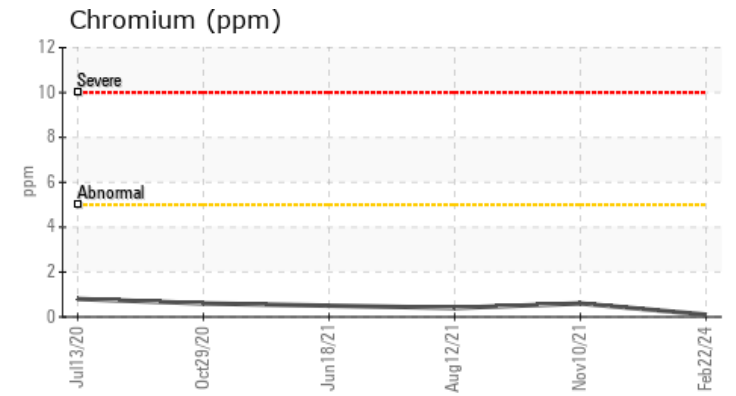
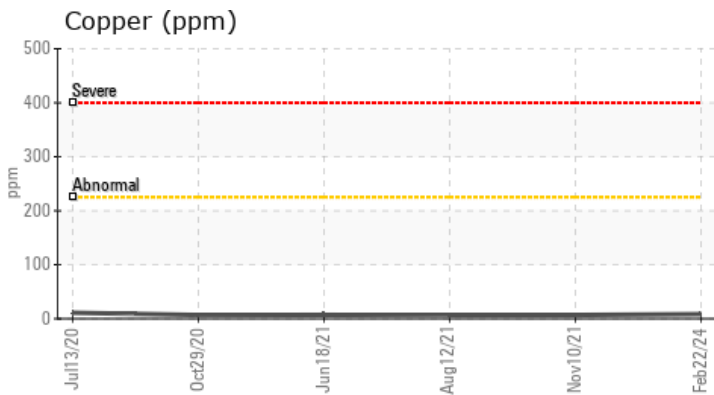
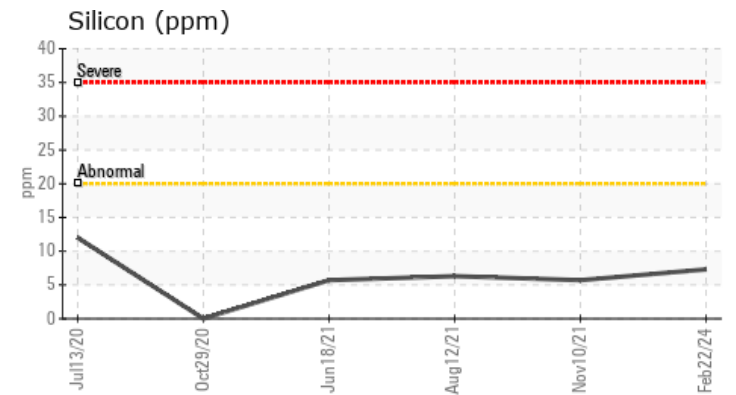
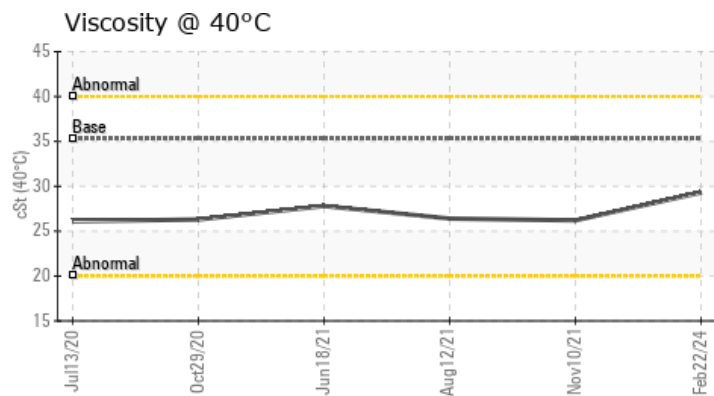
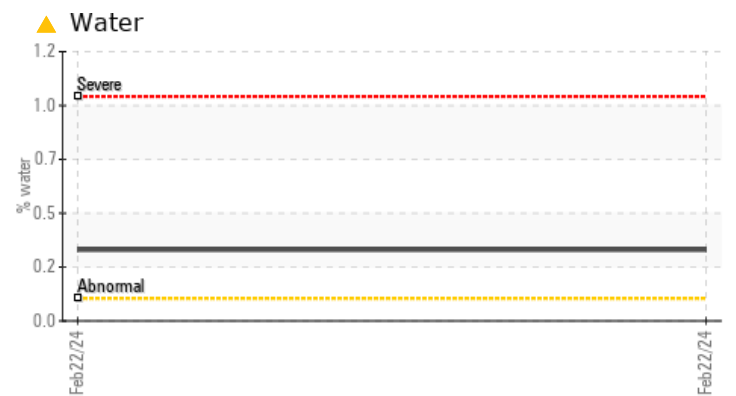
## VOLVO GRAPHS

We advise that you check for the source of water entry. We advise that you follow the water drain-off procedure for this component. We recommend an early resample to monitor this condition. Gear wear is indicated. Free water present. There is a light concentration of water present in the fluid. There is a moderate amount of visible silt present in the sample. The condition of the fluid is acceptable for the time in service.
