CONSTRUCTION EQUIPMENT

VOLVO L110H 631231 - TRANSMISSION (AUTO)

Sample No: VCP440128

Oil Type: DIESEL ENGINE OIL SAE 15W40

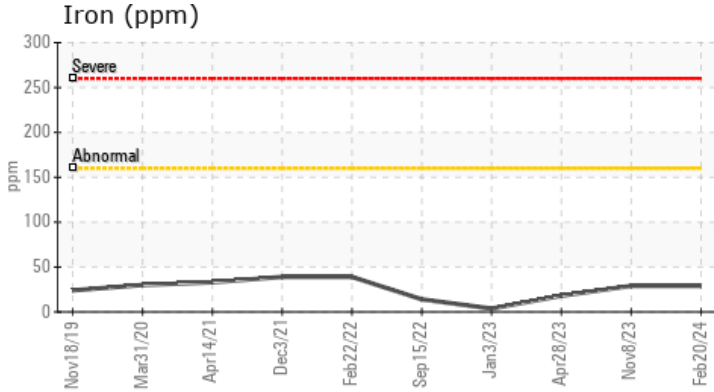
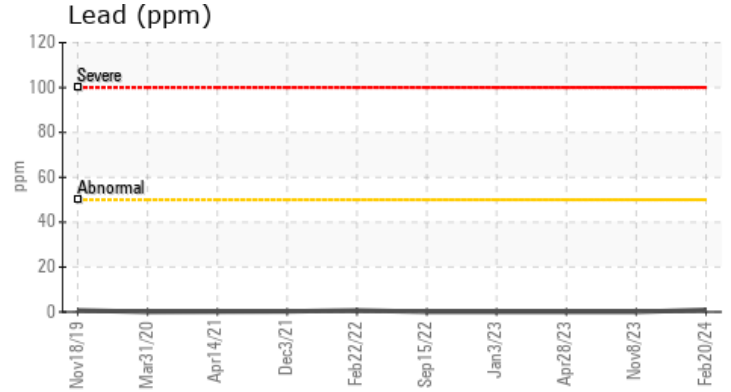
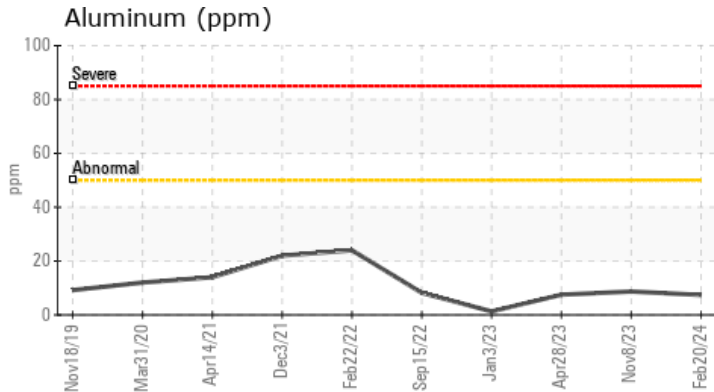
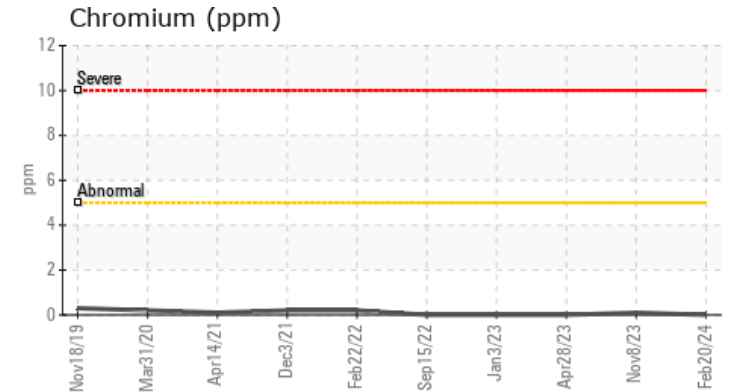
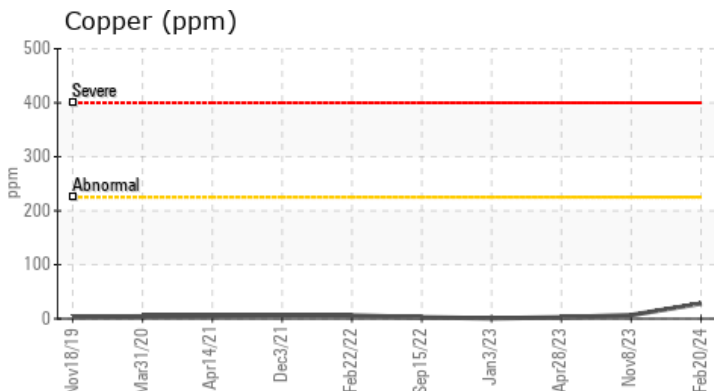
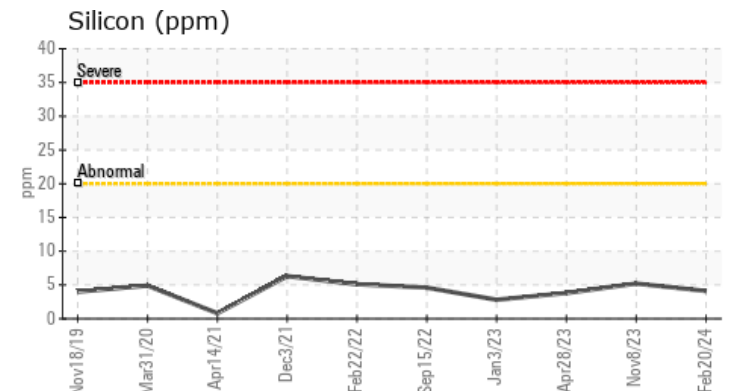
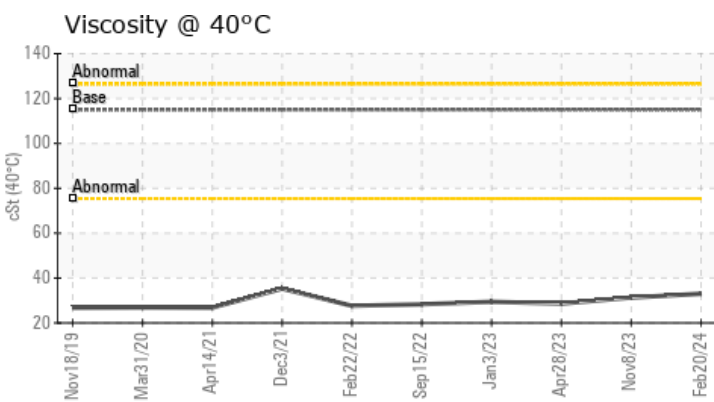
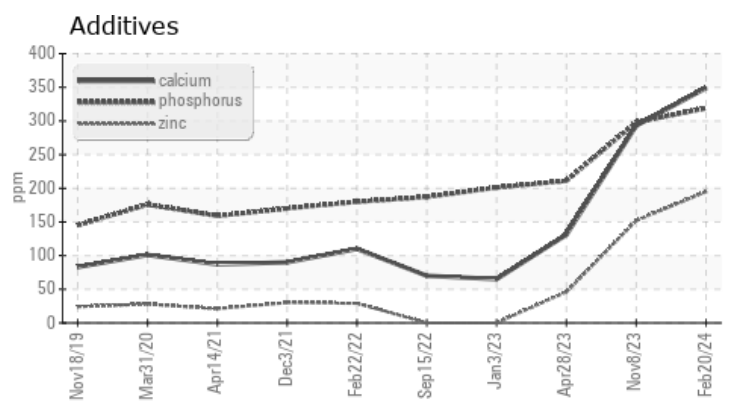
VOLVO GRAPHS

We recommend you service the filters on this component. Resample at the next service interval to monitor. Moderate concentration of visible metal present. All component wear rates are normal. There is no indication of any contamination in the fluid. The condition of the fluid is acceptable for the time in service.
